Report 95-011

de Havilland DHC-8, ZK-NEY

controlled flight into terrain

9 June 1995

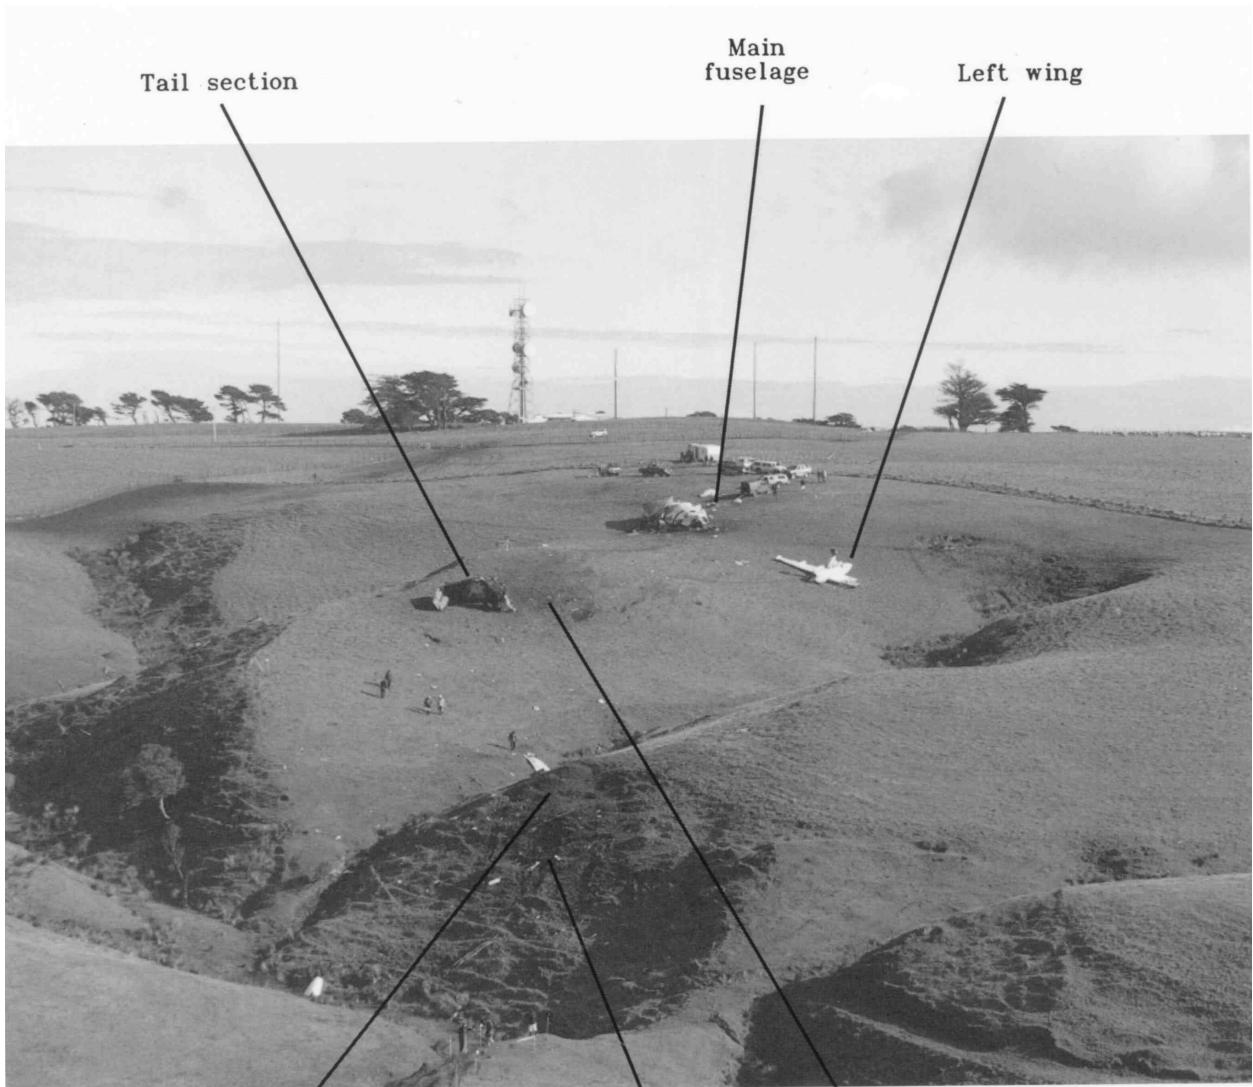
Accident Site - General View

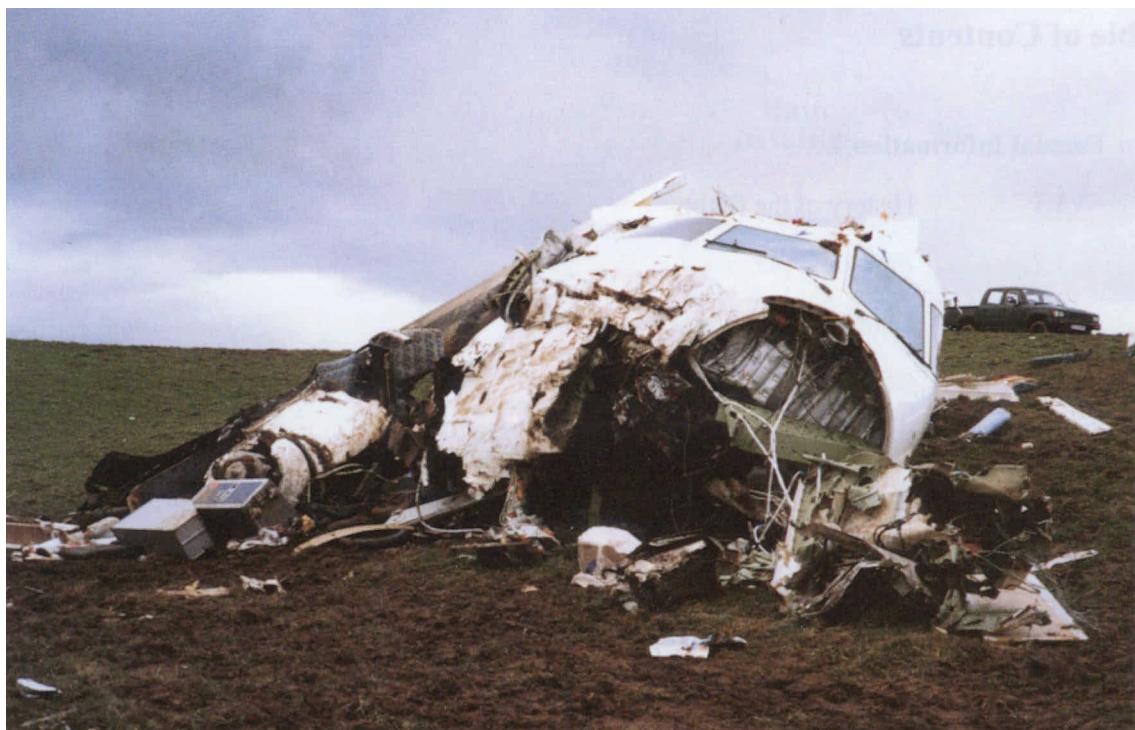
ZK-NEY looking aft

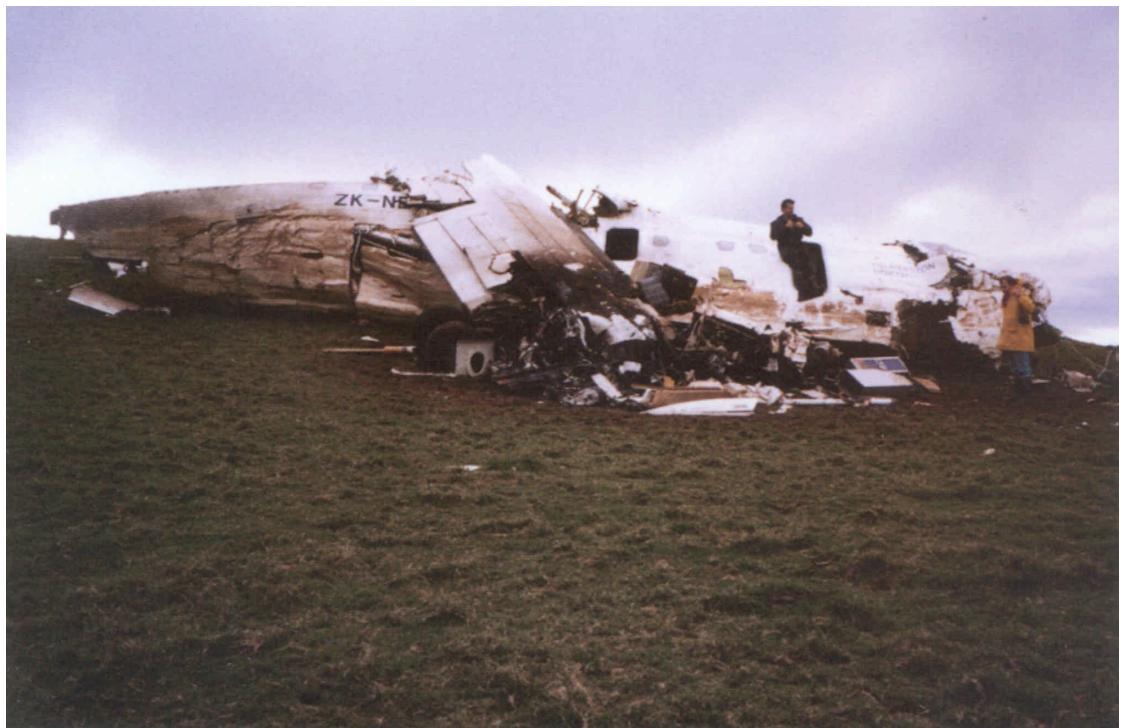
ZK-NEY right side

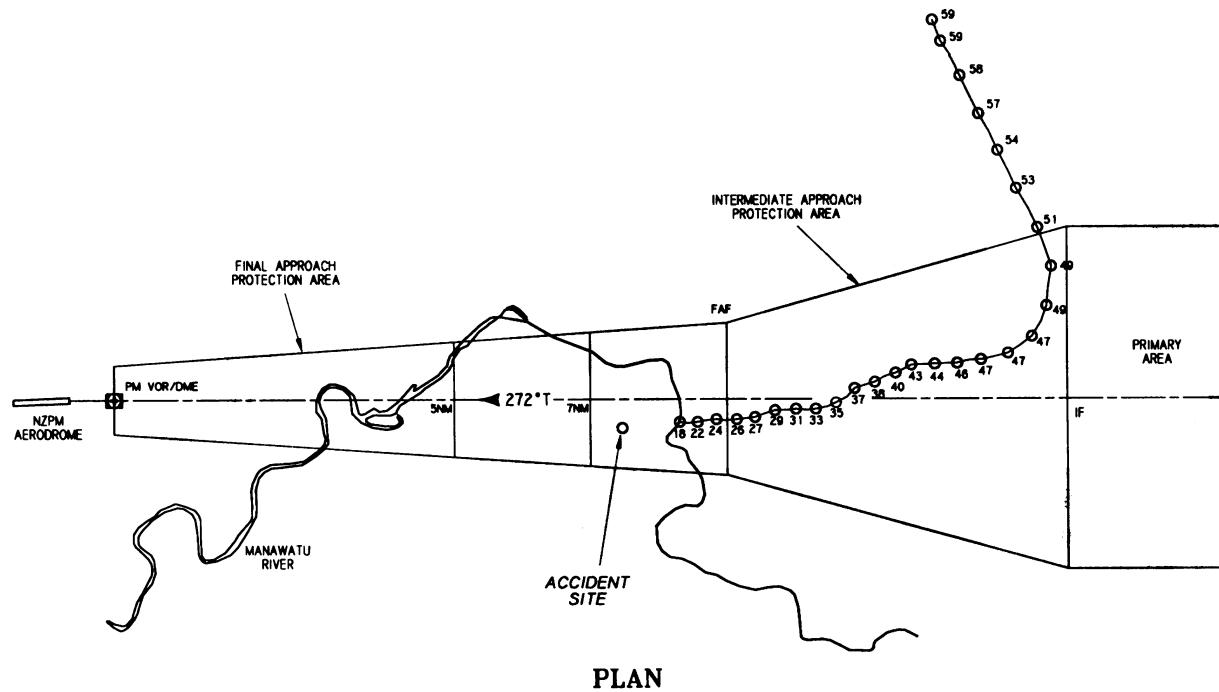
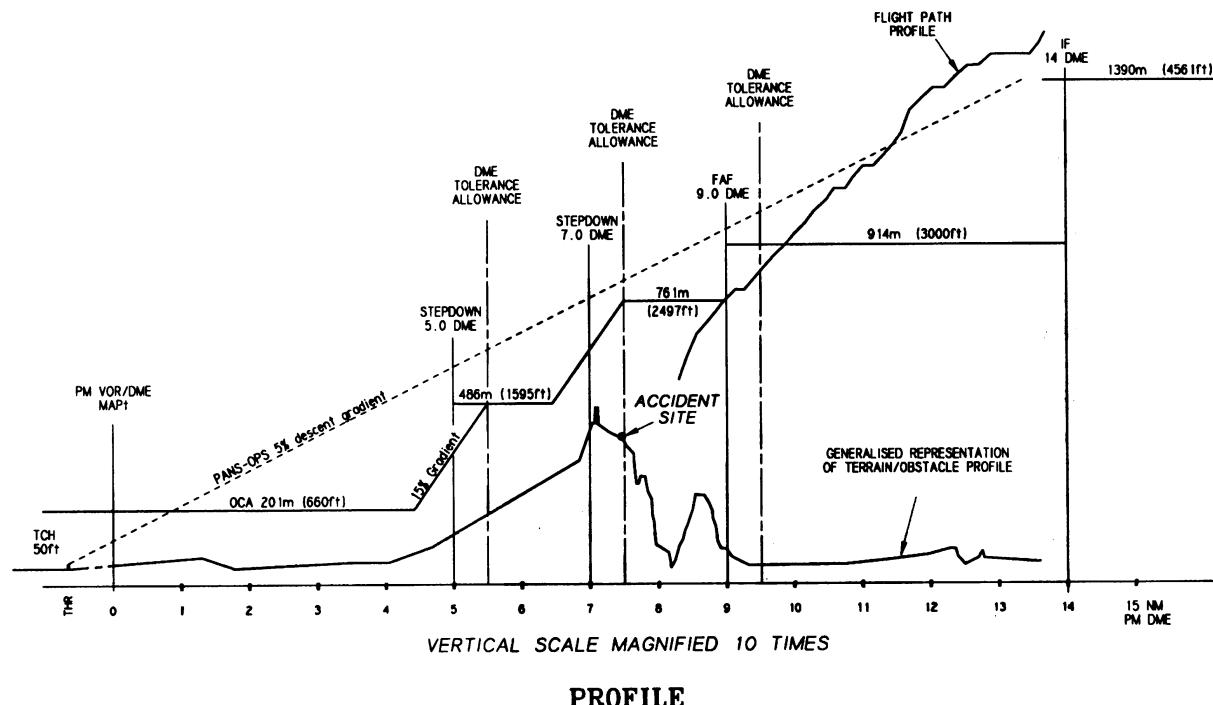
Figure 3
Copy of simplified procedure design
with radar data overlaid

1.8.19 The printout of the radar recording (see Figure 3) showed that the aircraft had descended around the 14 DME arc and had turned to intercept the final approach track normally at 5100 feet, at 0919.12 hours. On the final approach the aircraft was left of the specified track of 250° M to the VOR, being initially about one degree right of track, then crossing and maintaining about two degrees left of track to the last return. The Mode C altitude data showed a continuous descent through 2500 feet at 9 DME, to 1800 feet at the last return.

1.8.20 The study of the radar recording after the accident showed that the Mode C altitude data on the final approach, in conjunction with the aircraft’s position, could have enabled a radar controller to monitor the aircraft’s compliance with the instrument approach procedure while it was being carried out.

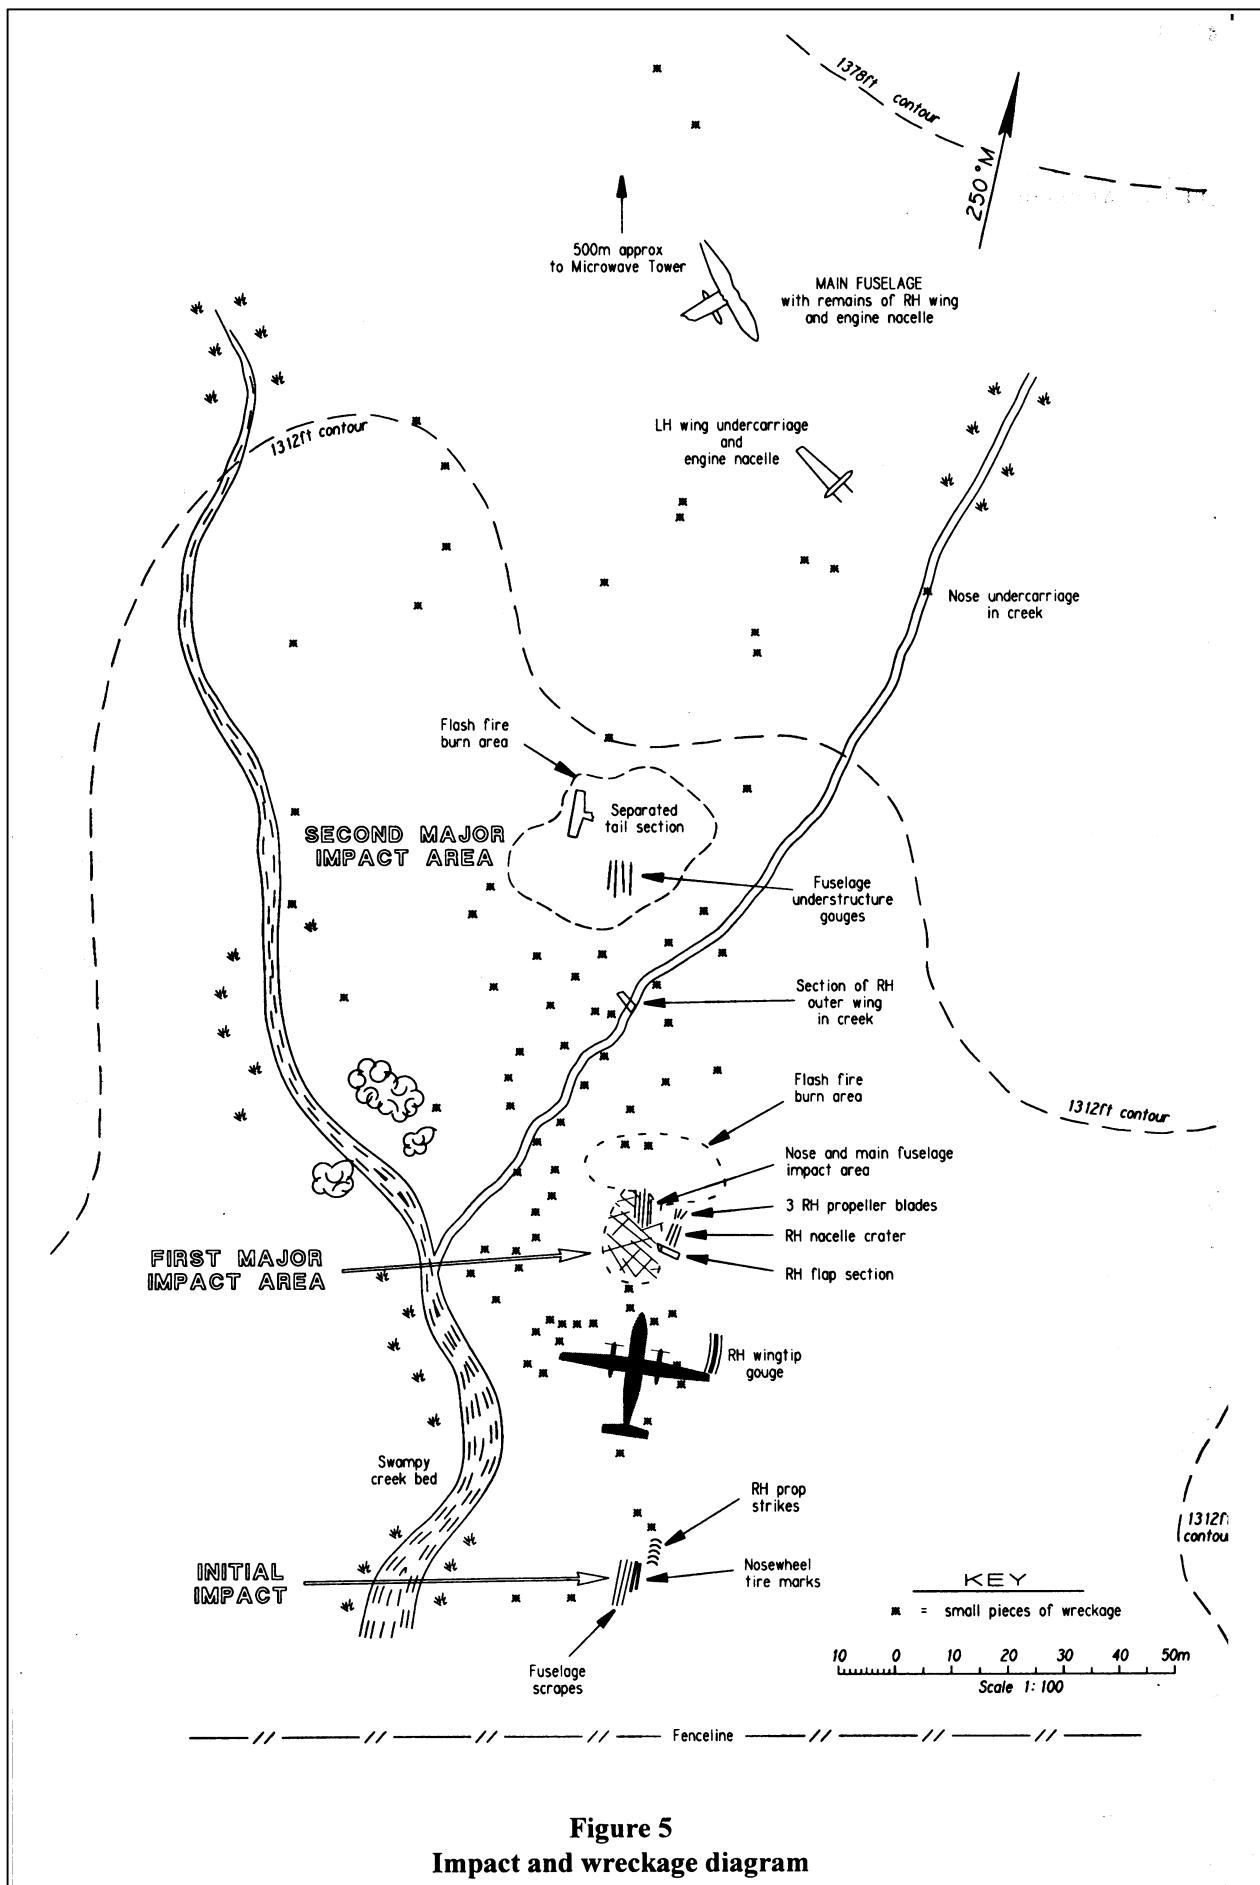
Figure 5
Impact and wreckage diagram

- 1.12.2 ZK-NEY collided with the upper slope of the hills on the eastern side some 740 m east of a microwave tower while flying the approach path 8 nm (15 km) from the threshold of runway 25 at Palmerston North Aerodrome.

- 1.12.3 The accident occurred on private farmland which was divided by post and wire fences for grazing. The various areas involved in the impact sequence and the pieces of wreckage were all located in one large hillside paddock. (See Figure 5.) The paddock included two gullies and intersecting spurs of high ground rising toward the hilltop. The principal impact zones and general wreckage trail followed an uphill pattern over open grassland, although items of wreckage were distributed into gullies during the accident sequence.

- 1.12.4 The initial ground impact occurred as the nosewheel of ZK-NEY contacted a gently rising grassy knoll which had an overall up-slope of about 5°. The aircraft was approximately level laterally at the time.

- 1.12.13 Approximately 28 m further on and 70 m beyond the grass knoll, the aircraft struck a terraced grass spur which had an upslope, in the impact area, of about 30°. The orientation of the spur was such that the major impact was absorbed by the aircraft's fuselage, right engine and right wing assembly. Three of the four already damaged right propeller blades detached from their hub and a four-metre-long section of the right outboard wing flap, together with smaller portions of other components from the lower fuselage and right side of the aircraft, were strewn over this impact area.

1.12.17 The damaged fuselage section comprising the flight deck and cabin, with the remains of the right wing and right engine installation loosely attached, continued uphill until brought to rest against a bank on the hillside, having traversed a total distance of about 235 m from initial impact. The fuselage was slewed through some 150° and lay across the slope on a heading of 040°M partially rolled onto its left side, at an elevation of 1345 feet amsl.

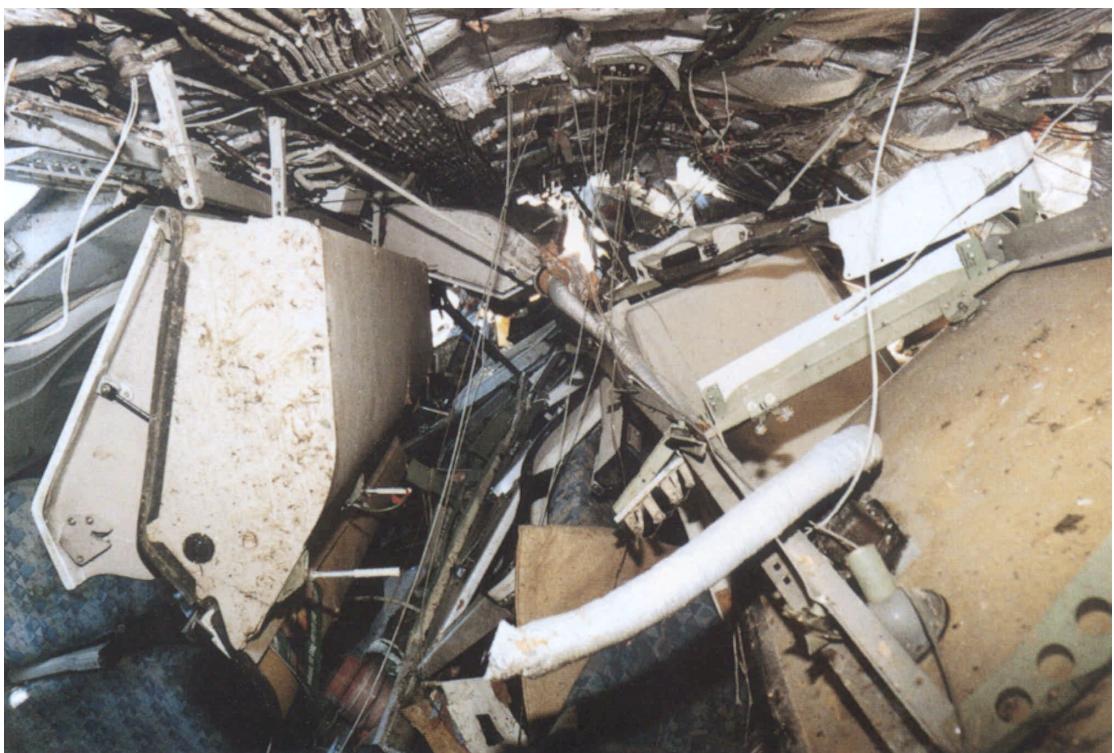
1.13.3 Prior to coming to rest the lower part of the fuselage structure failed and split longitudinally, resulting in a height difference of up to a metre between the right and left halves of the cabin floor.

1.13.5 During the initial vertical impacts, many of the mountings for the cabin ceiling and the baggage lockers failed, resulting in a partial collapse of the ceiling and lockers. Most of the disruption to the baggage lockers occurred in the wing root area.

Figure 6a
View of passenger cabin looking aft

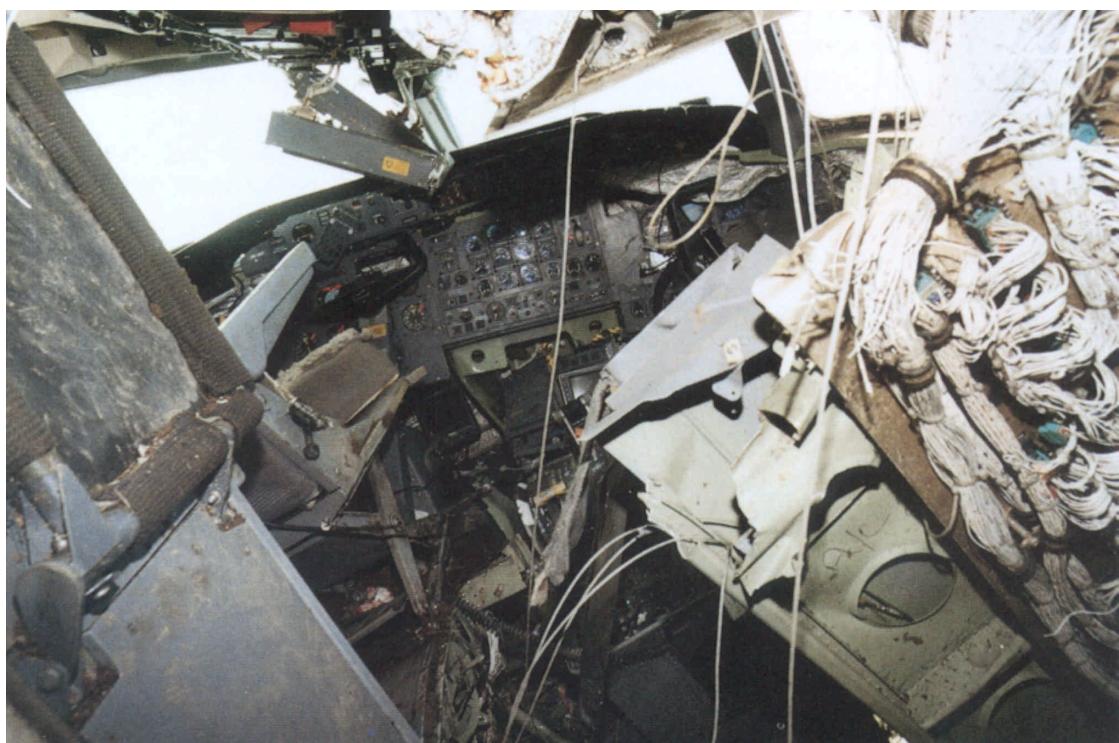
Figure 6b
View of flight deck
