ATSB TRANSPORT SAFETY INVESTIGATION REPORT  
Aviation Occurrence Report 200501977  
Final

Collision with Terrain  
11 km NW Lockhart River Aerodrome  
7 May 2005  
VH-TFU  
SA227-DC (Metro 23)

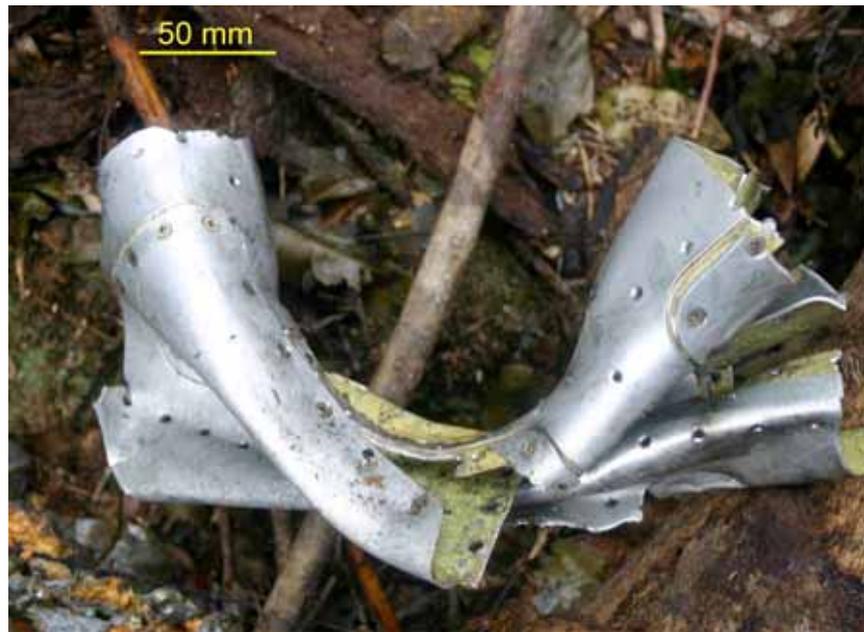
**Figure 20: Wing section showing impact damage with a tree trunk or branch**

As the aircraft flew through the crowns of the trees, the outboard sections of both wings and the blades of both propellers separated from the aircraft. The aircraft continued along a descending flight path, contacting tree trunks and branches. This resulted in further sections of both wings, the engines and sections of the horizontal stabiliser and elevators being torn off. The nose of the aircraft then impacted boulders and broke up. The remaining left wing structure then impacted a rock outcrop causing the fuselage to roll to the right approximately 50 degrees (Figure 21).

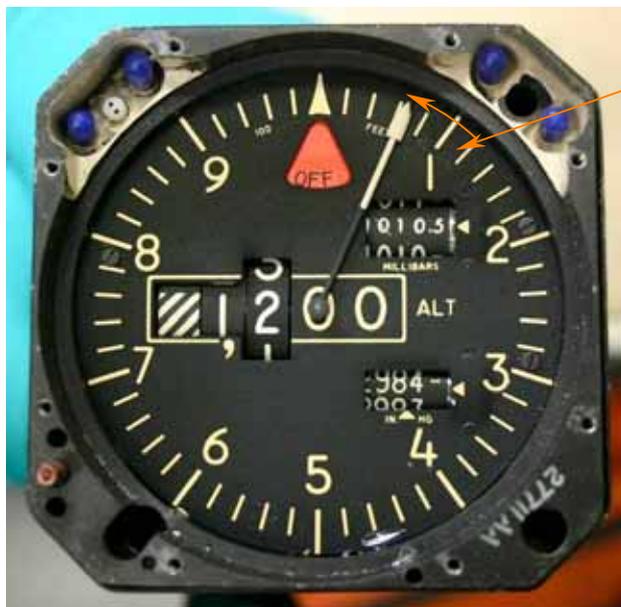
**Figure 23: Pilot in command's encoding altimeter**

Scrape marks on instrument face from pointer (arrow indicates direction of scrapes)

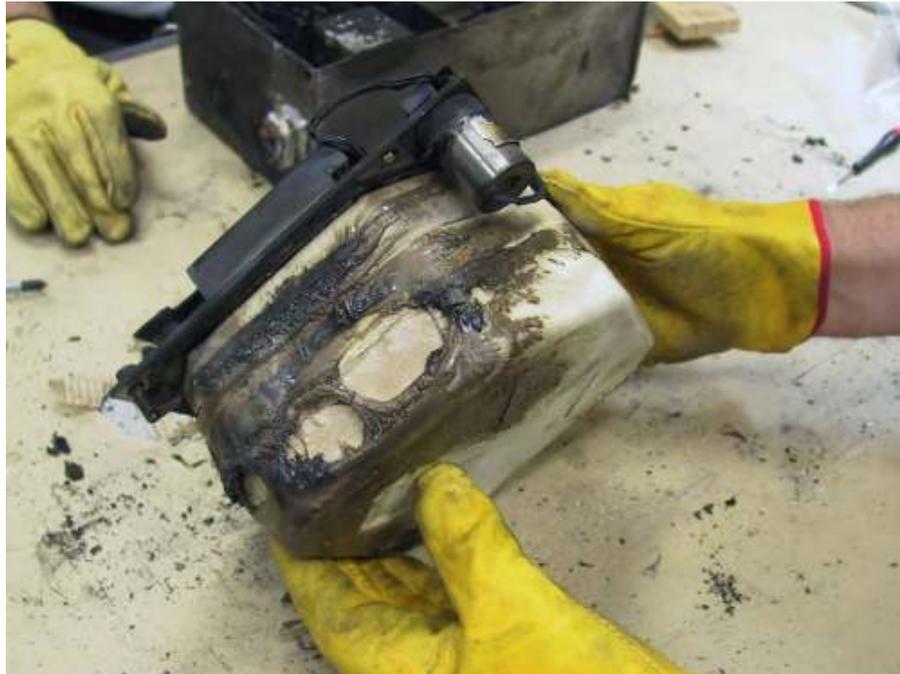
**Figure B-4: Crash protected module with armouring removed. Heat damage to the fire protection can be seen.**

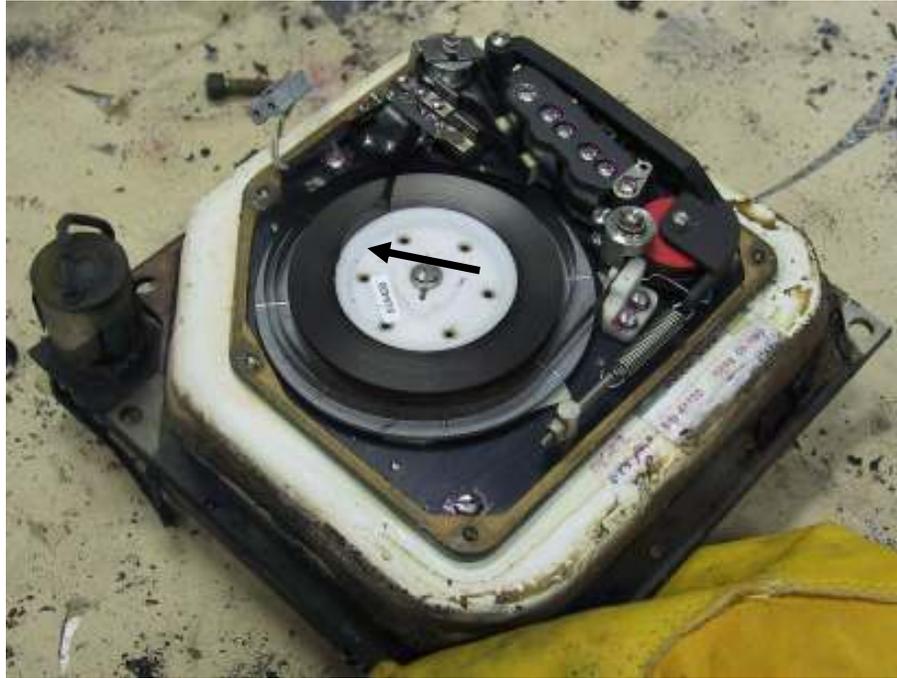
**Figure B-5: Recording tape in tape transport; note slight damage to tape at centre of spool.**

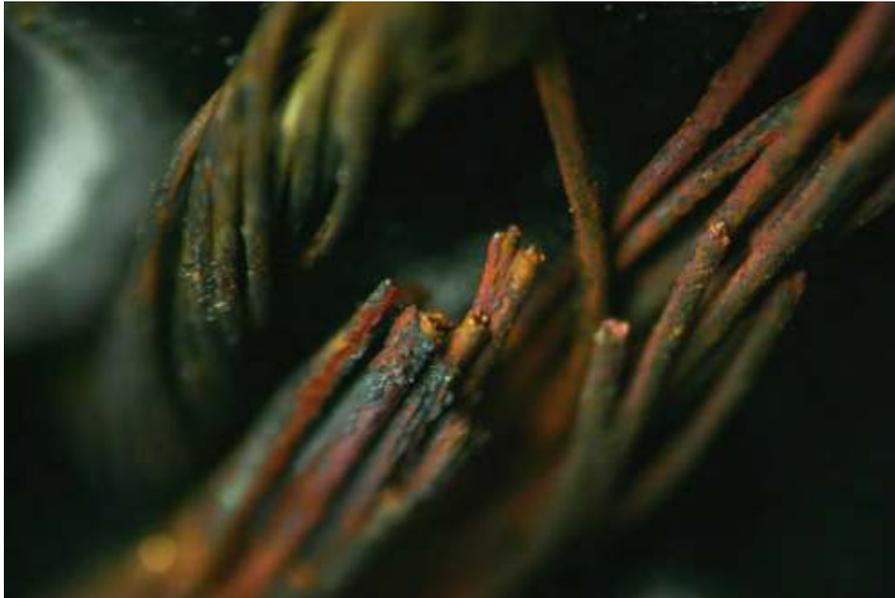
Examination of the wire strands showed they had failed in overload and exhibited ductile 'necking' and a crystalline fracture surface, as shown in Figure B-17. A similar characteristic was exhibited by the broken strands of the wire connecting to pin 9, the connection to the aircraft 27.5 V d.c. power supply. A close up photograph is shown in figure 18.

**Figure B-17: Photograph of aircraft interface connector wire strand ductile unpowered fracture**
