FINAL REPORT

AAIU Synoptic Report No: 2009-010
State File No: IRL00900939
Published: 21/04/09

Aircraft Type and Registration:	McDonnell Douglas MD-83, G-FLTM
No. and Type of Engines:	2 x Pratt & Whitney JT8D-219
Aircraft Serial Number:	53052
Year of Manufacture:	1990
Date and Time (UTC):	16 August 2007 @ 23.34 hrs
Location:	Santry Cross, near Dublin Airport
Type of Flight:	Public Transport
Persons on Board:	Crew – 6 Passengers – 112
Injuries:	Crew – Nil Passengers – Nil
Nature of Damage:	None
Commander's Licence:	Airline Transport Pilot's Licence (Aeroplanes), issued in Croatia
Commander's Details:	Male, aged 42 years
Commander's Flying Experience:	5,077 hours, of which 2,626 were on type
Notification Source:	Station Manager, Dublin ATC
Information Source:	AAIU Field investigation

SYNOPSIS

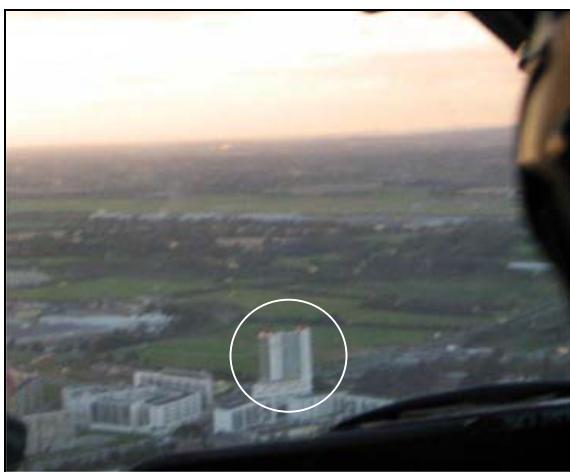
Photo No. 1:
16-storey building at Santry Cross
(under daylight conditions)

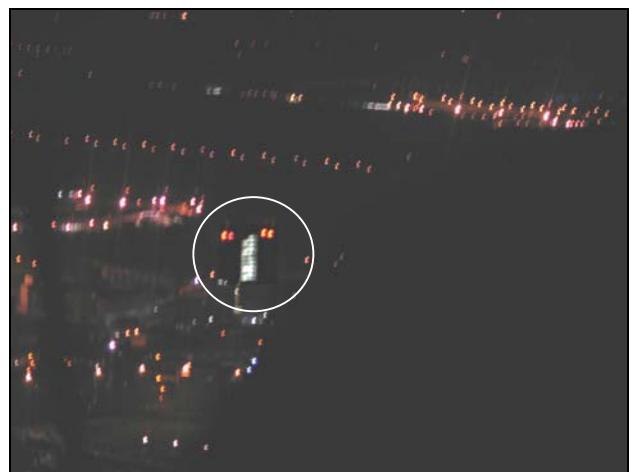
Photo No. 2:
16-storey building at Santry Cross
(under night conditions)

It was readily apparent to the Investigation that under night conditions, the lighting on the 16-storey building at Santry Cross, resembled the approach lighting on RWY 34. It was also evident that, under night conditions, the approach lighting can be difficult to identify due to extraneous lighting from the city environs on this approach. **Photo No. 4** illustrates the visual picture of the approach, at a distance of 5.5 nm to RWY 34, with the Hotel and Approach lights both visible. As this distance from the runway, the PAPI's indicate all red as the aircraft is below the visual profile.

11. On becoming visual, under clear night conditions, the Flight Crew misidentified the lighting of the 16-storey building as being the approach lighting for RWY 34.

1. The fixed red obstacle lighting on the roof of the building, together with the white internal lighting, resembled the approach lights of the landing runway when viewed from the approach path.
2. The failure of the Flight Crew to follow Company Standard Operating Procedures.
3. Poor CRM of the Flight Crew.
4. Communication with Maintenance Crews on RWY 10-28 distracted the AMC at a crucial time during the approach, while the AMC was the sole occupant of the Tower.

2. That the IAA reviews the suitability of obstacle lighting as installed on the 52 metre-high building situated at Santry Cross, Dublin (**SR 17 of 2007**). The IAA responded as follows: '*The Authority accepts Safety Recommendation SR 17 of 2007. We have reviewed the lighting scheme installed on the 52m high hotel at Santry Cross and have been in contact with the Building Management Company to have the lights changed from fixed red obstacle lights to flashing red obstacle lights. The lighting has been operational in flashing mode since Monday, 8 October 2007*'.

The two *interim* Safety Recommendations (**Section 1.19.4**) made to the IAA were put in place without delay - the modification of the obstacle lighting to flashing red from 8 October 2007 reduced the risk of misidentification re-occurring as the PAPI indicators either side of the runway always appear as a combination of white/red, but steady lights.

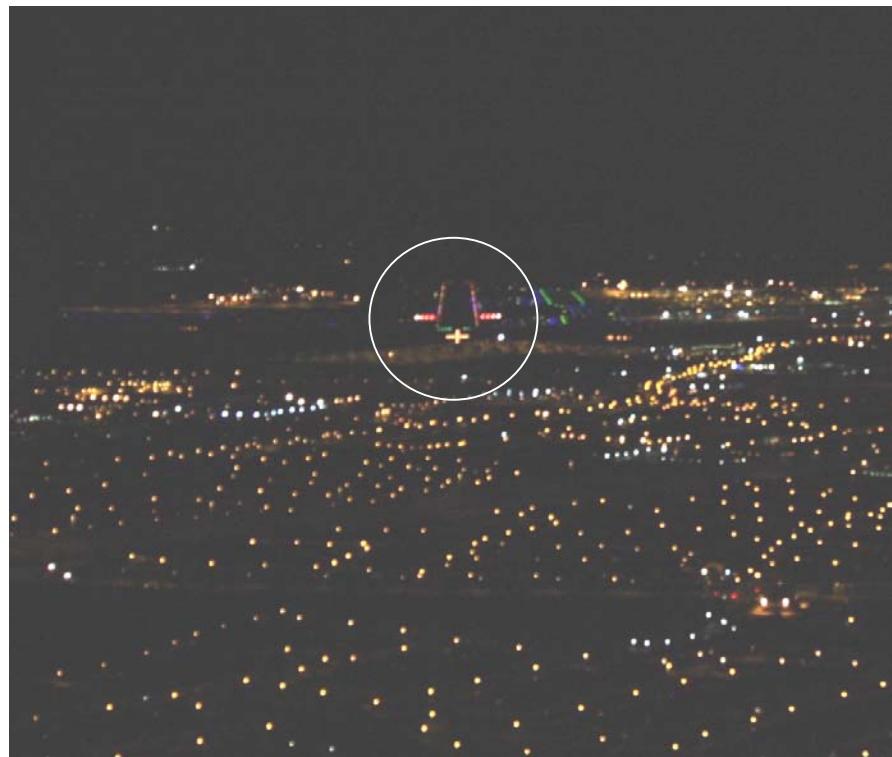
Photo No. 3 shows the RWY 34 Approach lighting as it would appear to an aircraft on finals. The aircraft is now on a 3-degree visual descent path, with guidance to the Pilot being provided by PAPI, indicating white/red either side of the RWY.

Photo No. 3: RWY 34 approach lights at 3 nm to the RWY

8. The Investigation found that due to extraneous lighting from the city environs, the approach lighting on RWY 34 was not easy to identify at a distance.

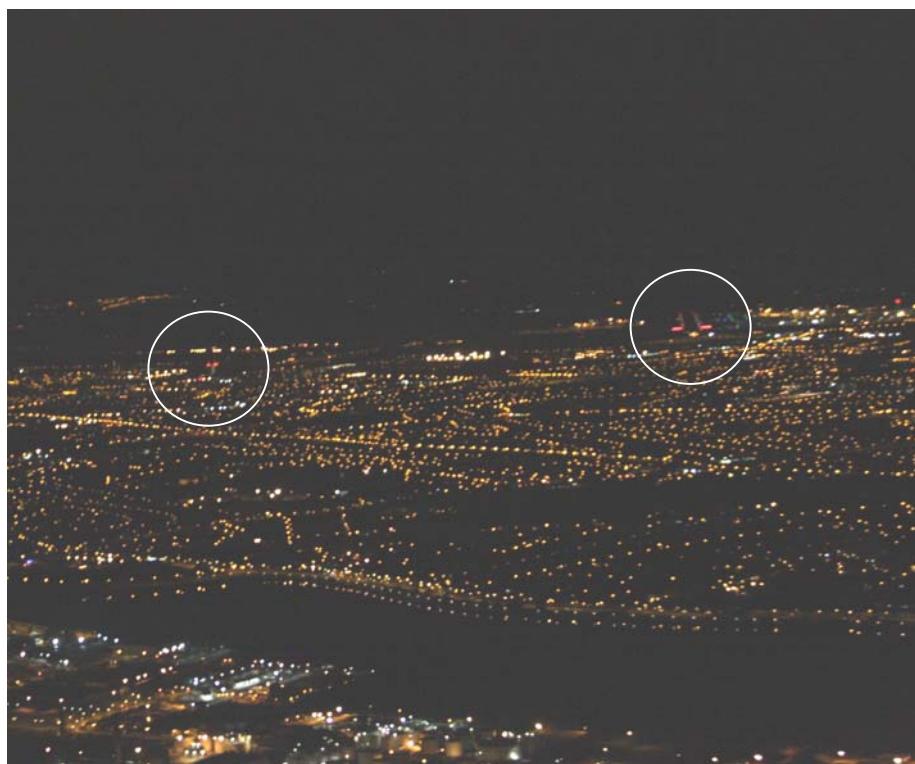
Photo No. 4: View of the RWY 34 approach at 5.5 nm to touchdown, with the Hotel building at Santry Cross indicated on the left of the photograph.

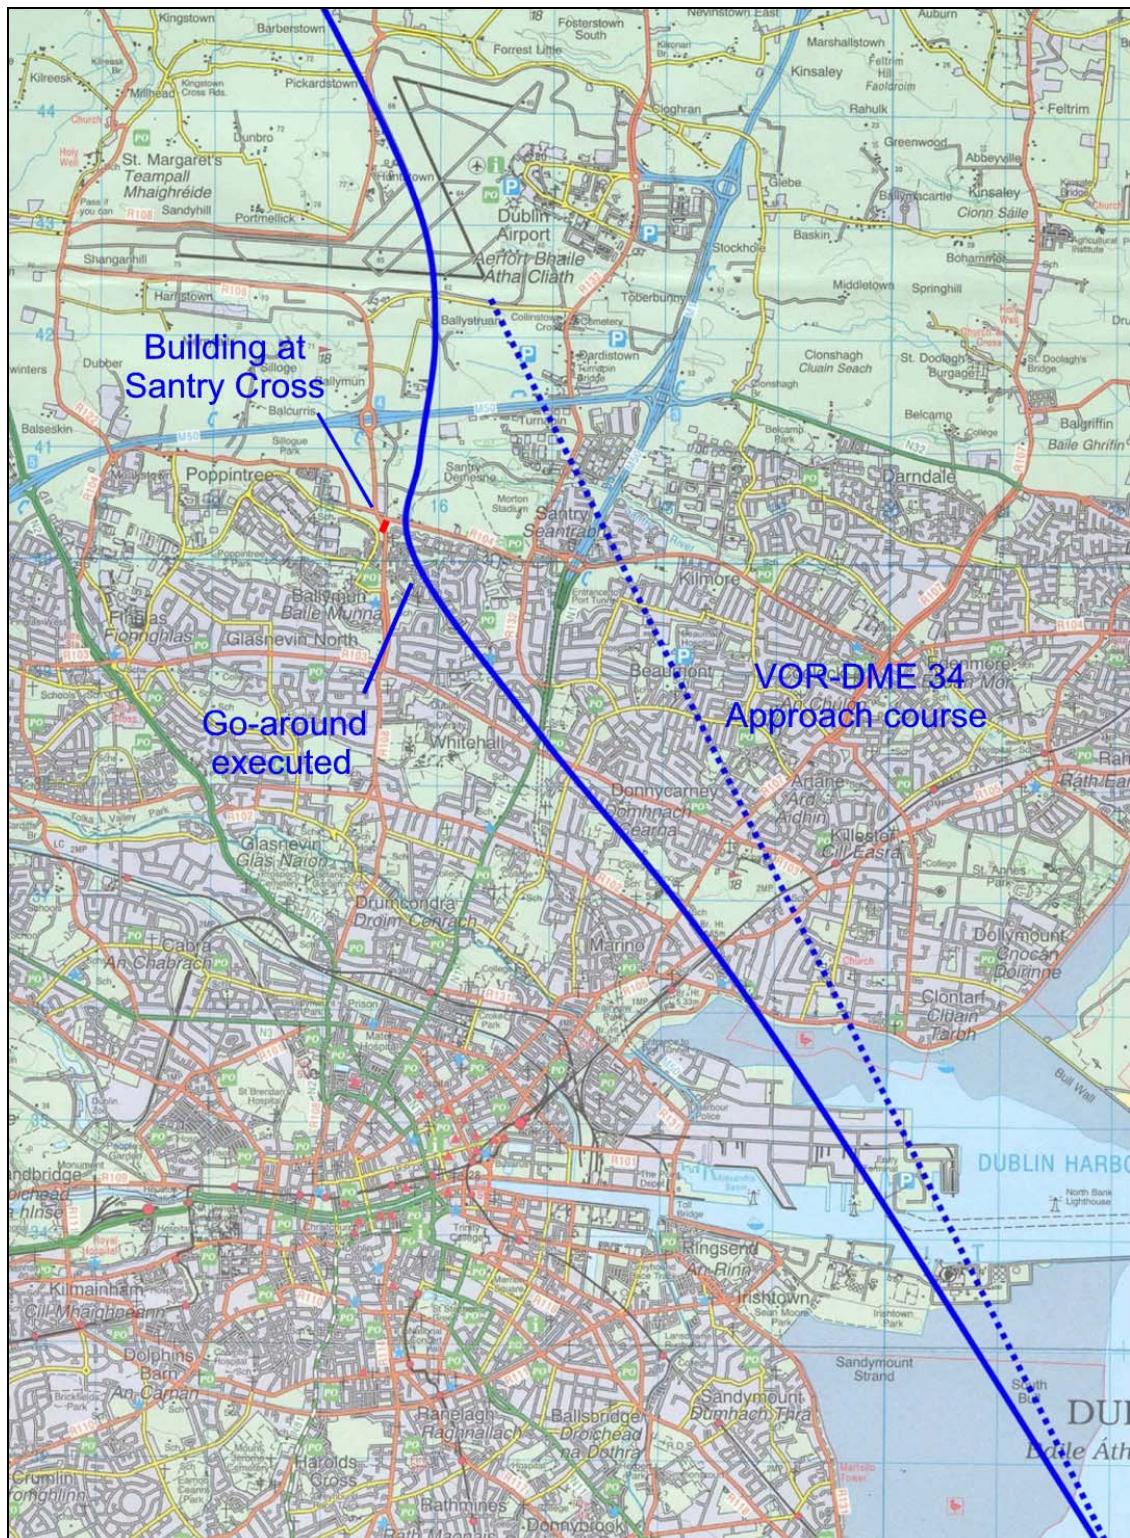
Flight track of FLT344E

The aircraft began to deviate from the final approach course at 4.8 miles from the runway threshold. At this point the aircraft was at 2,000 ft and a speed of 130 kts. At 1.3 miles the MSAW on the Radar screen activated. Passing 1,100 ft the aircraft turned further left tracking directly towards an obstacle identified as a 16-storey Hotel situated at Santry Cross. Radar information confirmed the aircraft had descended to below 600 ft AMSL before the go-around was executed. The aircraft continued to descend until instructed to turn and climb by the AMC in the Tower. At the point where the go-around commenced, the aircraft was approximately 520 metres (1,706 ft) from the building and 61 metres (200 ft) above it.

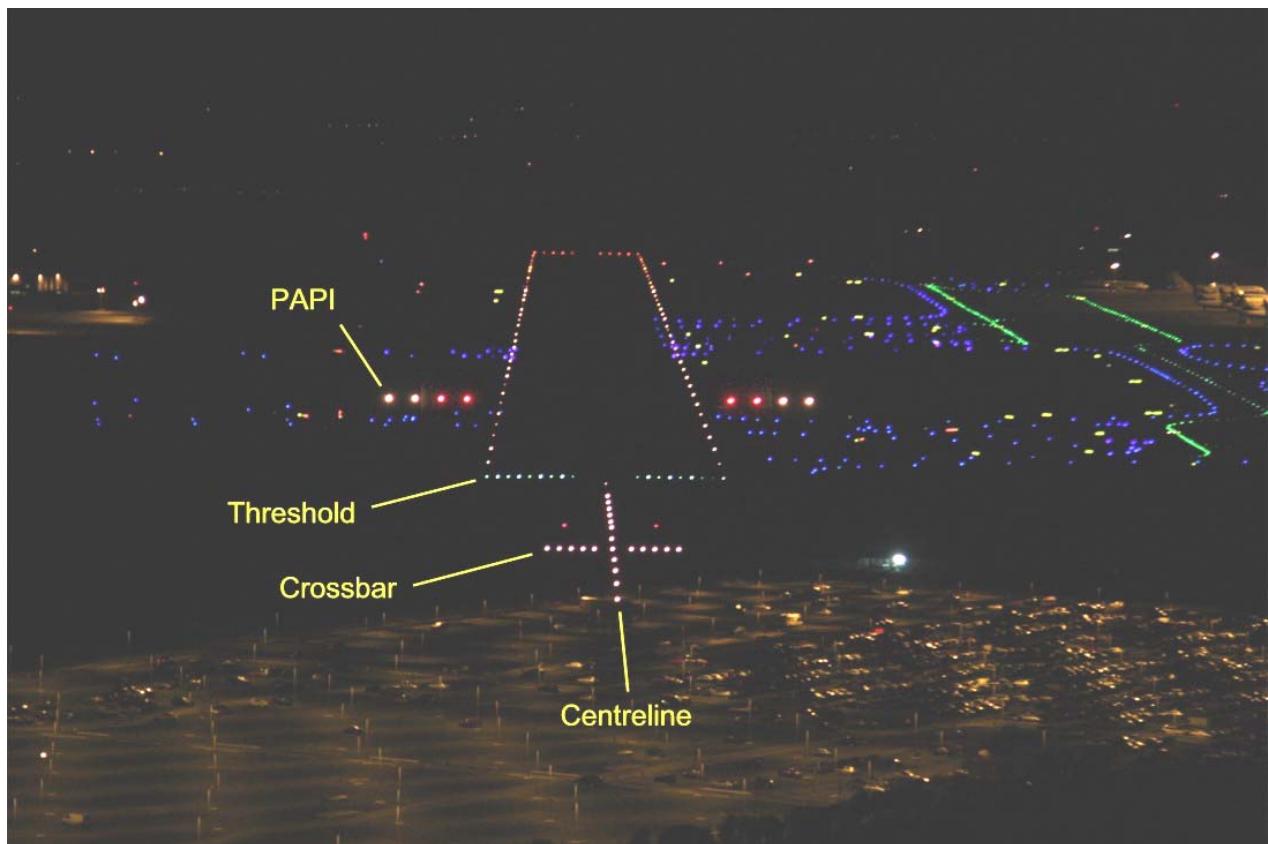
Detailed view of RWY 34 and Simple Approach Lighting System

Detail view of the RWY 34 Simple Approach Lighting System.

The approach lights consist of a centreline of white lights with one crossbar. Threshold lighting is green in the direction of landing aircraft with white runway edge lights. Taxiway lights are blue. In the visual profile, the PAPI's should appear as pairs of white and red lights either side of the runway. From a distance, however, the PAPI's indicate all red as the aircraft is normally below the final approach profile of 3 degrees.
