FINAL REPORT

SERIOUS INCIDENT
to
MD 11
N803DE
at
Dublin Airport

3 February 2002

AAIU Report No: 2003/004

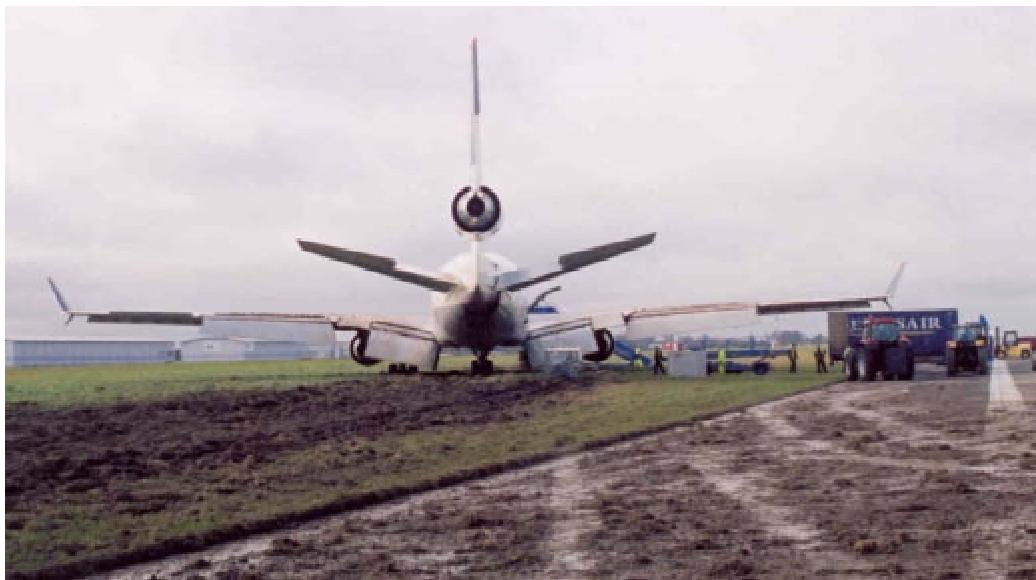
Fig 1

Auto-pilot (AP) disconnect occurred about 25 seconds prior to main wheel touch-on, at a radio altitude (RA) height of approximately 362 feet - above ground level (AGL). A short time later, at approximately 08.04:37 hours, the aircraft touched down RWY 28 and in the words of the Captain, “*It was a firm centreline landing, within the touchdown zone*”.

Approximately 3 seconds after touchdown, the FO confirmed “*Spoilers out*” and “*Three in reverse*” thereby indicating that the ground spoilers had fully deployed and that the three engines were providing reverse thrust. The Captain then called out that “*.....it's slippery*”, as the aircraft started drifting initially to the right and then to the left. Inputs from the Captain, consisting of full right rudder and right tiller, failed to arrest the drift to the left and the aircraft departed the paved surface on an indicated heading of approximately 270°, at a point halfway abeam Taxiway E5 and E6³. The aircraft continued through the prepared graded ground, which was rain soaked, for a distance of approximately 250 metres before finally coming to a halt at approximately 08.05:13 hours (See **Fig 1**). The RFO immediately asked the Captain if he required “*Engines off/Auxiliary Power Unit (APU) on*”. The Captain replied, “*Affirmative, tell them to remain seated*” and this action was carried out by the RFO, with the FO calling out the shutdown checks. The subsequent emergency response and disembarkation is covered under **Section 1.15, Survival Aspects**.

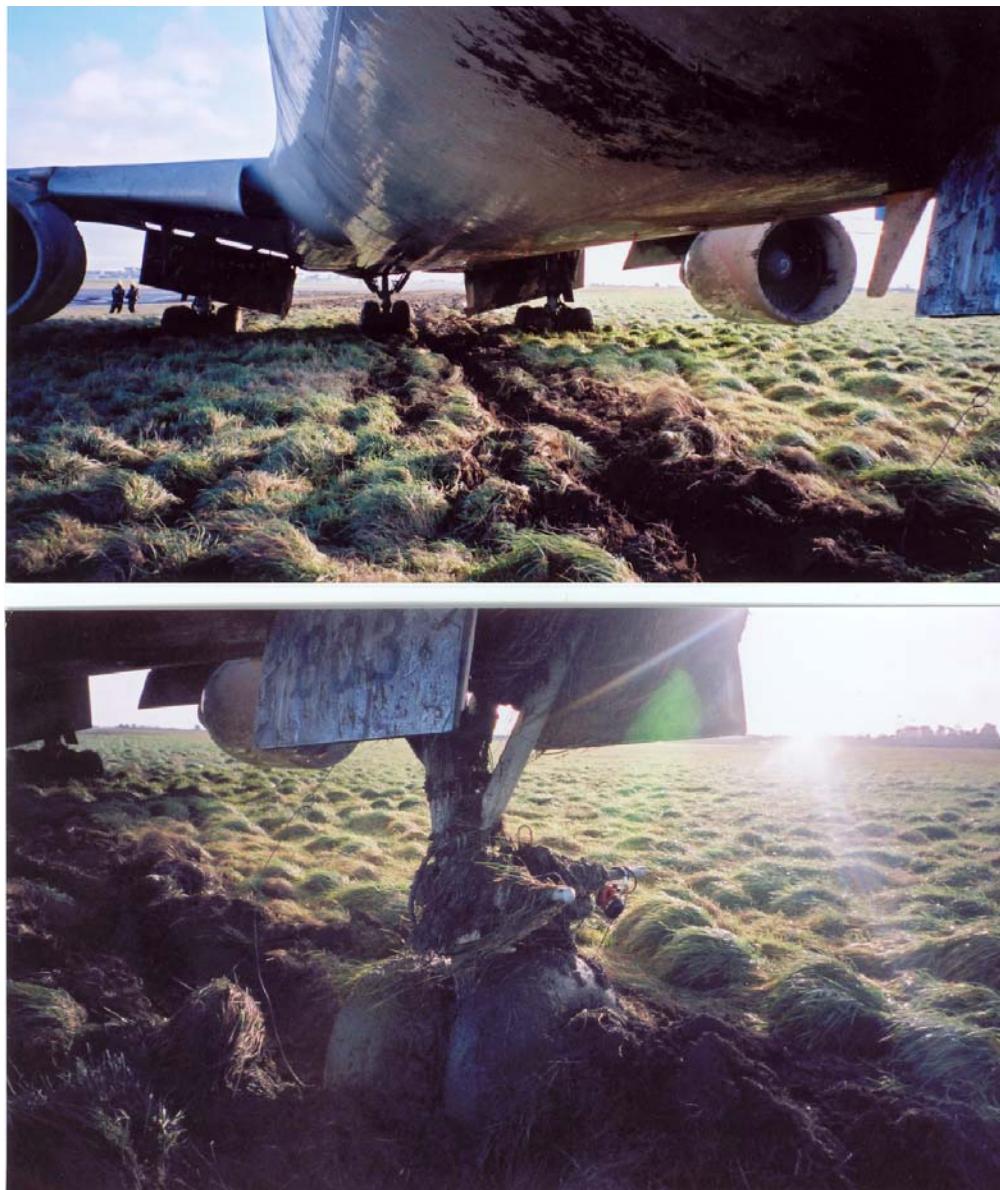
Fig 2

The initial damage inspection determined that the aircraft was covered in mud splash, in particular on the left side. The flaps and slats were deployed and the thrust reversers were stowed. The nose gear wheels were rotated at near 90° to the right of the aircraft centreline (See Fig 2). The brakes and wheels were embedded with mud. All wheels were still inflated and the brakes were intact.

No 1 and No 3 engine showed evidence of moderate Foreign Object Damage (FOD) ingestion in both the hot and cold sections, and damage was caused to the fan blades. The No 1 engine intake acoustic lining had a 3-inch hole in the (8) o’clock position. There was also evidence of mud around the No 2 engine intake. The left inboard flap fairing was damaged.

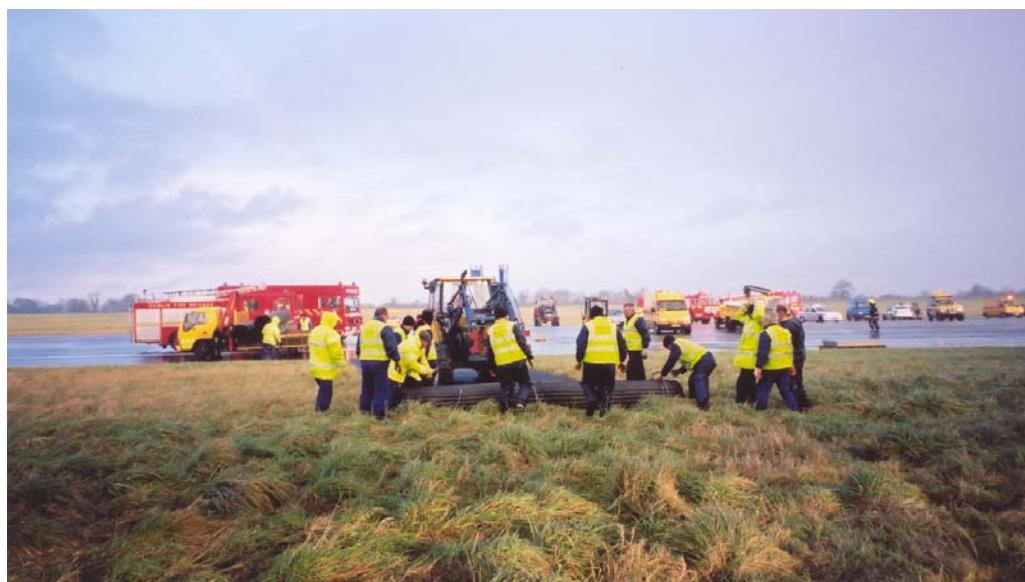
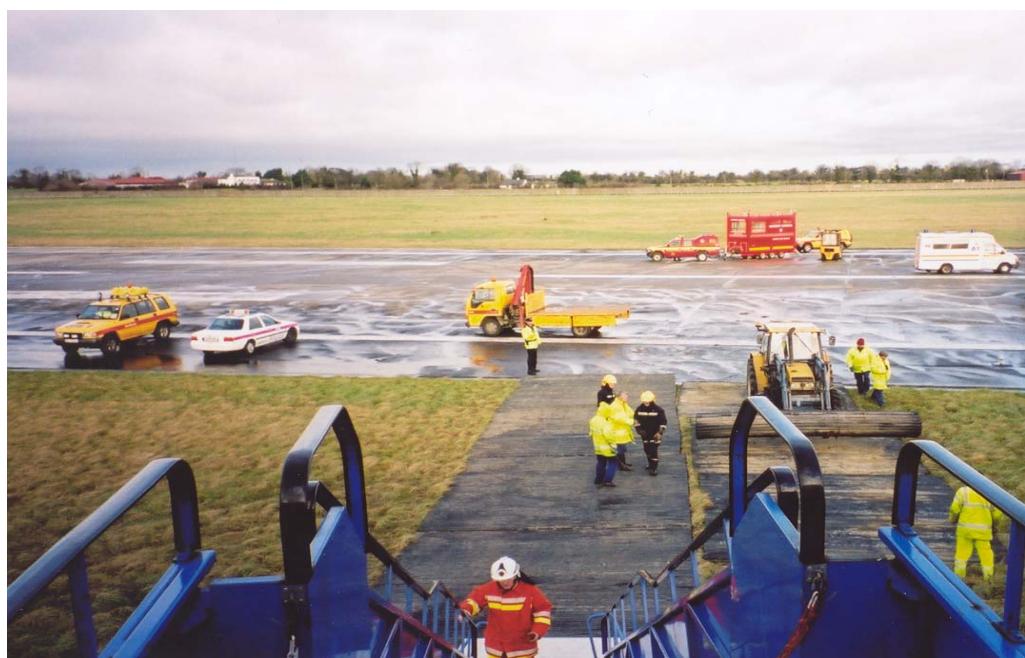
Fig 3

Disembarkation of the passengers and the crew commenced at approximately 10.05 hours through the R2 door and down the mobile stairs to the waiting buses. Both the Operator's Station Manager and one Company Agent were present for the passenger disembarkation and subsequent bus transfer. The passengers were bussed (about 10.29 hours) to Stand 34 (Gate B 26), where they were met by representatives from the Handling Agent and the Airport Authority.
