Airbus A321-211, EI-CPE & Boeing 747-436, G-BNLK

AAIB Bulletin No: 11/2004	Ref: EW/C2004/03/07	Category: 1.1 1.1
Aircraft Type and Registration:	1) Airbus A321-211, EI-CPE 2) Boeing 747-436, G-BNLK	
No & Type of Engines:	1) 2 CFM 56-5B/3P turbofan engines 2) 4 RB211-524H2-T-19 turbofan engines	
Year of Manufacture:	1) 1998 2) 1990	
Date & Time (UTC):	23 March 2004 at 1024 hrs	
Location:	Heathrow Airport, London	
Type of Flight:	1) Public Transport (Passenger) 2) Under tow	
Persons on Board:	1) Crew - 8 2) N/A	Passengers - 186
Injuries:	1) Crew - None 2) N/A	Passengers - None
Nature of Damage:	1) Rudder damaged 2) Left wing tip damaged	
Commander's Licence:	1) Air Transport Pilot's Licence 2) N/A	
Commander's Age:	1) 39 years 2) N/A	
Commander's Flying Experience:	1) 8,000 hours (of which 900 were on type) Last 90 days - 140 hours Last 28 days - 30 hours 2) N/A	
Information Source:	Aircraft Accident Report Form submitted by the pilot of EI-CPE and subsequent enquires by the AAIB

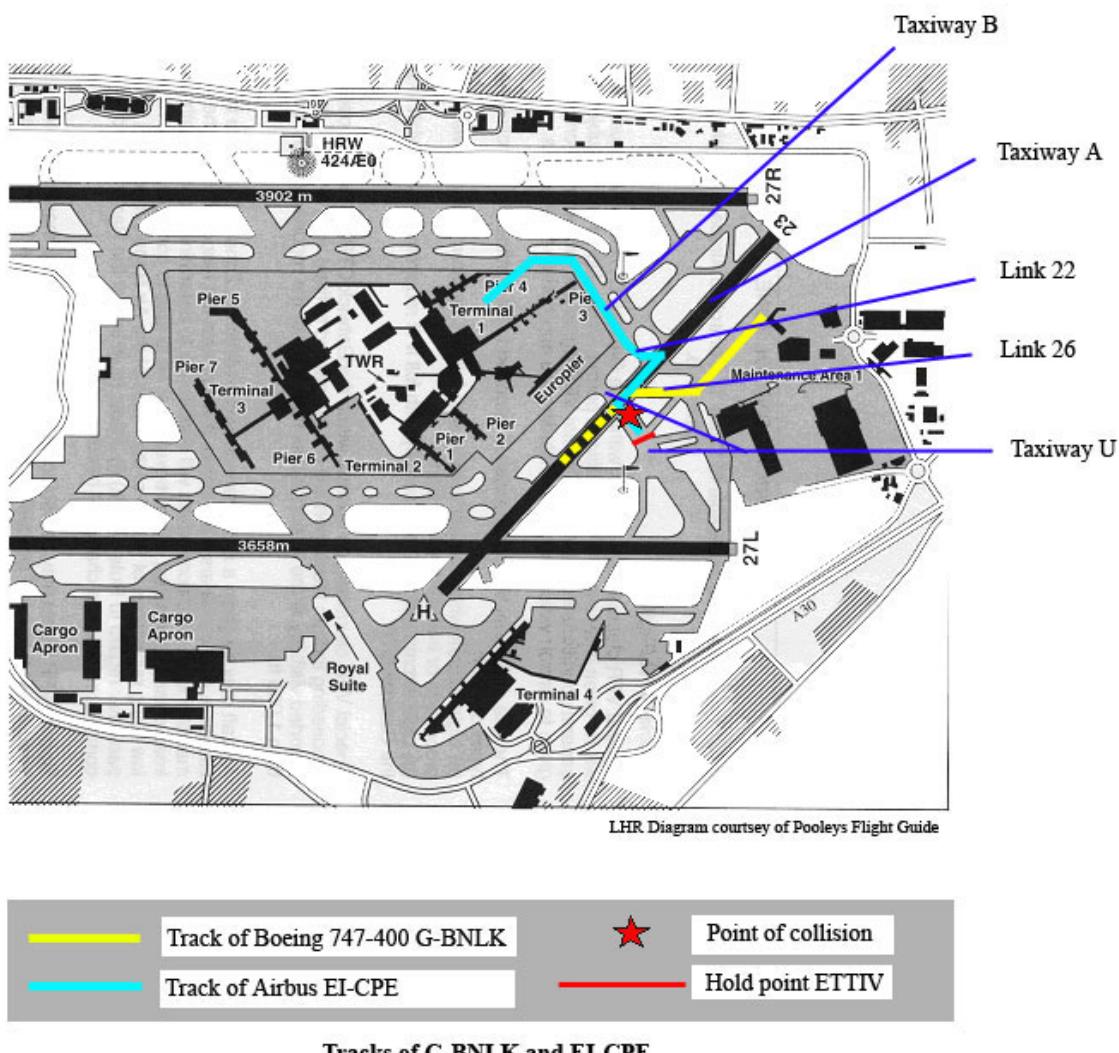
Figure 1 Tracks of G-BNLK and EI-CPE

ALPHA, HOLD SHORT OF MIKE", with another instruction at 1013 of "LK GIVE WAY TO THE AIR FRANCE AND RIGHT 180 TO YOUR STAND". This manoeuvre put G-BNLK on a path that passed behind the tail of EI-CPE.

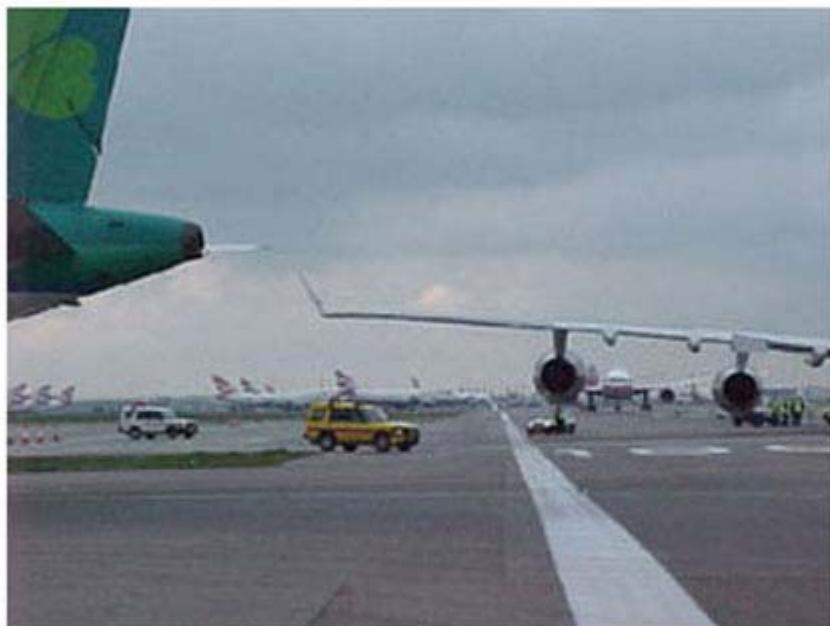
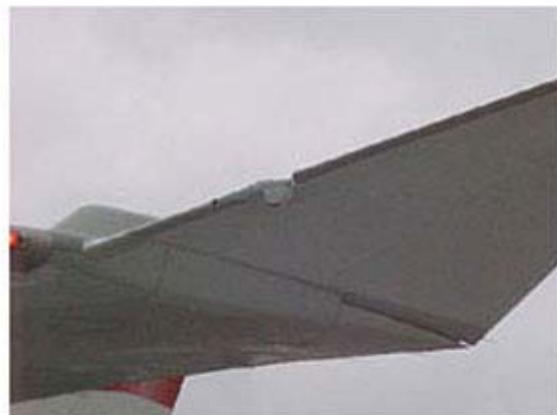
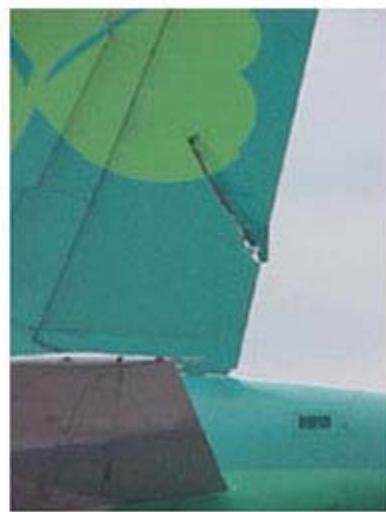
The base of the rudder on EI-CPE had sustained damage in the form of an angled slice through its structure aft of the hinge line, consistent with the left winglet of the B747-400 passing through the rudder, and the winglet exhibited damage on its leading edge, consistent with such contact, Figure 2. No other damage was reportedly found relating to this collision. The rudder of EI-CPE was subsequently replaced, as was the winglet of G-BNLK, and both aircraft were returned to full commercial service.

Figure 2 Damage Details between EI-CPE and G-BNLK

This accident was clearly due to the winglet of G-BNLK slicing through the rudder of EI-CPE because of insufficient clearance between the two aircraft. The outcome of this accident could have been a lot worse. In the first instance, the towing crew were not aware that their aircraft had struck the tail of another aircraft, and were continuing with the tow until stopped by ATC. Secondly, if the flight crew on EI-CPE had not noticed the rudder deflection through their rudder pedals and cockpit display, they may have assumed that the judder was from the jet efflux of the A330 ahead of their aircraft, and continued with the flight. If the flight had taken place with the rudder damaged, then it is possible that part of the rudder on the A321 could have departed in flight and maybe have caused control difficulties.

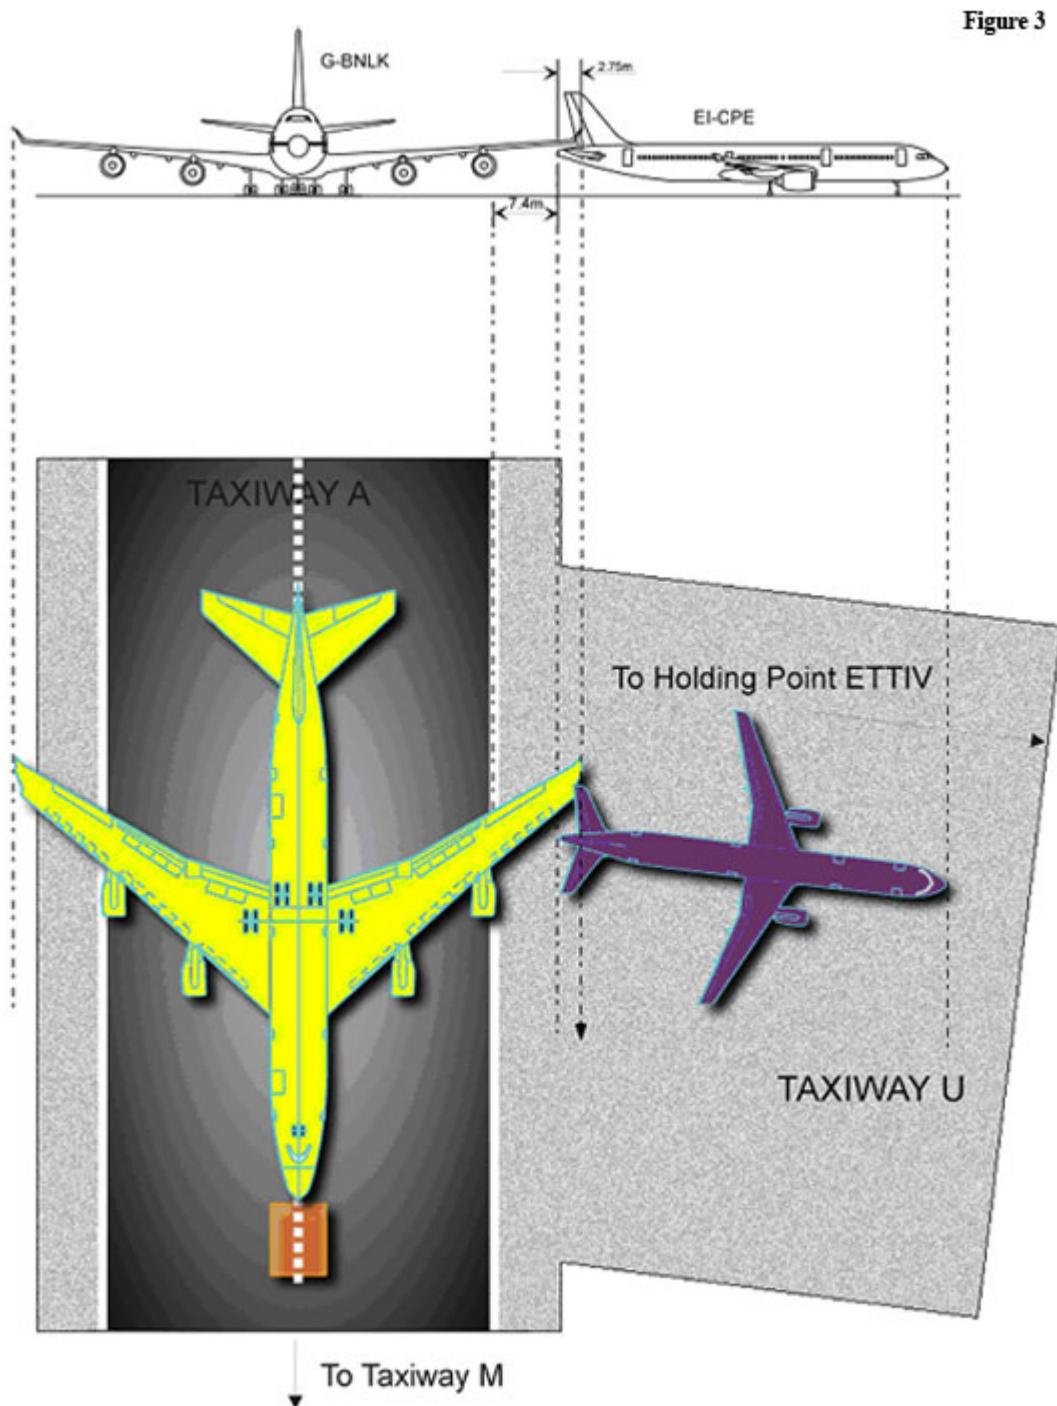
From photographs taken after the accident, G-BNLK appeared to have been on the centre line of Taxiway A, but some distance past EI-CPE, which was in the holding area short of the holding point ETTIV. The longitudinal axis of this aircraft was perpendicular to the taxiway edge line and its tail was clear of the line by some 7.4 metres. With a Boeing 747-400 on the centre line of Taxiway A, its wing tip wing extends beyond this runway edge line by about 10.3 metres, leaving an overlap, in this case, between its wing tip and the tail of EI-CPE of approximately 2.75 metres, Figure 3.

Figure 3 Collision geometry between EI-CPE and G-BNLK
