**ATSB TRANSPORT SAFETY INVESTIGATION REPORT**

Aviation Occurrence Report – 200600524

**Ground Collision – Melbourne Airport  
02 February 2006**

**N127UA**

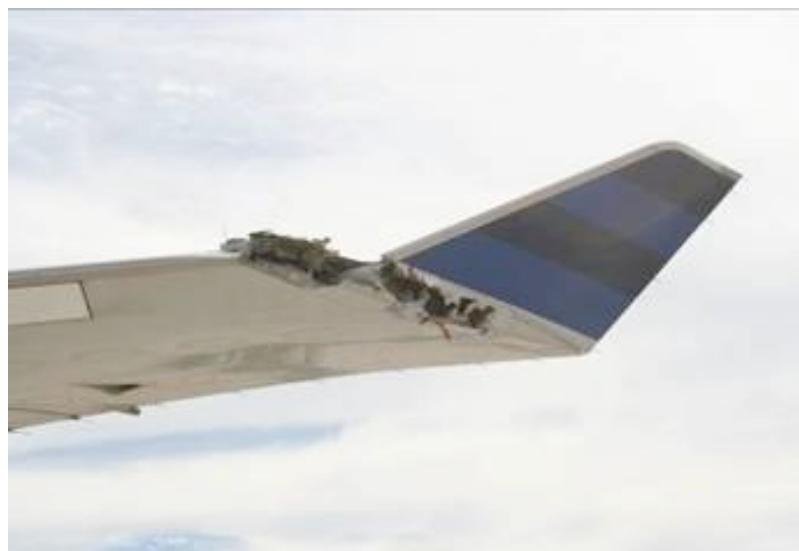
**Figure 1: Damaged left wingtip of the 747**

The 747 sustained substantial damage to the leading edge of the left wing tip. The left wing tip fairing sustained chord-wise damage except for a small section near the trailing edge of the wing. The left navigation and strobe light coverings were destroyed. The left winglet remained undamaged (Figure 1).

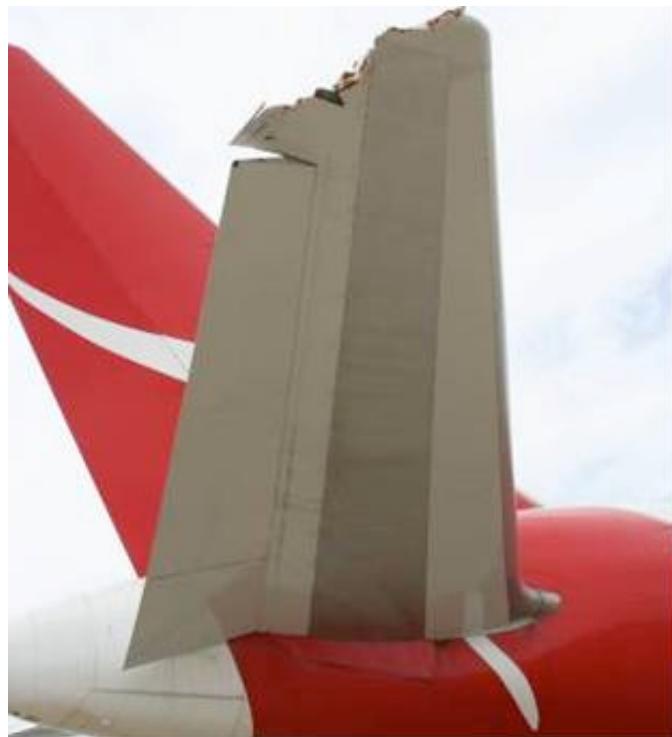
**Figure 2: The damaged right horizontal stabiliser of the 767**

The 767 sustained significant damage to the right horizontal stabiliser. A substantial section outboard of the elevator was destroyed (Figure 2).

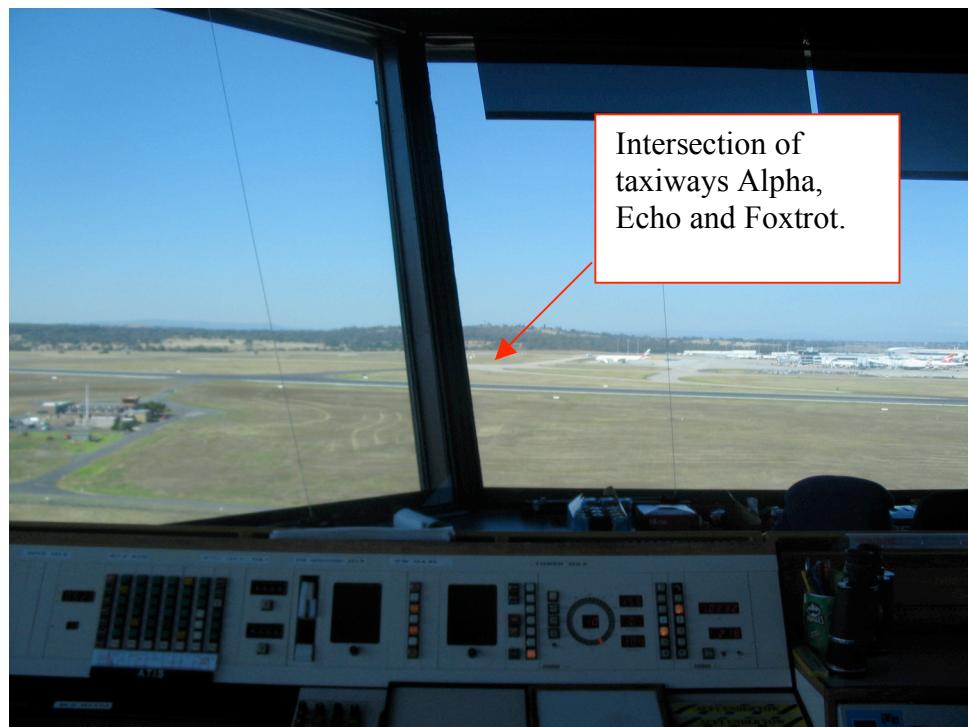
**Figure 3: View from SMC position in the control tower looking north-east**

The SMC at Melbourne Airport was seated towards the left side of the console in the control tower. There were structural posts in the windows around the tower that obscured the view of parts of the airport from the SMC. Examination of the SMC position revealed that the intersection of taxiways Alpha, Echo and Foxtrot could periodically become obscured from the view of the SMC, depending on how the controller was seated in the SMC position (Figure 3). Further, the angle from the SMC position to the intersection of the taxiways made any visual assessment of the position of an aircraft on taxiway Echo, relative to taxiway Alpha, difficult to judge. The SMC reported that he could see both the 767 on taxiway Echo, and the 747 taxiing along taxiway Alpha although he could not determine the extent to which the 767 was protruding into taxiway Alpha.

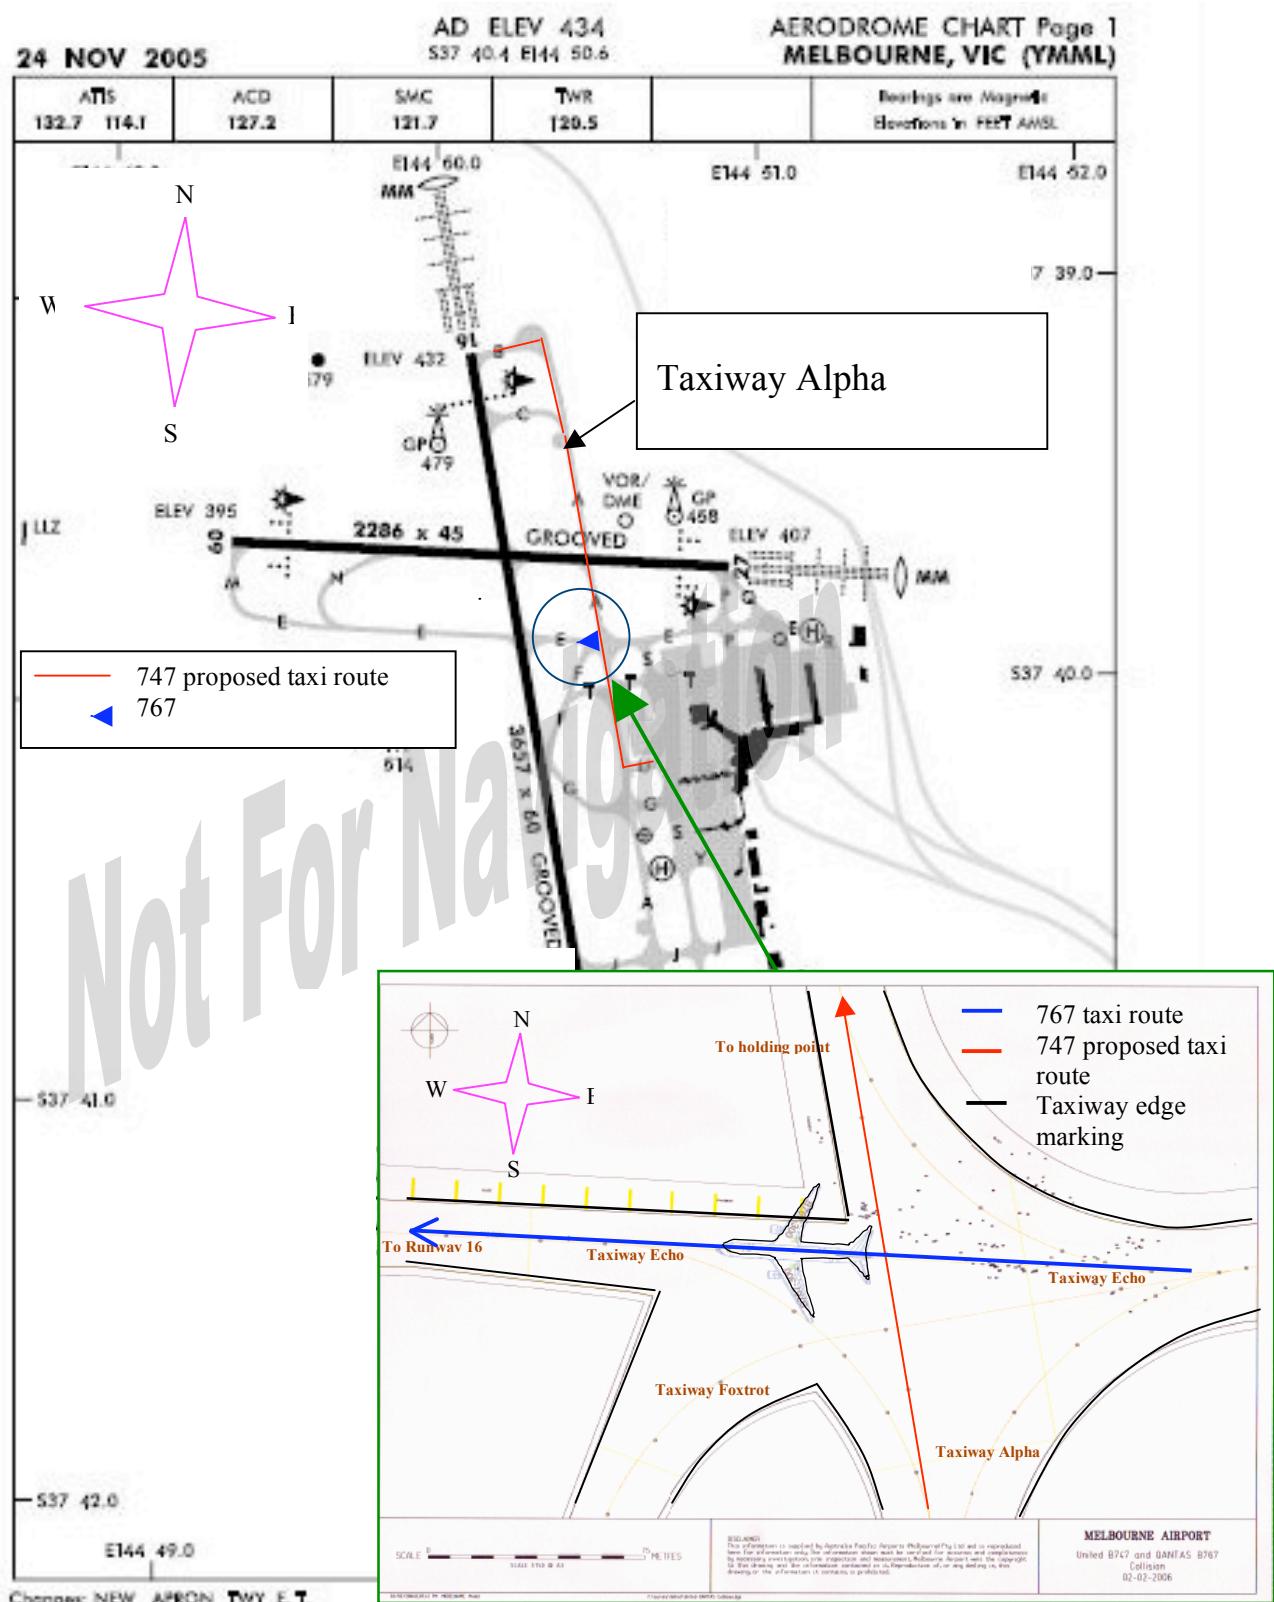
## **APPENDIX A: Melbourne Airport Taxiways and Runways. Insert: Intersection of Taxiways Alpha, Echo and Foxtrot**

There were two pilots in the cockpit of the 747 at the time of the occurrence. The pilot in command was steering the aircraft and reported that he could see the left wingtip of the aircraft. The 767 was stationary on taxiway Echo between taxiway Alpha and runway 16. It was the third aircraft in a queue for departure from runway 16 from taxiway Echo. The right horizontal stabiliser of the 767 was protruding approximately 8.75 m into taxiway Alpha and 1.7 m west of the centreline of taxiway Alpha (Appendix A).

There was a large concrete area at the intersection of taxiways Alpha, Echo and Foxtrot (Appendix A). The intersection provided considerable room for the 747 to manoeuvre to the south and east of the 767. However, the north-eastern side of the concrete area narrowed, reducing the space available for the 747 to manoeuvre past the 767. The pilot in command reported that, as he taxied behind the 767, he thought the left wingtip of the 747 was clear of the tail section of the 767, and decided it was safe to proceed past the 767.

Although there was enough room to safely manoeuvre in the taxiway intersection to the south and east of the 767, the intersection was narrower to the north of taxiway Echo, which reduced the space available for the 747 to pass behind the protruding tail section of the 767.
