FINAL REPORT

AAIU Report No: 2010-002
State File No: IRL00909037
Published: 03/03/10

Aircraft Type and Registration:	Boeing 757-28A, C-GTBB
No. and Type of Engines:	2 x Rolls-Royce RB211-535
Aircraft Serial Number:	32447
Year of Manufacture:	2001
Date and Time (UTC¹):	29 May 2009 @ 01.53 hrs
Location:	Dublin Airport (EIDW)
Type of Flight:	Public Transport
Persons on Board:	Crew - 8 Passengers - 198
Injuries:	Crew - Nil Passengers - Nil
Nature of Damage:	None
Commander's Licence:	Air Transport Pilot Licence (Canada)
Commander's Details:	Male aged 54 years
Commander's Flying Experience:	14,000 hours, of which 1,800 were on type
Notification Source:	Operations Manager, Dublin Air Traffic Control (ATC)
Information Source:	AAIU Field Investigation

SYNOPSIS

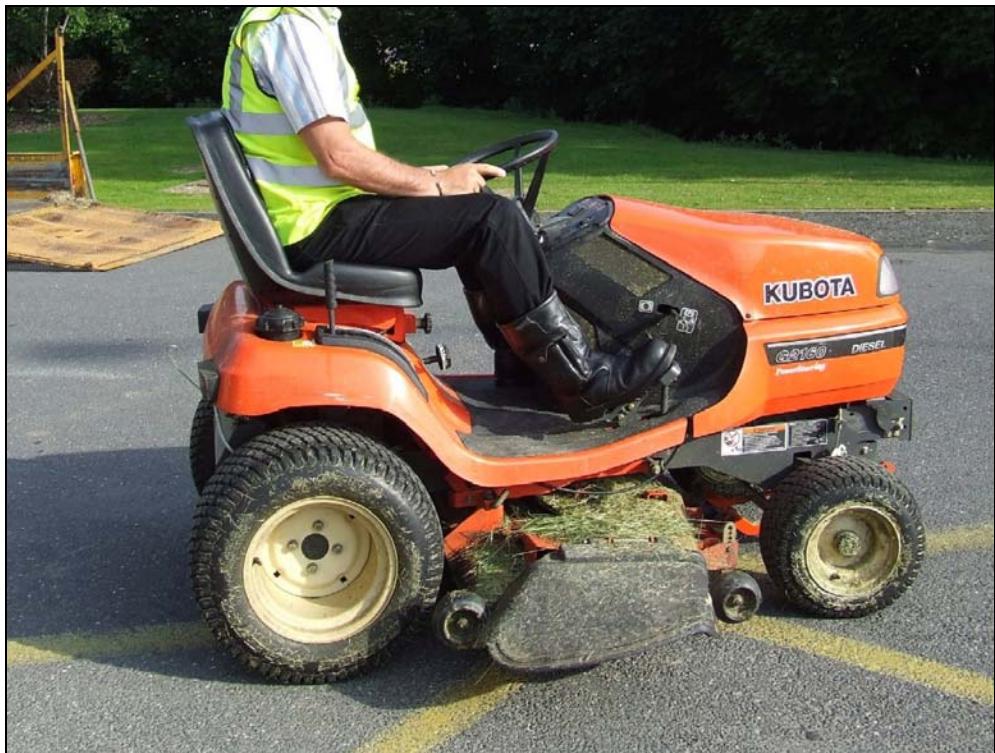
Photo No. 1: Ride-on Mower T3

- (c) A ride-on grass mower (T3), (**Photo No. 1**), operated by a DAA employee. He had also been issued with a hand-held radio by the supervisor for communication with Maintenance 12 on the discrete DAA frequency. He had no airfield radio equipment and thus he was unable to listen out on the Tower frequencies. T3 was not fitted with a transponder.

He was reluctant to go onto the grass between the runway and the perimeter road because in places the ground was very soft and he was afraid that his vehicle might get bogged down. His ride-on vehicle had no cab or rotating beacon and it was equipped with headlights on the front and reflectors at the rear. He carried the maintenance radio in one hand and steered the mower with the other. He was not wearing ear-defenders so that he would hear the hand-held radio. The first he knew of the landing aircraft was when he heard a roar behind him on the runway as it braked. He stated that after it passed him to his left, he immediately turned right and exited the runway into the grass.

3. The ride-on mower was equipped with inadequate radio communications equipment and inadequate lighting, and it did not conform to the requirements of Airport Direction 20.

Following the incident, the DAA immediately withdrew the ride-on mower T3 and replaced it with a larger unit with a cab, equipped with a flashing beacon, an airfield radio capable of operating on the relevant ATC frequencies, and a transponder.

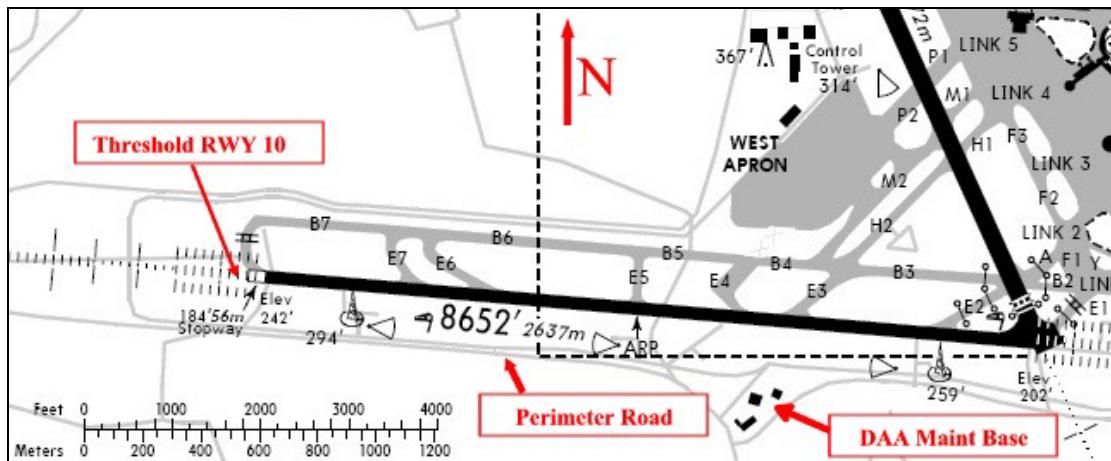
Figure No. 1: Airport Layout – EIDW (Source Jeppesen)

The ride-on mower operator, T3, informed the Investigation that he had commenced cutting close to taxiway E2 towards the eastern end of RWY 10/28. His small vehicle was suitable for cutting around lights and runway signage and he gradually made his way westwards in the grass to the North of RWY 10/28 across taxiways E3 through to E7. By 01.40 hrs he was operating in the threshold area of RWY 10, as was T2, the DAA operator with the forage harvester, (Figure No. 1).

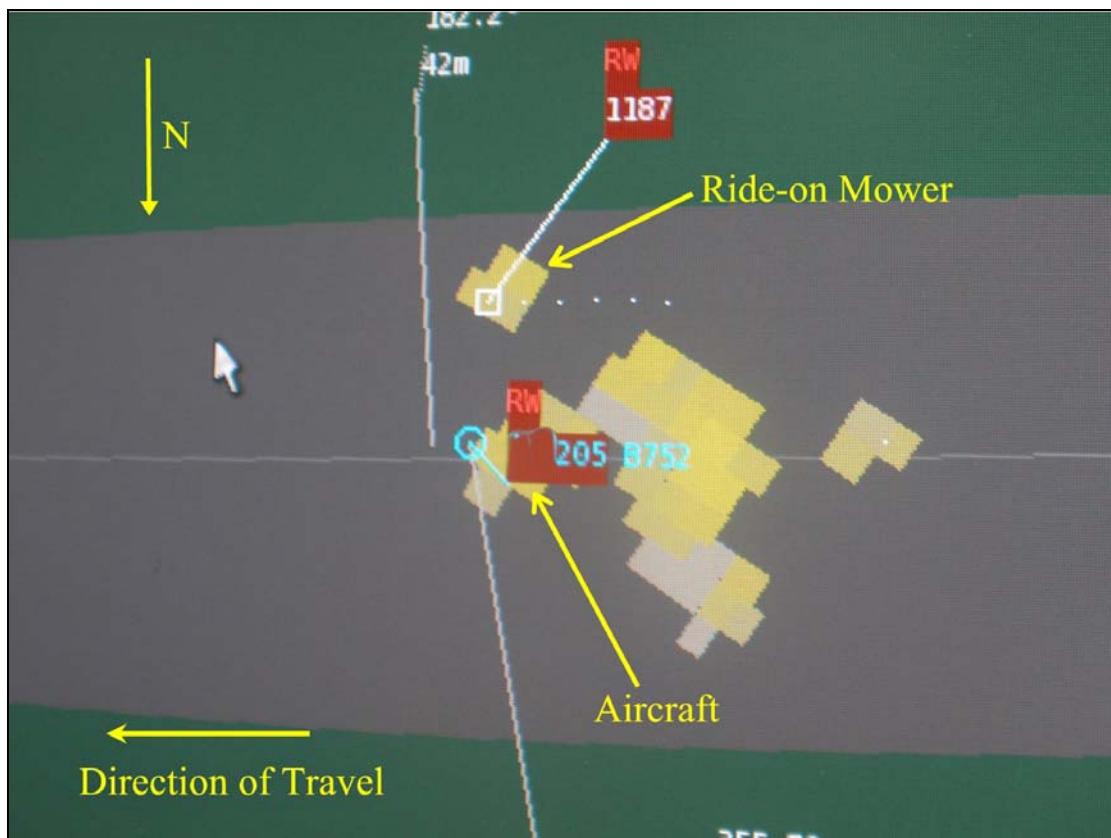
Figure No. 2: ASMGCS Image

At 01.52:45 hrs C-GTBB landed on RWY10. The ASMGCS recording shows that the aircraft passed the ride-on mower T3 at 01.53:00 hrs at a point approximately 150 m west of taxiway E5 at an approximate speed of 96 kts. The mower was moving eastwards along the runway, approximately 4 m to the left of the interface between the runway and its right (southern) shoulder pavement, or approximately 18.5 m to the right of the centreline. The wingspan of a Boeing 757-200 is 38.05 m. The mower T3 continued along RWY 10 for a short distance and its ASMGCS target is seen to disappear off the runway to the right at 01.53:15 hrs.

Figure No. 2 is an image of the ASMGCS screen at the moment that the aircraft passed by the ride-on mower on RWY 10. The image is oriented with south at the top and thus the direction of travel of the aircraft and the mower is from right to left. The aircraft can be seen on the centreline with the port wing clearly defined.

The starboard wing is not as clearly defined due to shielding by the fuselage from the surface movements radar antenna. The ride-on mower is designated by the label “1187”. The labels for both the aircraft and the mower are highlighted in red, indicating a conflict situation.
