AVIATION INVESTIGATION REPORT
A07A0134

TOUCHDOWN SHORT OF RUNWAY

JETPORT INC.
BOMBARDIER BD-700-1A11 (GLOBAL 5000) C-GXPR
FOX HARBOUR AERODROME, NOVA SCOTIA
11 NOVEMBER 2007

A07A0134

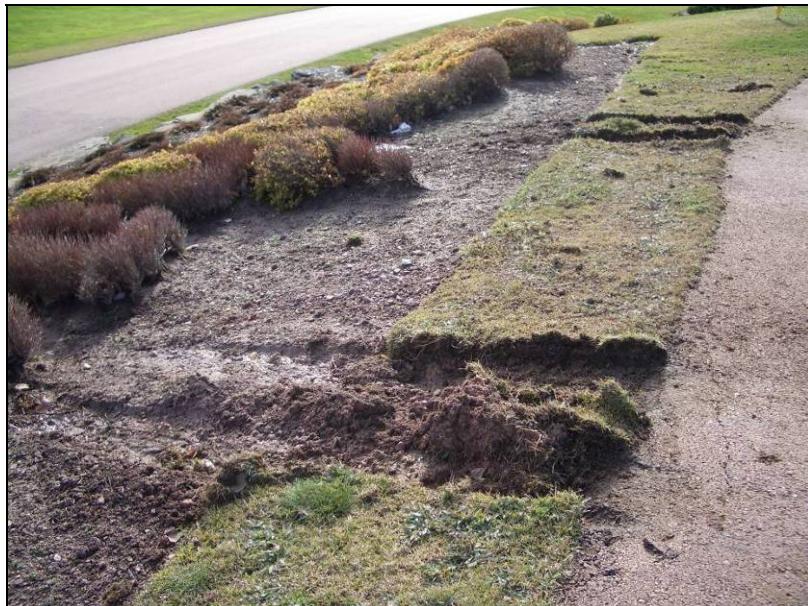
At 1434:25, the aircraft touched down 7 feet 6 inches short of Runway 33 and 18 inches below the surface of the runway (see Photo 1).

Photo 1. Initial impact point showing tire marks ending at the runway threshold

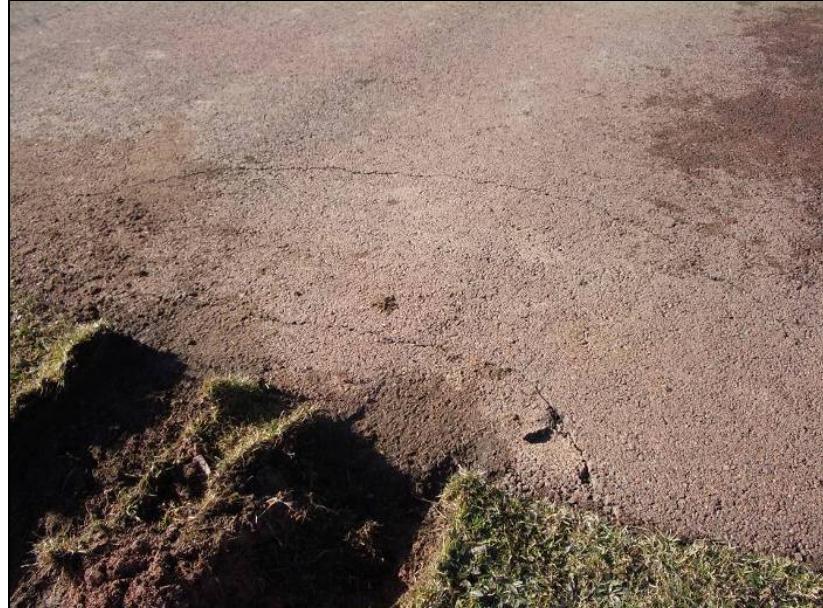
The tire tracks leading up to the paved asphalt runway surface were approximately five inches deep. Two semi-circular cracks were found in the asphalt, in line with the right main landing gear touchdown point (see Photo 2), resulting from the force of the gear striking the runway edge.

Two scrape marks, caused by the right wing outer and centre flap canoe fairings, start to appear on the runway at a point located 140 feet from the runway threshold and 27 feet and 37 feet respectively right of the centreline. A third scrape mark, caused by the right wing inboard flap canoe fairing, starts 170 feet from the runway threshold and 18 feet right of the centreline, indicating that the right main landing gear was totally collapsed at this time.

Photo 2. Runway edge damage from right main landing gear

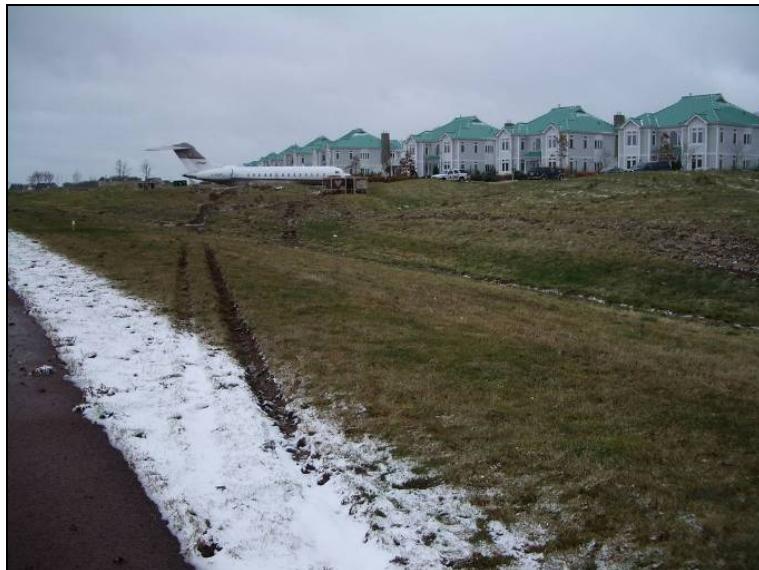
The left main landing gear tire tracks cross the centreline 457 feet from the threshold. A runway edge light located 600 feet from the threshold was broken. A ground scar indicates that the right main landing gear departed the runway surface 640 feet from the threshold (see Photo 3) while the left main landing gear departed the runway surface 694 feet from the threshold.

Photo 3. Point of departure from runway

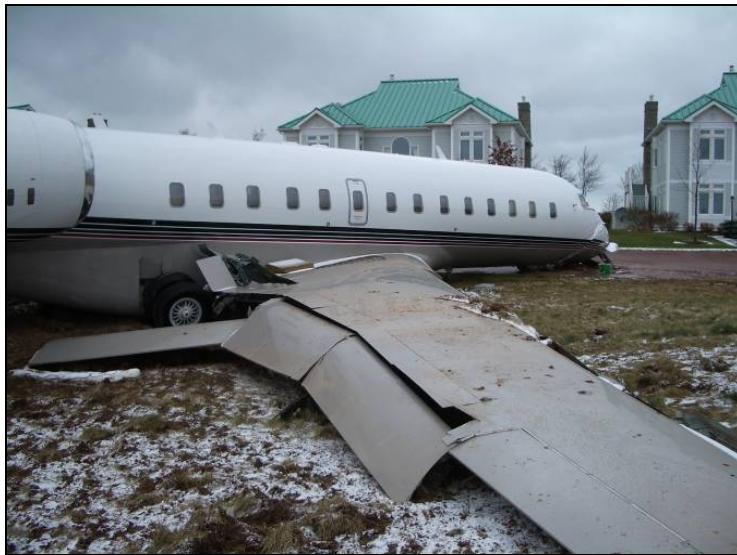
The aircraft sustained extensive damage all attributed to the impact and post-impact accident sequence (see Photo 4). There was extensive damage to the fuselage structure and systems in both main landing gear bay areas caused by the detachment and pivoting of the landing gear following the initial impact with the runway edge.

Photo 4. Aircraft damage

Most of the other damage was incurred as the aircraft departed the right side of the runway and travelled through the series of mounds. The nose section of the aircraft between fuselage stations 169 to 288 had structural buckling 6 to 8 inches deep. Both wings sustained extensive damage to the auxiliary spar and surrounding structure due to the detachment of the main landing gear. The flap system was also heavily damaged. Both engines were damaged after ingesting debris.

The main passenger door was skewed rearward and the occupants were unable to open it for the evacuation. The cockpit floor was buckled in several places and both the captain's and first officer's seats were deformed and jammed in the seat rails. Some of the passenger seats sustained damage, mostly due to the side load experienced during the post-impact accident sequence. Some glassware was dislodged from the galley storage and broken glass littered the galley floor. Damage to the left wing resulted in a small fuel spill that was contained by the first responders.

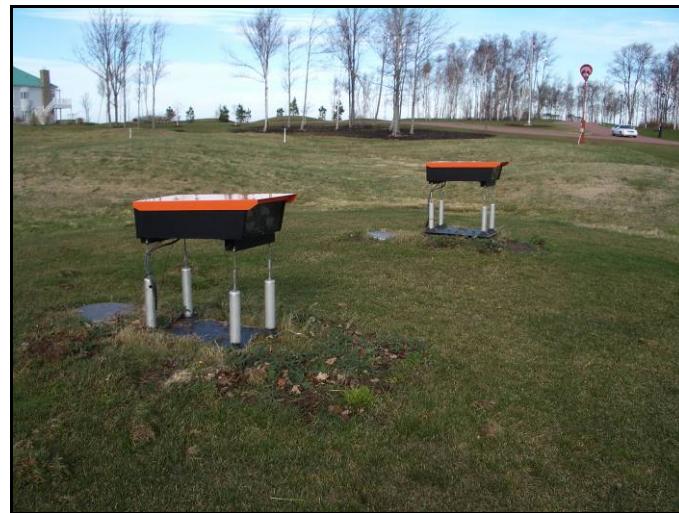
In addition to cutting trees on the approach to Runway 33, one of the safety actions taken was the installation, in August 2000, of an APAPI for Runway 33 (see Photo 6). At that time, Fox Harbour Development Limited indicated to the TSB that calibration of the APAPI would be verified on a weekly basis as per the manufacturer’s instructions.

Photo 6. Fox Harbour APAPI

The APAPI was installed 480 feet from the threshold on the right side of the runway, because a ramp on the left side of the runway precluded installation on that side. It was calibrated using the manufacturer’s operating manual information, which describes the recommended Transport Canada aiming angles for a 3.0° glideslope. This operating manual also describes unit alignment procedures, recommended check intervals, and maintenance. For an APAPI installation, it recommends that the aiming check be carried out at least once per week.

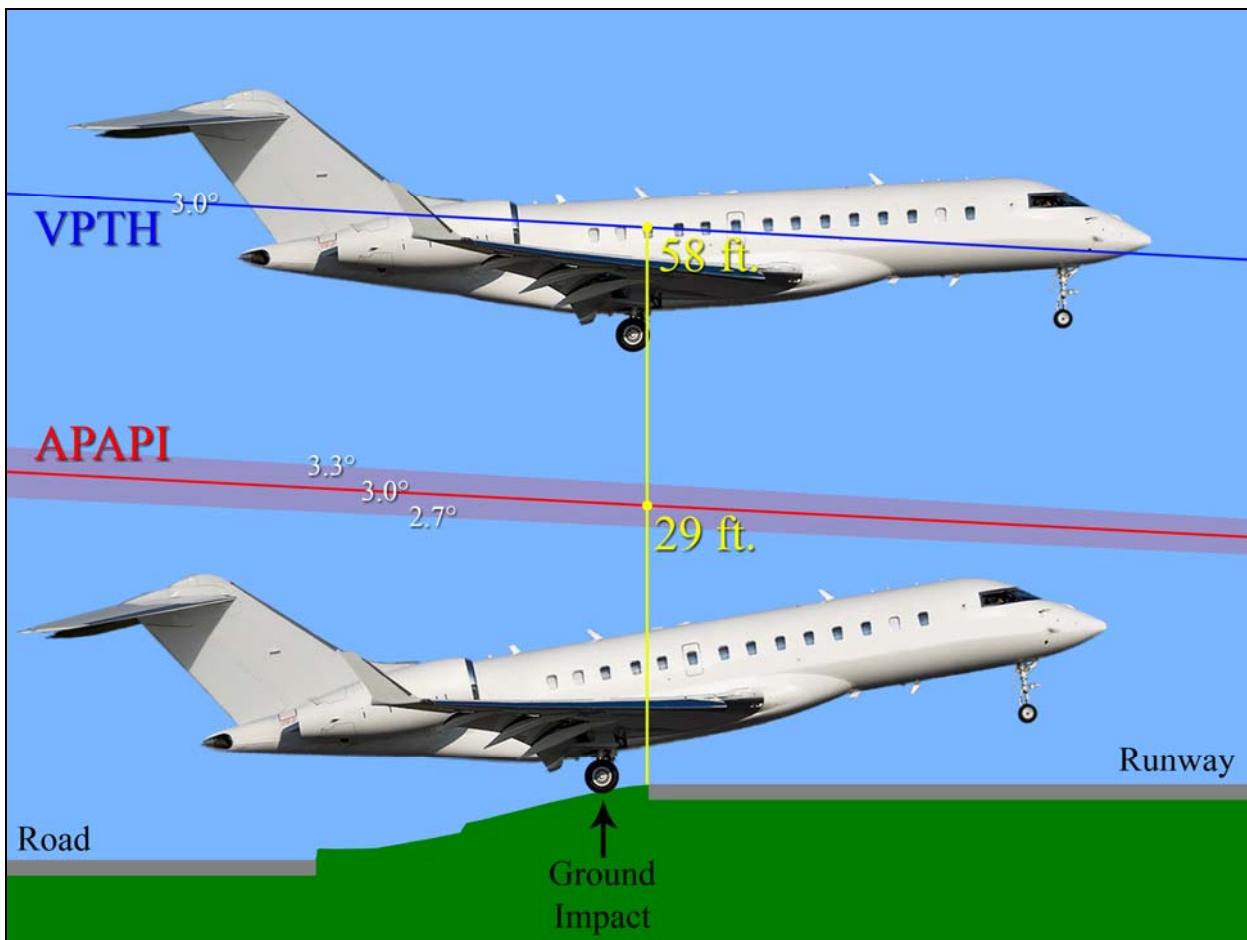
Figure 7. Aircraft in relation to vertical path (VPTH) and APAPI path

At a distance of 1.4 nm from the threshold of Runway 33, the PF disconnected the autopilot, which was following vertical path guidance. The PF continued the approach manually, initially correcting the flight path with reference to the abbreviated precision approach path indicator (APAPI) guidance. While the vertical path (VPTH) approach path of 3° meets the runway approximately 1000 feet from the threshold, the APAPI 3° path meets the runway approximately 500 feet from the threshold. Therefore, the aircraft was initially slightly above the APAPI on-slope indication (see Appendix B – Flight Data Recorder Approach Data) and the PF had to increase the descent rate to intercept the APAPI approach path.

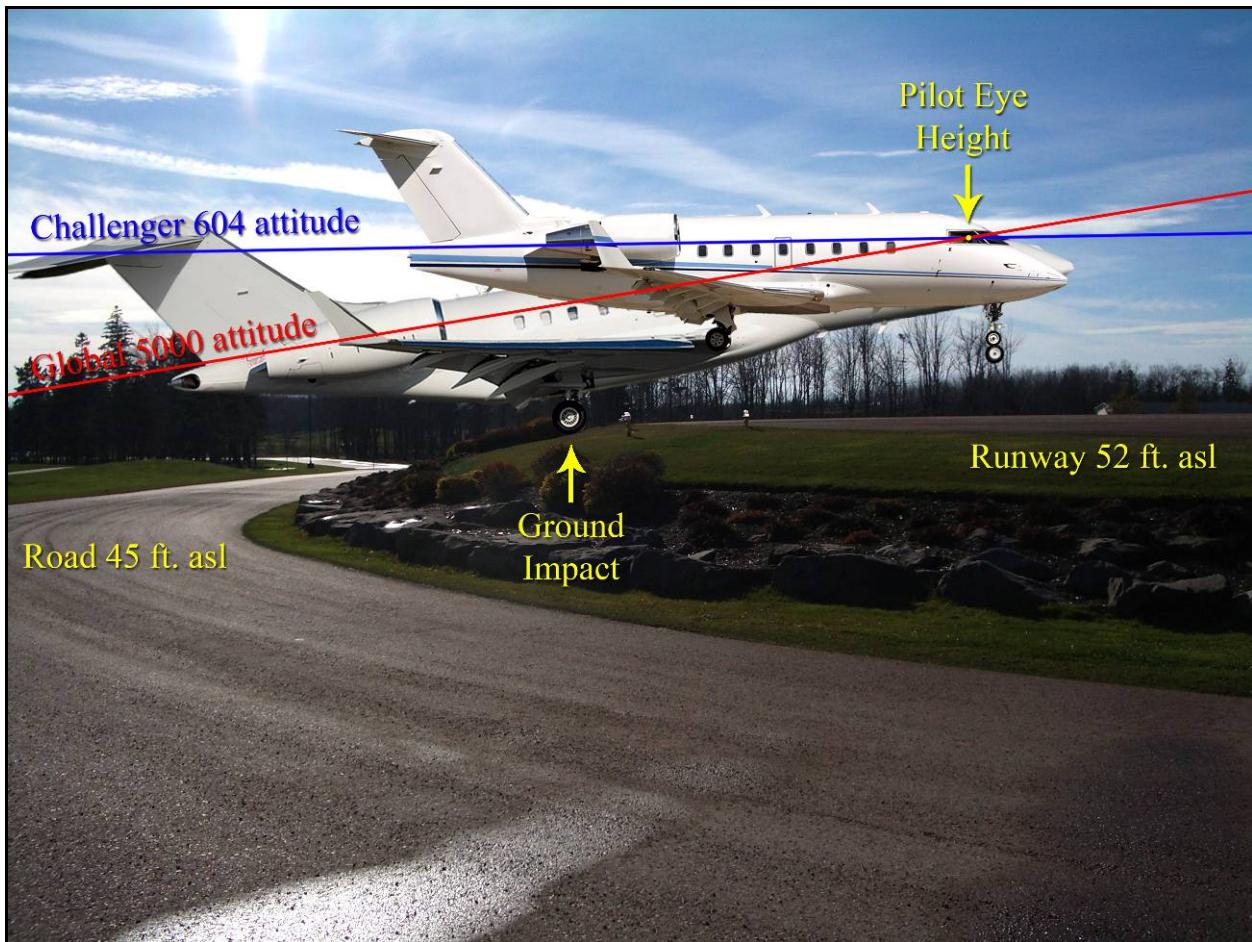
The pilot not flying (PNF) had less experience than the PF and it had been a considerable amount of time since he had completed his initial training on the Global 5000. It is therefore unlikely that the PNF could have helped the PF detect the unsafe profile. Like the PF, he was used to flying the same approach profile at CFH4 in the CL604 and Gulfstream G100. The profile flown on the occurrence day would have provided enough height for a CL604 to cross the threshold and land in the first 500 feet of runway (see Photo 7).

Photo 7. Aircraft attitude at threshold

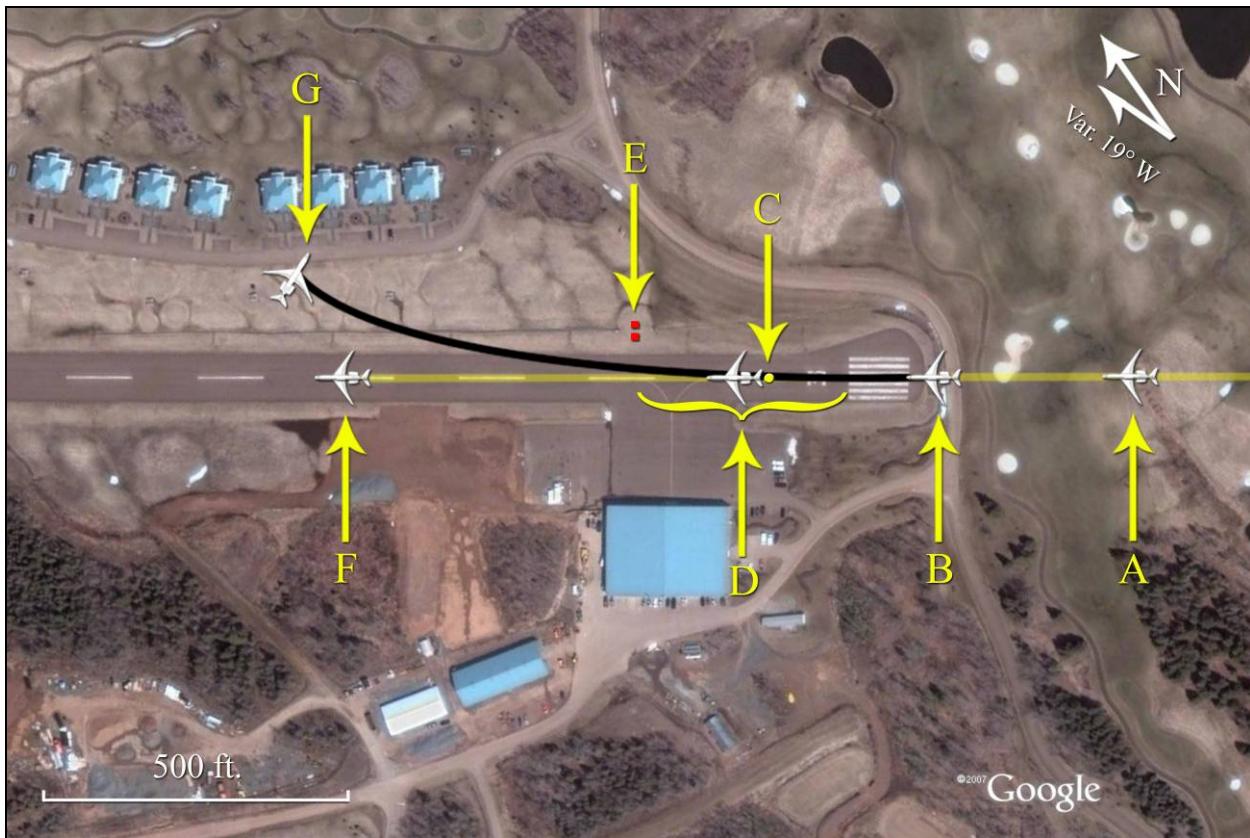
Appendix A - Touchdown Points

- A. Aircraft on final approach
- B. Impact point (-7.5 feet)
- C. Touchdown point if APAPI 3° slope was followed and aircraft not flared (213 feet)
- D. Planned touchdown area and main area of tire rubber deposits from other landings (129 to 500 feet)
- E. APAPI units (480 feet)
- F. Manufacturer recommended touchdown point (1000 feet)
- G. Final aircraft position (1017 feet)

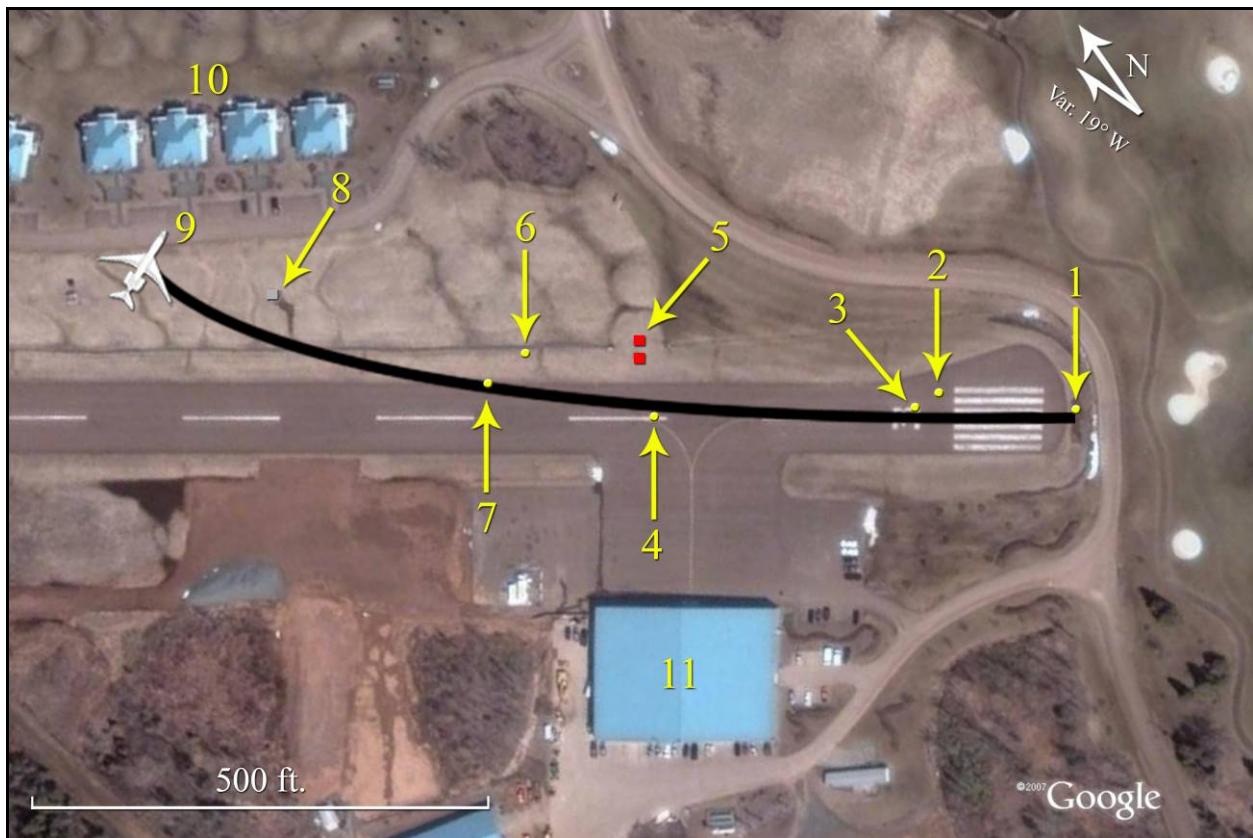
Appendix C – Wreckage Path

1. Impact point (-7.5 feet)
2. Start of scrape marks caused by outboard and centre canoe fairing (140 feet)
3. Start of scrape marks caused by inboard canoe fairing (170 feet)
4. Left main landing gear crosses centreline (457 feet)
5. APAPI units (480 feet)
6. Ground scar caused by right wing (600 feet)
7. Right main landing gear departs runway (640 feet)
8. Air conditioning units for condominiums (893 feet)
9. Final aircraft position (1017 feet)
10. Condominium units
11. Hangar
