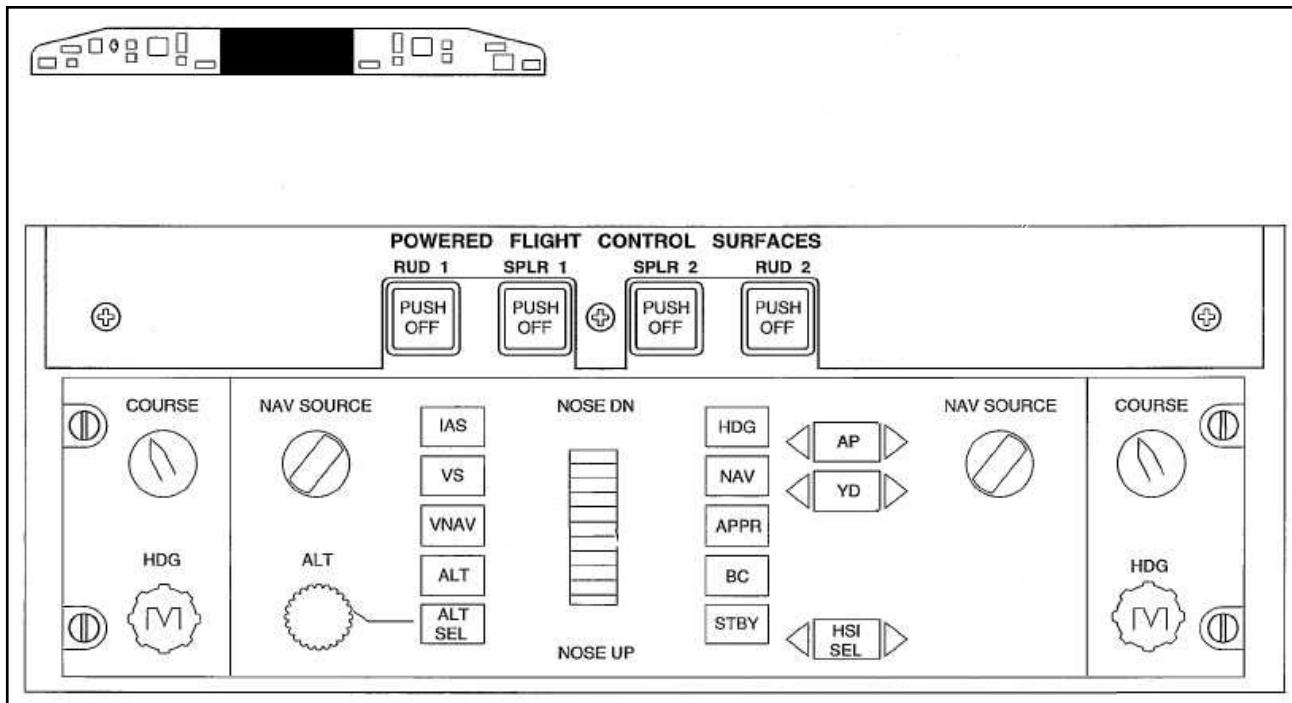
Figure 1

Flight guidance and control panel, location and functions

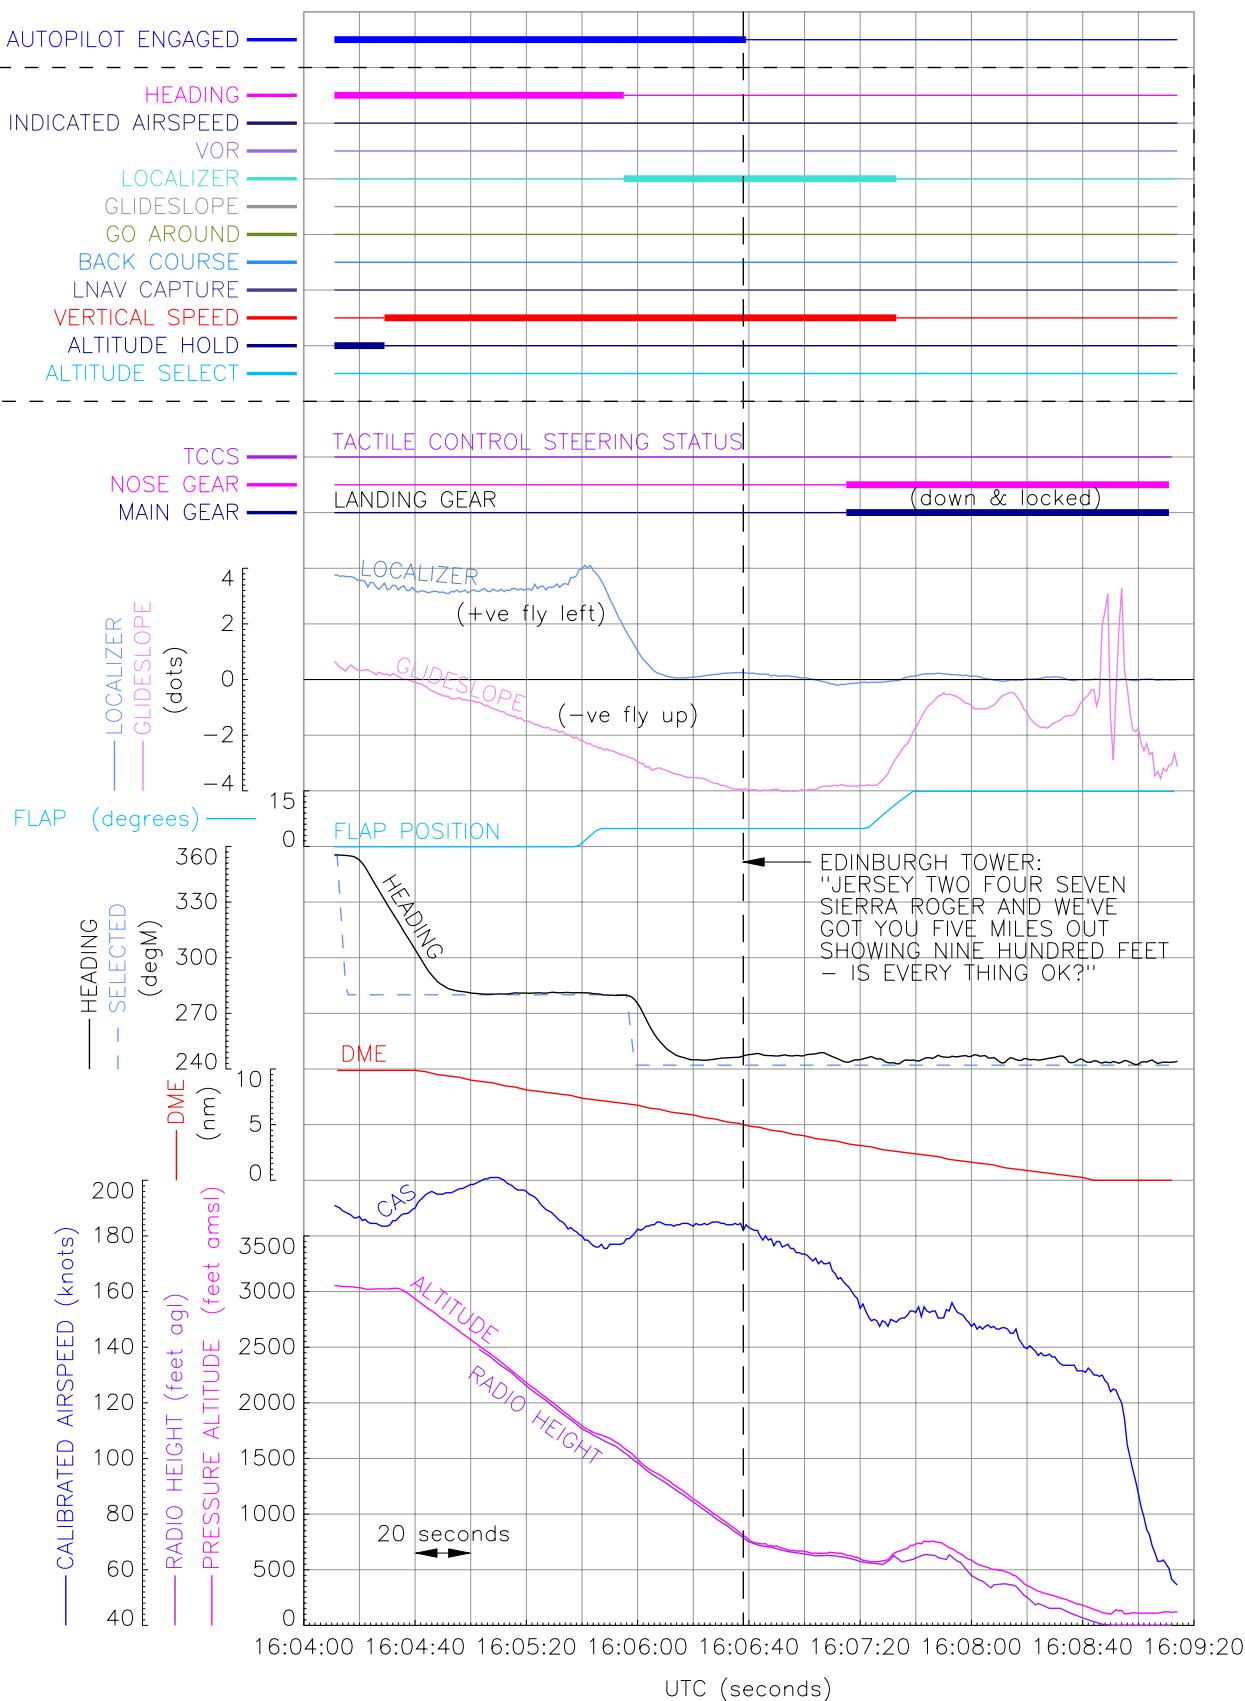
Figure 2
Salient FDR Parameters, G-JECI

Salient parameters obtained from analysis of the data from G-JECI's Quick Acces Recorder (QAR) for the incident are presented in Figure 2. The data starts just under four minutes before touchdown on Runway 24 at Edinburgh airport. At this point, the aircraft was flying straight and level at 3,000 ft amsl, with the landing gear and flaps retracted; the airspeed was 190 kt and decelerating. The autopilot was engaged with ALTITUDE HOLD mode and HEADING mode selected.

A heading of 280° was then selected, and as the aircraft turned, the autopilot was switched from ALTITUDE HOLD mode to VERTICAL SPEED with a descent rate of 1,100 ft/min.

Flap 5 was selected as the aircraft passed through 1,800 ft amsl. The aircraft was four dots right of the localizer and two dots below the glideslope. The autopilot was then switched from HEADING mode to LOCALIZER. The aircraft was now two dots to the right of the localizer so a turn to the left was initiated. The aircraft captured the localizer 20 seconds later at 1,250 ft amsl, 3.5 dots below the glidepath. The crew selected the Edinburgh Tower frequency and as the aircraft passed through 1,000 ft amsl they transmitted:

With the aircraft at 800 ft amsl and four dots below the glidepath, the autopilot was disengaged and the descent

During the descent the landing gear was selected down, and by 630 ft amsl (still four dots below) and 3.5 nm DME², the gear was down and locked.

At 570 ft amsl and 3 nm DME, Flap 15 was selected and clearance to land was given. The aircraft commenced a short climb, reaching 750 ft amsl (0.5 dots below) about 20 seconds later, before completing an uneventful descent and landing.

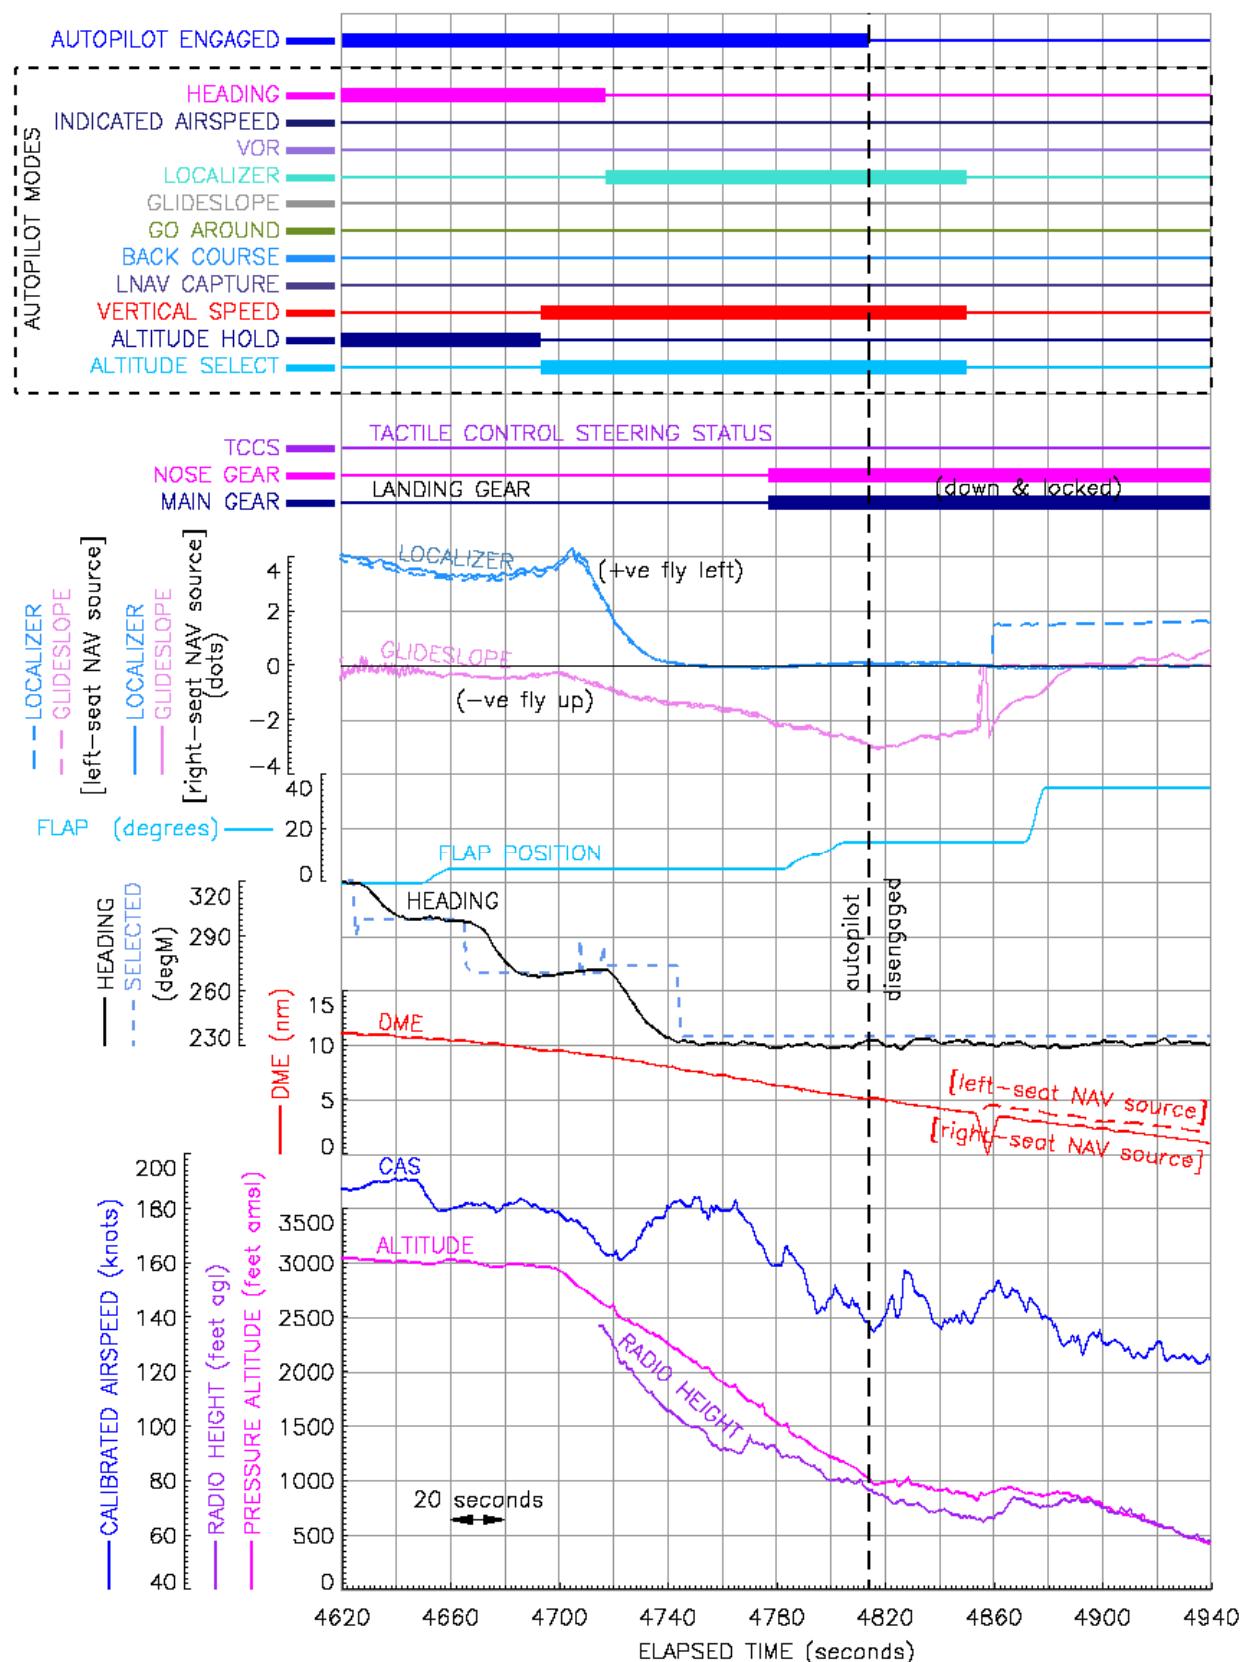
Figure 3
Salient FDR Parameters, G-JECI

Salient parameters from the QAR for this flight are presented in Figure 3 which start about six minutes before touchdown on Runway 23 at Glasgow Airport. At this point, the aircraft had levelled at 3,000 ft amsl, the landing gear was up, the flaps retracted and the airspeed was 190 kt. The autopilot was also engaged with ALTITUDE HOLD mode and HEADING mode selected.

A heading of 300° was selected and as the aircraft turned, the flaps were extended to the Flap 5 position. The selected heading was then changed to 300° and the autopilot was switched from ALTITUDE HOLD mode to VERTICAL SPEED with a descent rate of 1,000 ft/min.

As the aircraft passed through 2,600 ft amsl, the autopilot was switched from HEADING mode to LOCALIZER. The aircraft was 3.5 dots right of the localizer and one dot below the glideslope at 9 nm DME.

The aircraft continued descending at 1,000 ft/min, turning to the left, and intercepted the localizer at 7.5 nm DME and at 2,150 ft amsl (1.5 dots below the glideslope). By 1,600 feet amsl the landing gear was down and locked. The flaps were then moved to Flap 10 then Flap 15. The first GPWS “glideslope” warning was recorded at 5.4 nm DME as the aircraft descended through 975 ft agl, 3 dots below the glideslope.

Initially the aircraft continued to descend with the same vertical speed but after the second GPWS “glideslope” warning was recorded at 920 ft agl and 5.3 nm DME, the autopilot was disconnected and the rate of descent reduced. The third GPWS “glideslope” warning was recorded at approximately 730 ft agl and the aircraft continued in level flight over slightly rising ground. At 630 ft agl, 4.1 nm DME the fourth GPWS glideslope warning was recorded. The aircraft remained in level

flight with a full “fly up” indication on the glideslope indicator and the final GPWS “glideslope” warning was recorded at 4.0 nm DME. The aircraft intercepted the ILS glideslope at 3.6 nm DME, and continued to an uneventful landing.
