SERIOUS INCIDENT

Aircraft Type and Registration:	Fokker F50, OO-VLF	
No & Type of Engines:	2 Pratt and Whitney Canada PW 125B turboprop engines	
Year of Manufacture:	1991	
Date & Time (UTC):	15 January 2009 at 1008 hrs	
Location:	Ronaldsway Airport, Isle of Man	
Type of Flight:	Commercial Air Transport (Passenger)	
Persons on Board:	Crew - 2	Passengers - 20
Injuries:	Crew - None	Passengers - None
Nature of Damage:	No reported damage	
Commander's Licence:	Airline Transport Pilot's Licence	
Commander's Age:	37 years	
Commander's Flying Experience:	6,500 hours (of which 4,950 were on type) Last 90 days - 120 hours Last 28 days - 9 hours	
Information Source:	AAIB Field Investigation

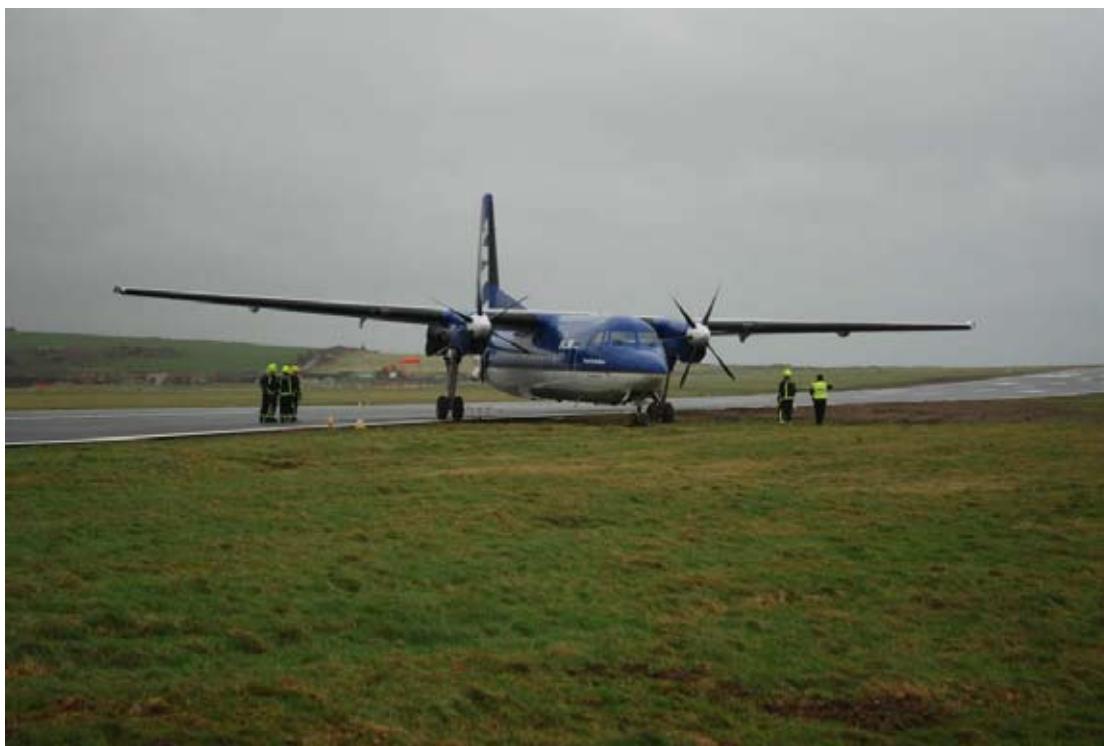
Figure 1

shortly before the aircraft departed the left side of the paved surface. The aircraft came to a stop with the nose and left main gear off the paved surface. The aircraft's speeds during final approach and at touchdown were consistent with its weight, configuration and the weather conditions.

shutting the engines down was the most sensible course of action, as the aircraft was becoming increasingly bogged down. The commander accepted this advice and shut the aircraft down. The passengers were deplaned using the rear right exit which had remained above the paved runway surface (see Figure 1). Several passengers commented that the height of the door sill above the runway caused difficulties as they jumped down from the aircraft.
