On a scheduled cargo flight from Liège Airport to London Stansted Airport the crew diverted to Nottingham East Midlands Airport¹ due to unexpectedly poor weather conditions at Stansted. The weather conditions at EMA required a CAT IIIA approach and landing. On approach, at approximately 500 feet agl, the crew were passed a message by ATC advising them of a company request to divert to Liverpool Airport. The commander inadvertently disconnected both autopilots whilst attempting to reply to ATC. He then attempted to re-engage the autopilot in order to continue the approach.

The aircraft diverged to the left of the runway centreline and developed a high rate of descent. The commander commenced a go-around but was too late to prevent the aircraft contacting the grass some 90 m to the left of the runway centreline. The aircraft became airborne again but, during contact with the ground, the right main landing gear had broken off.

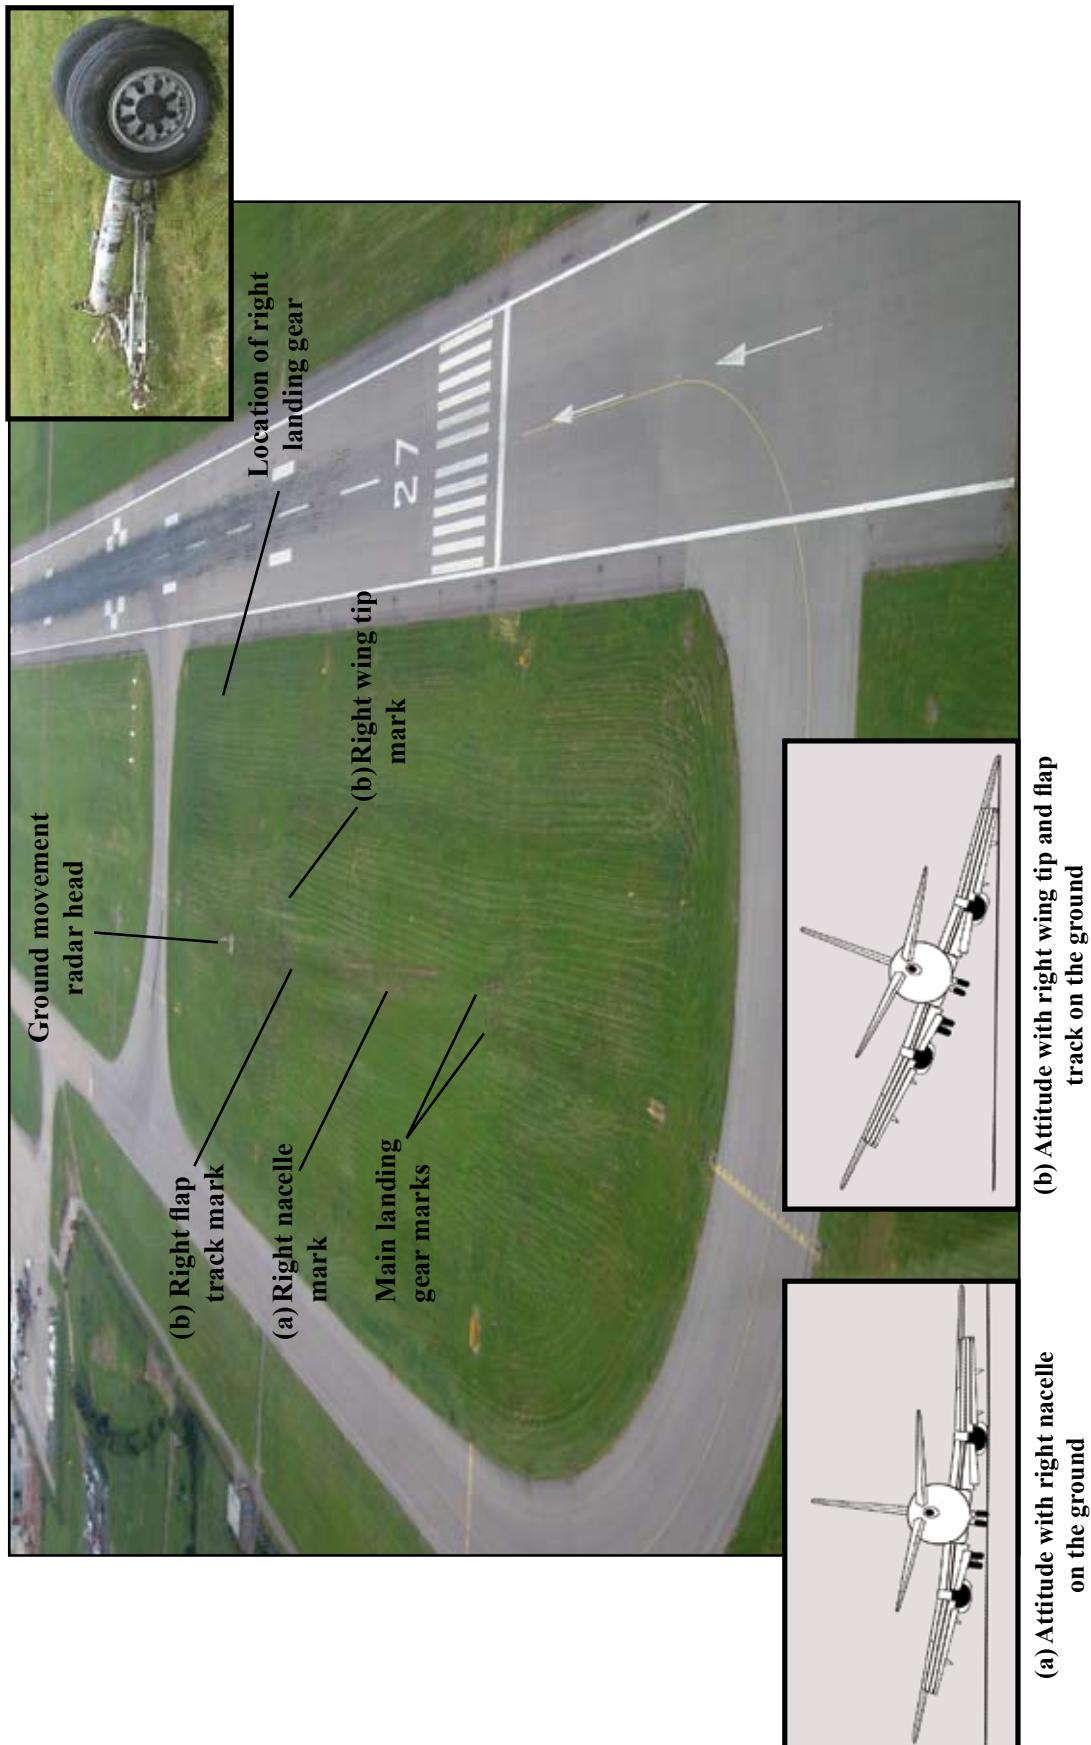
Figure 7

The main landing gear wheel furrows continued for 5.5 m, at which point the left main landing gear wheels appeared to have lifted up and run along the surface for a further 14 m. The right main landing gear tracks stopped at the end of the wheel furrows, indicating the most likely point at which the leg separated from the aircraft. Debris was found in the area immediately beyond these furrows. This consisted of pieces of landing gear door, cables, hydraulic lines from the landing gear leg, and the right main landing gear up-lock actuator, Figure 8.

Two impact craters were evident which were consistent with having been made by the detached landing gear leg. The first crater was 57 m beyond the end of the furrows made by the right main landing gear wheels, the second 100 m beyond. The right main landing gear unit and the landing gear retraction actuator were found 190 m beyond the point of separation, and 36 m from the left shoulder of Runway 27.

Ground marks made by OO-TND at East Midlands Airport

Some 35 m beyond the end of the ground marks made by the right main landing gear, the right engine nacelle made contact with the ground and remained in contact for 45 m. Debris found along this ground mark consisted of pieces of nacelle and thrust reverser fairing.

Some 30 m beyond the start of the right engine nacelle ground mark, other marks were present, approximately 35 m in length, consistent with the right wing outboard flap track fairing having made contact with the ground. These marks showed that, at this point, the aircraft was veering onto a heading of 270°. A landing light, which is normally located in the right flap track fairing, was found embedded in this ground mark.

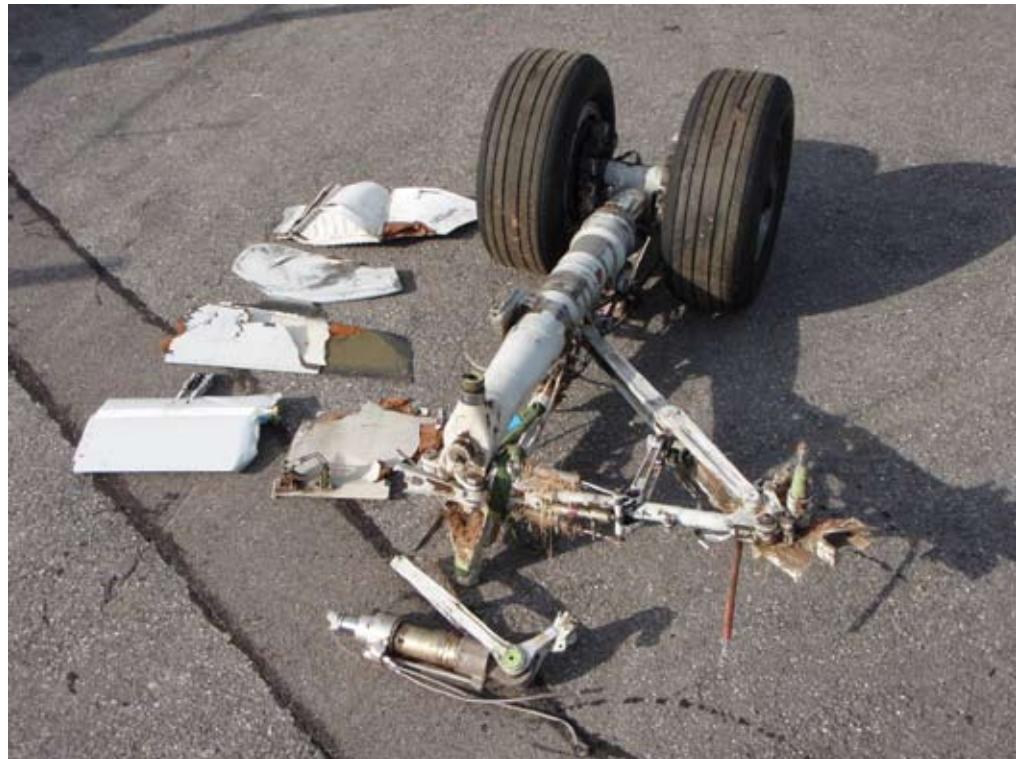
Figure 8
OO-TND debris recovered at East Midlands Airport

The right main gear leg was retrieved from EMA and examined in relation to the aircraft. The leg had become detached from the wing structure at four locations. The two structural fuse pins in the forward and aft trunion bearings had both failed, leaving the wing/fuel tank structure intact. The other two locations were the uplock support structure and the walking beam hanger structure. The main gear actuator and the walking beam had also failed, resulting in the gear leg assembly breaking into two distinct parts.

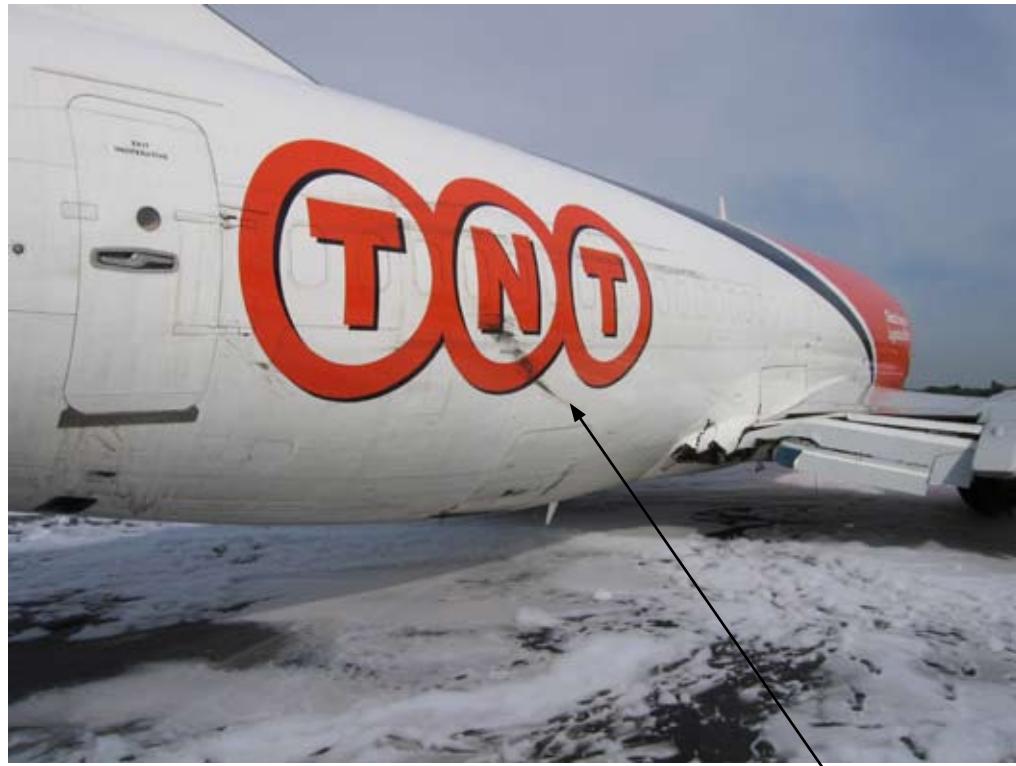
Figure 9

Structural damage had occurred to the right inboard trailing edge flap, and further damage and tyre marks were present on the side of the fuselage, aft of the right wing. This was consistent with the right landing gear leg having struck the fuselage after becoming detached. At their highest point, these marks were close to the line of blanked out windows, Figure 9, and it was apparent that the departed leg had come close to striking the horizontal stabiliser.

Details of flap damage and tyre marks on rear fuselage

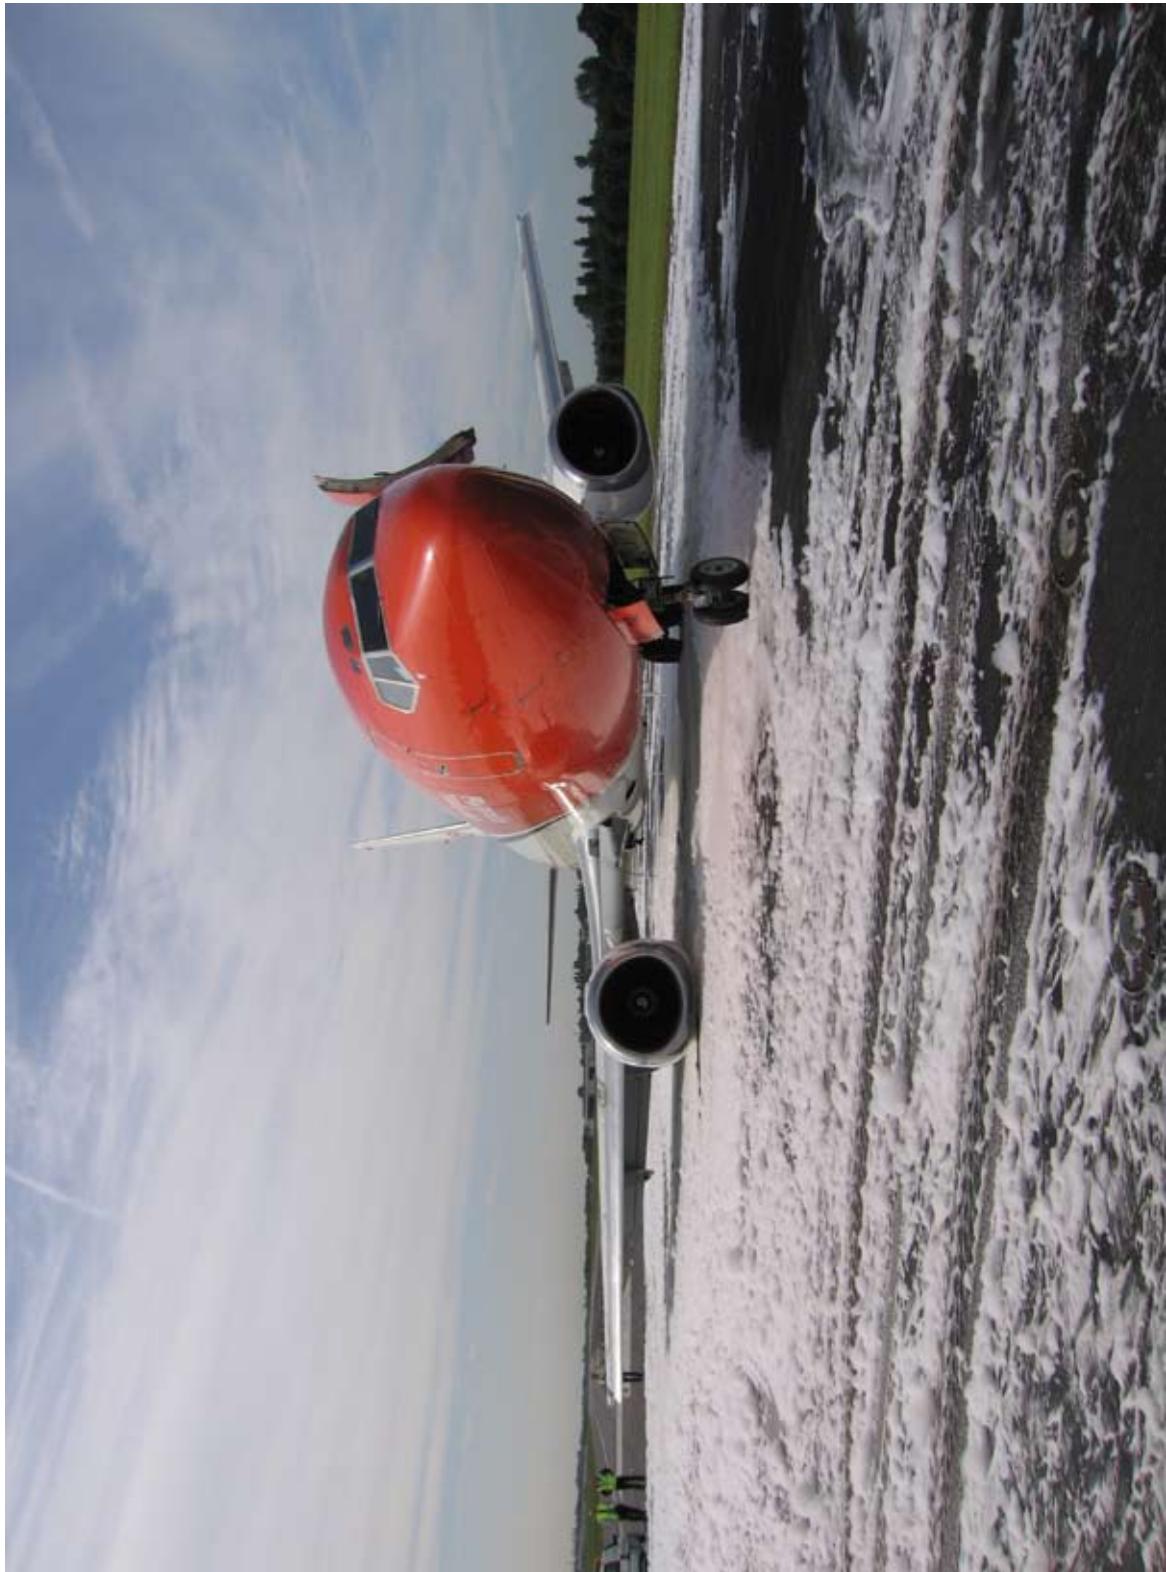
As a consequence of the aircraft hitting the ground, the complete right landing gear leg assembly had detached from the aircraft at its 'fuse pin' attachment points in the wing. As a result, hydraulic System A was lost. The leg was found on the grass within the sterile⁷ area to the left of Runway 27. The detached leg had caused significant damage to the right inboard flap assembly, and some damage to the right lower rear fuselage structure around the rear baggage hold door. Structural damage had also been caused to the two flap track fairings on the right outboard flap, the underside of the right engine nacelle and the right wing tip.

In the absence of the right MLG, additional damage to the underside of the right engine nacelle occurred as it slid along the surface during the landing roll.

OO-TND after landing at Birmingham International Airport
