**Report of the Board of Review on the Accident to Boeing MD-11 B-150 at
Hong Kong International Airport on 22nd August 1999**

**Pursuant to Civil Aviation (Investigation of Accidents) Regulations,
Cap. 448, Laws of Hong Kong**

**Hong Kong SAR
November 2004**

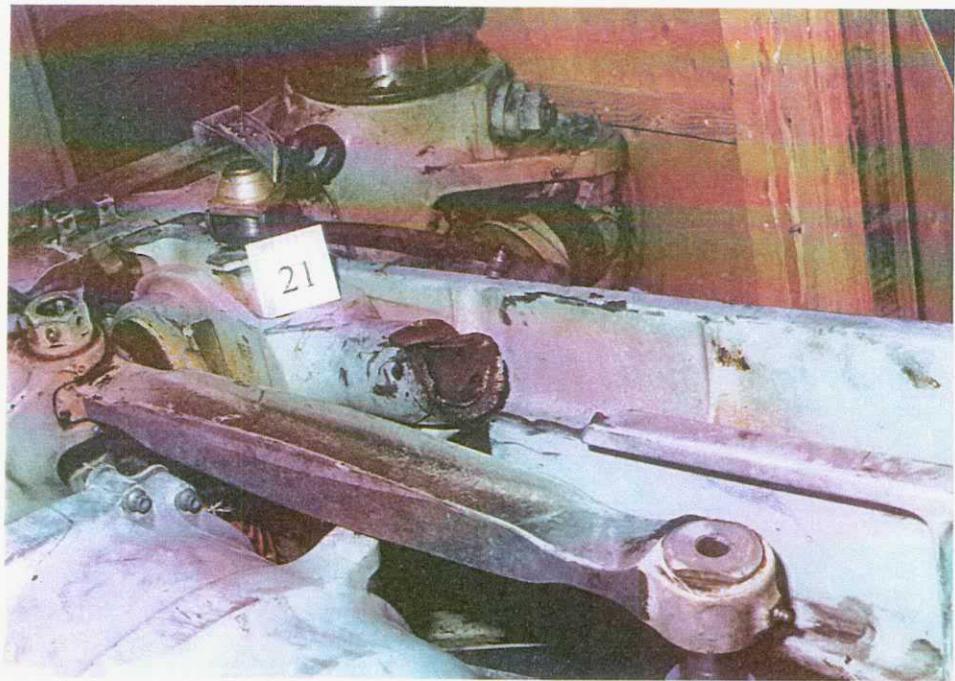
**Fractured RMLG Aft Attachment Fitting with Aft Shear Pin (Trunnion Bolt)
(Figure 10)**

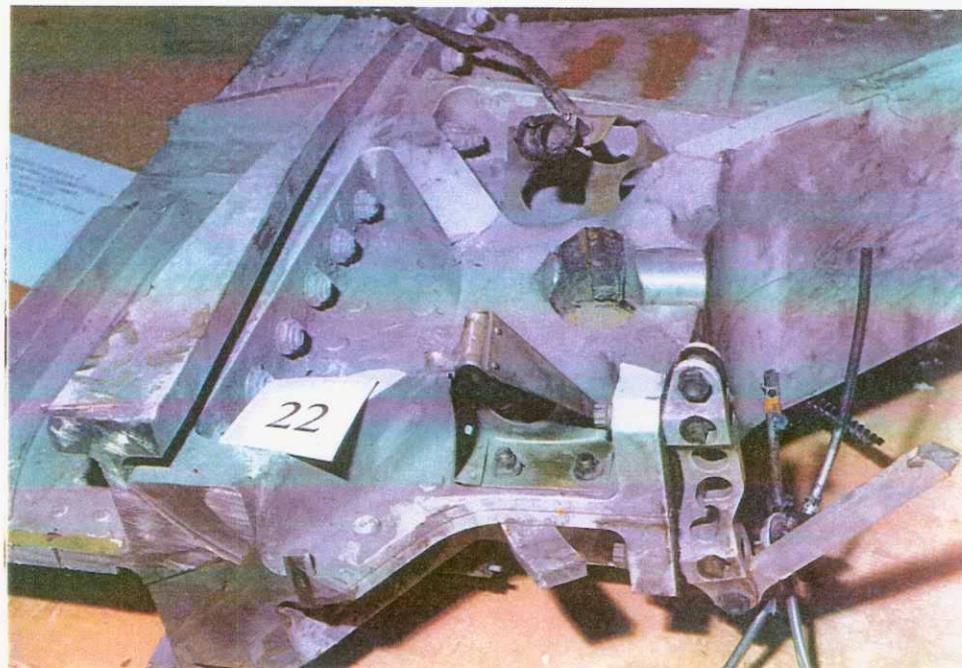
Fractured Fixed Side-Brace (Figure 11)

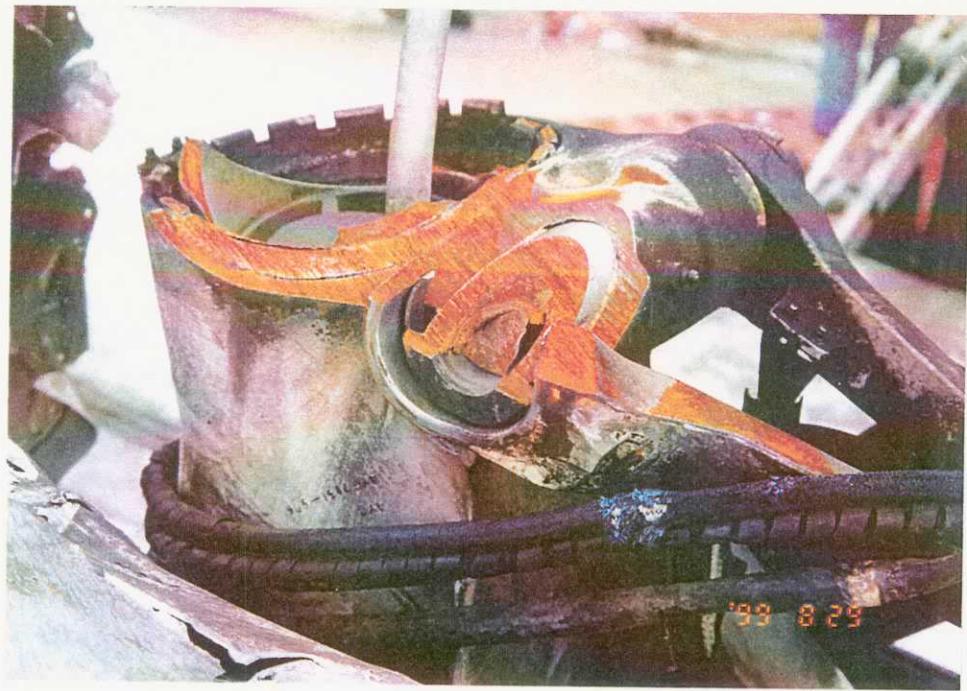
Fractured Trapezoidal Panel (Figure 12)

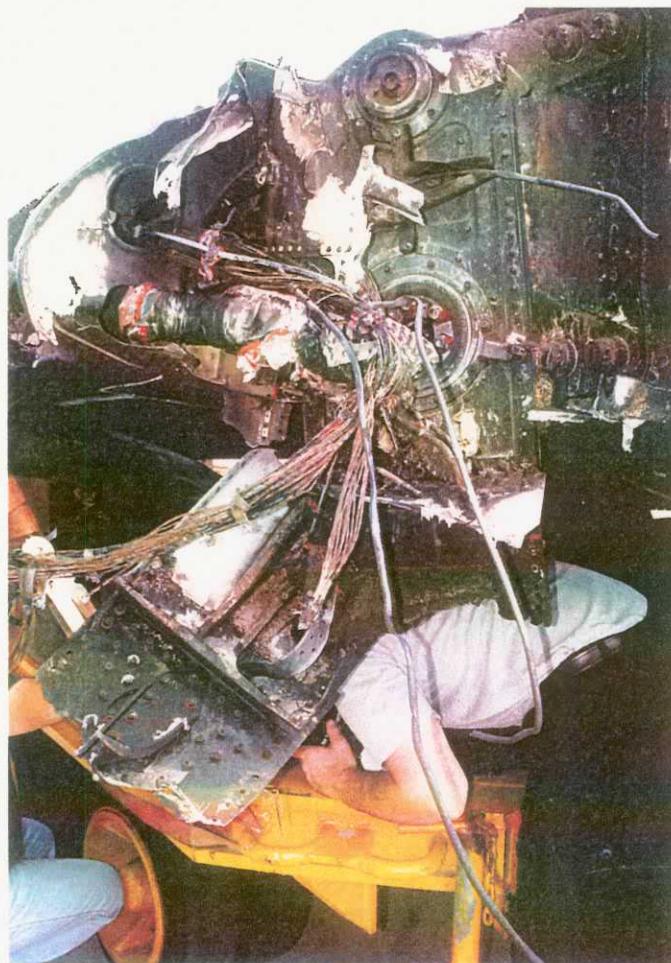
Fractured Center Landing Gear Oleo (Figure 13)

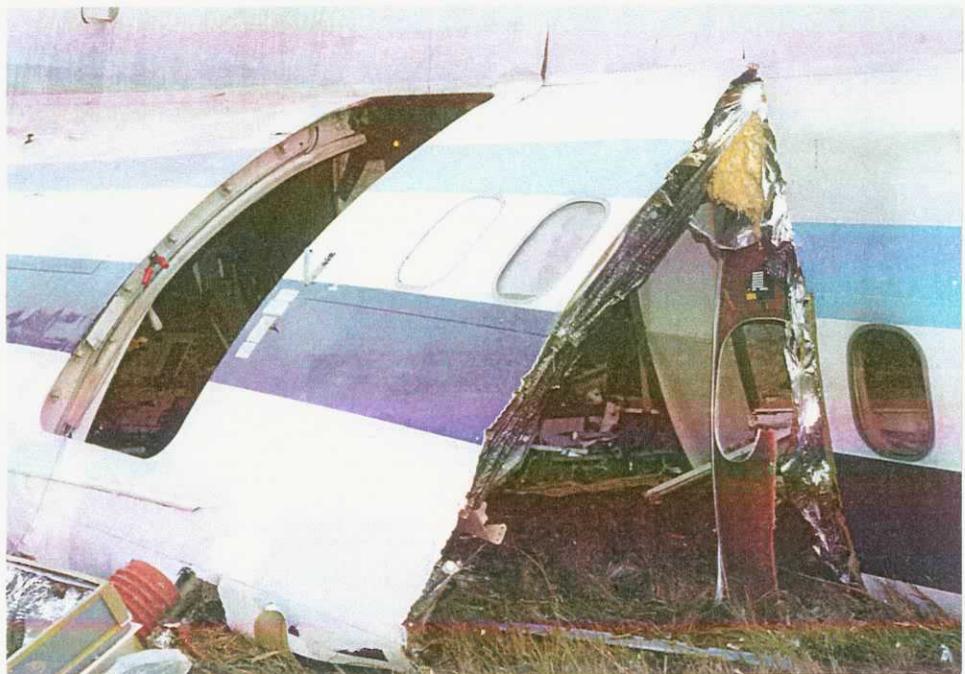
8. View of crack in right fuselage (forward) including Door 2R.

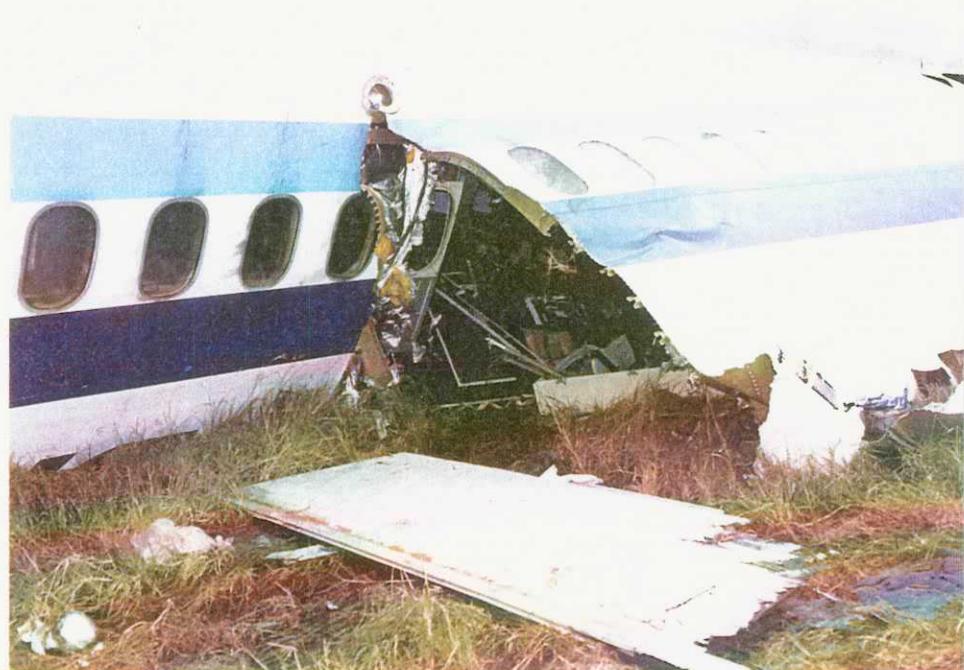
9. View of crack in right fuselage (aft).

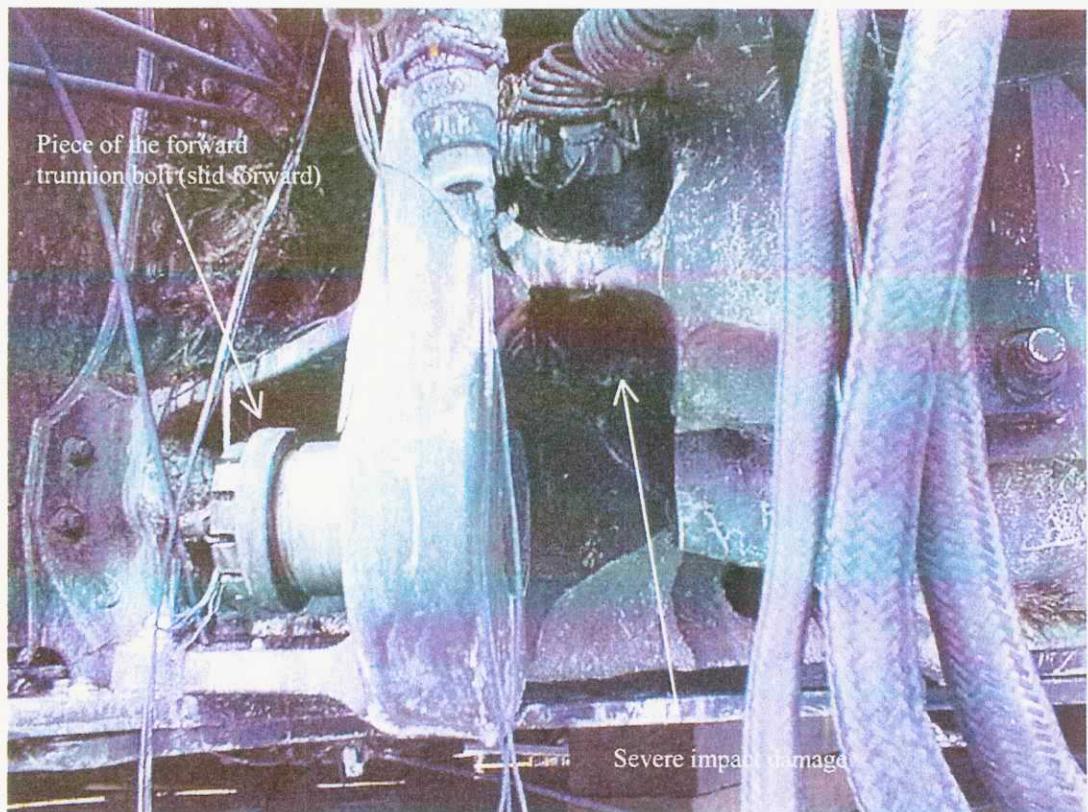
Figure 6. Damage to MLG-to-Wing Attach Fitting at the forward lugs

After shearing the forward trunnion bolt at the forward zero-margin groove, the forward trunnion of the right main landing gear was driven upwards and contacted the wing attach fitting, damaging the fitting. This is clearly evident in a photograph taken at the crash site (Figure 6) and in Figures 34 and 35 of the Materials and Process Engineering Report (Reference 2).

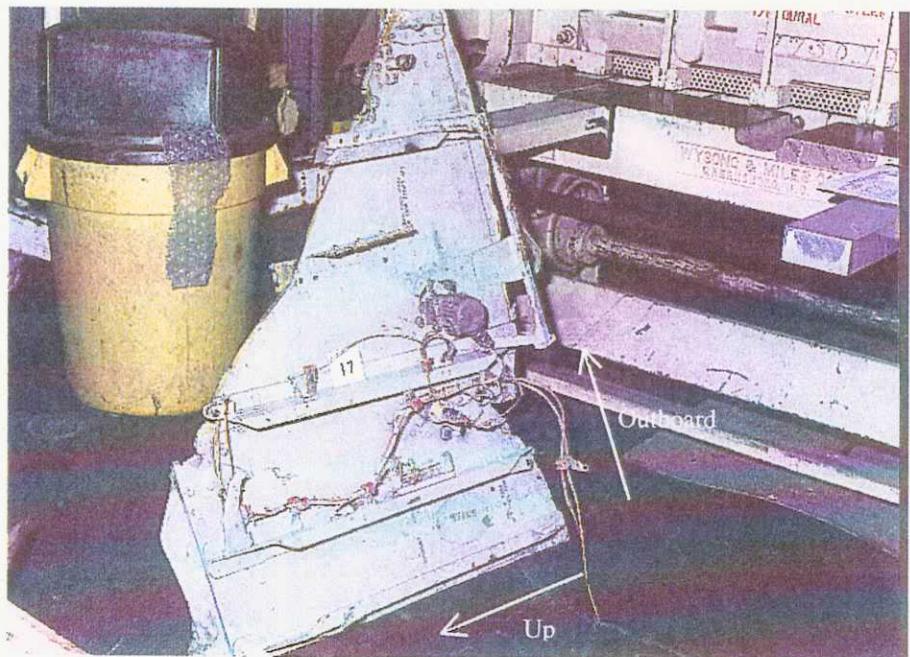
Figure 8. Right Wing Rear Spar Web Fracture from Ship 518 (China Airlines)

The rear spar web was identified as the first structural element thought to have failed in the FedEx accident that occurred in Newark, New Jersey on August 31st, 1997. A significant amount of analysis was conducted to validate the FedEx failure sequence, so this failure mode was quickly recognized when the wreckage of the China Airlines aircraft was examined.

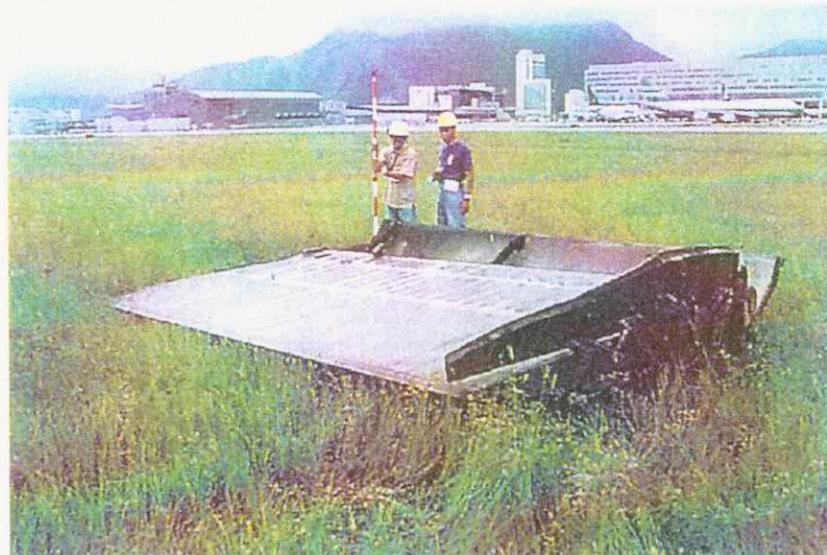
Figure 15. Right Inboard Flap from Ship 518 (China Airlines)

The China Airlines inboard flap was found off to the left of the runway and is thought to have been carried there by the crosswind (which was blowing right-to-left) after it departed the aircraft. The flap, as it was found, is pictured in Figure 15. The FedEx inboard flap was found on a taxiway to the right of the runway (Figure 16); note there was little or no crosswind present when the FedEx accident occurred.

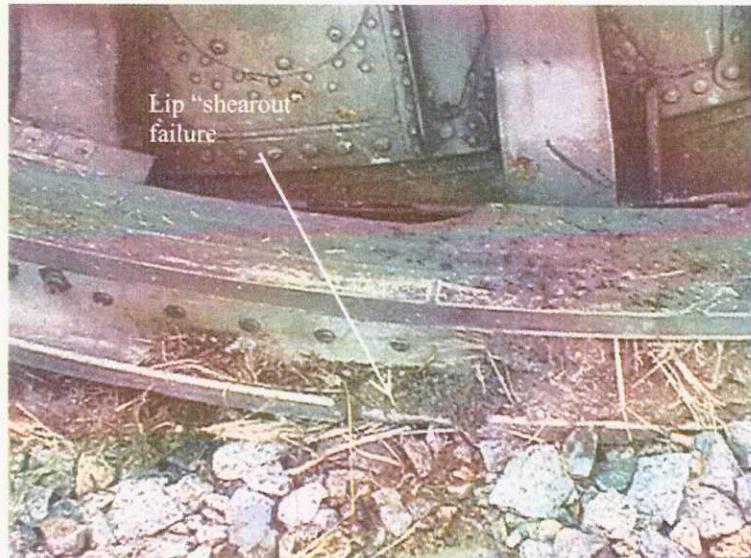
Figure 17. Right Inboard Flap track from Ship 518 (China Airlines)

The local shear-out failure of the flap track is evident in a photograph taken at the accident site (Figure 17). The location of this failure is consistent with the position of the side rollers for the reported flap setting of 35 degrees. The same type of failure is observed in the photograph of the inboard flap from the FedEx-Newark aircraft (Figure 18); in this case the failure location is consistent with the reported flap setting of 50 degrees.

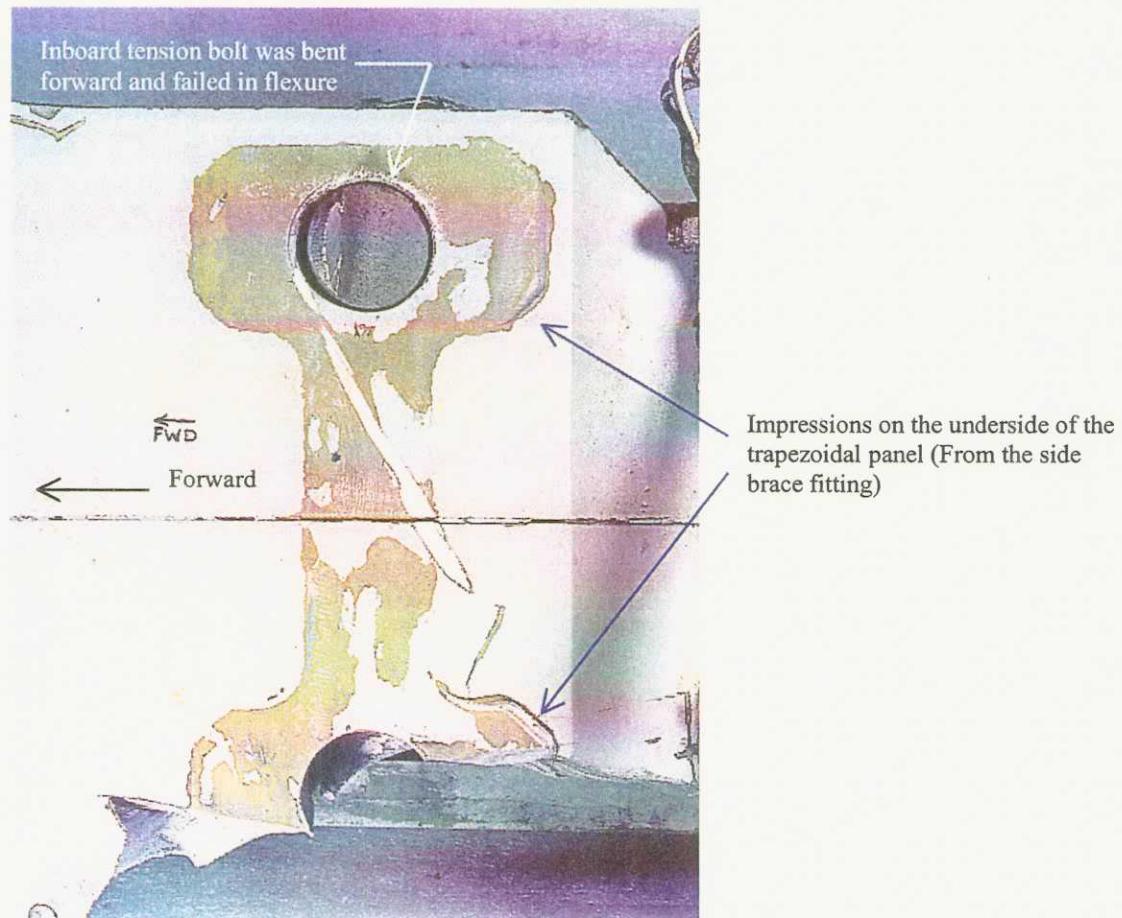
Figure 21. Underside of the right trapezoidal panel

As was the case for the inboard flap's departure, the damage to the S-B-F-T-T-P joint was the result of large relative displacements between attach points on the wing and on the fuselage. After the right wing rear spar failed, the MLG-to-wing attach fitting moved up (relative to the fuselage) and the outboard wing twisted severely nose-down. This motion effectively tilted the truss formed by the MLG strut, and the fixed and folding side braces, and applied a nose-down twist to the S-B-F-T-T-P joint. This applied twist rocked the side brace fitting (bottom-end-aft) and resulted in "impressions" on the lower surface of the trap panel (Figure 21). Similar impressions were observed on the underside of the trap panel from the FedEx-Newark accident aircraft.

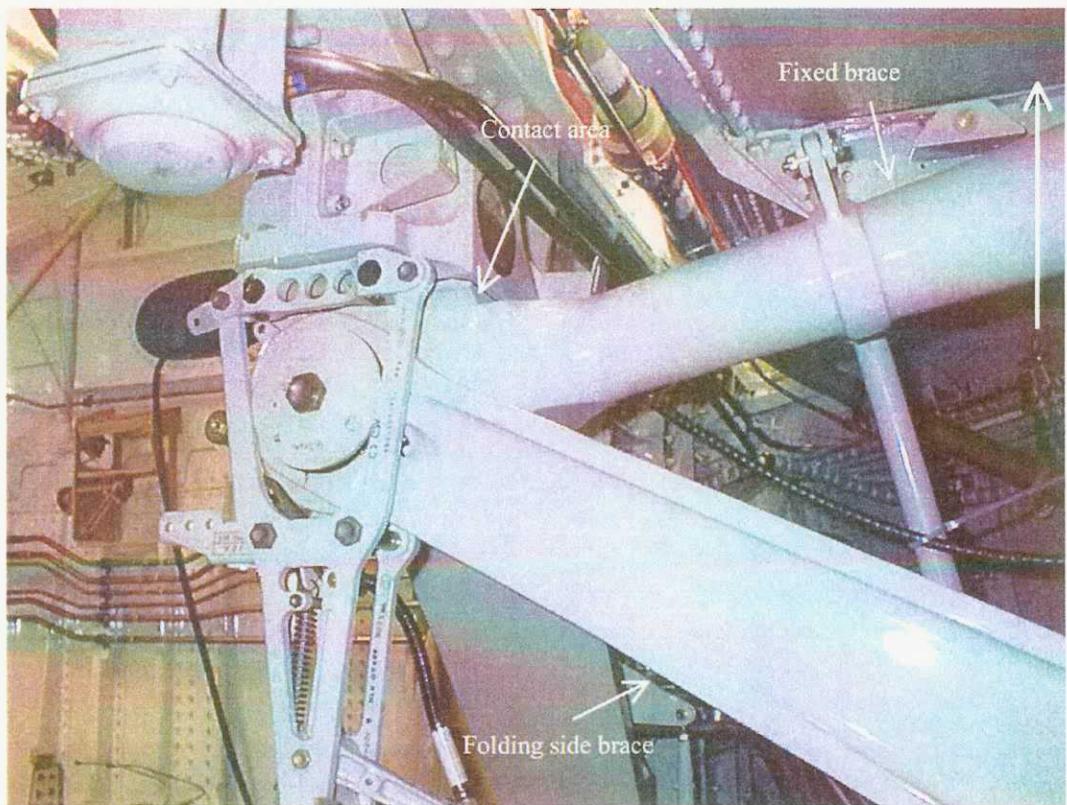
Figure 22. Side-brace-fitting-to-trap-panel joint (from aft and outside the right wheel well)

Figure 22 is another photograph of the S-B-F-T-T-P joint area. The photograph is annotated to point out the limited clearance between the clevis end of the fixed brace and the side brace fitting. Excessive upward motion of the outboard end of the fixed brace (which is connected to the MLG-to-wing attach fitting) results in contact in the noted area, and creates a "short couple" prying load at the joint. Evidence of contact in this area for parts taken from the China Airlines accident aircraft is seen in Figure 23. Similar evidence was also noted for the FedEx-Newark accident aircraft.

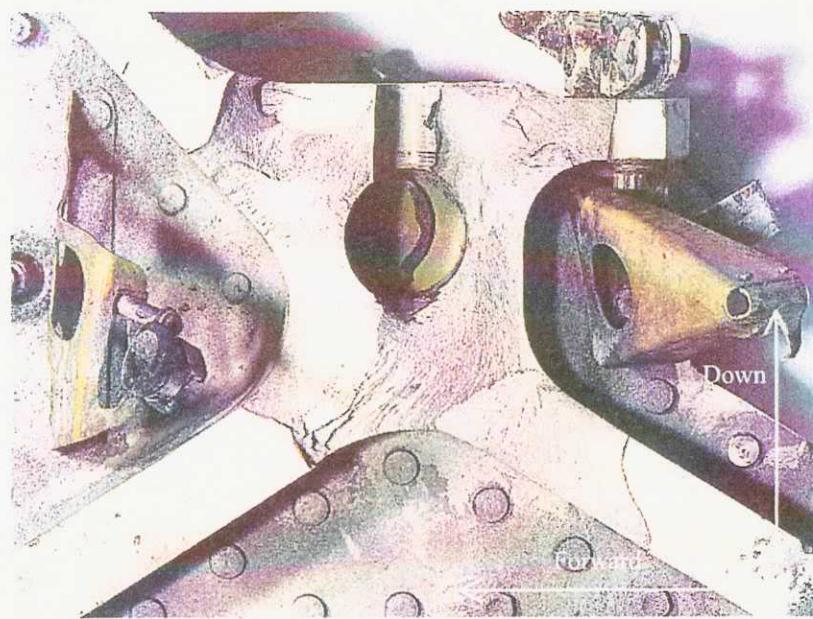
Figure 26. Outboard trap panel failure at the S-B-F-T-T-P joint

The outboard tension bolt did not fail. Instead a portion of the outboard face of the trap panel appears to have "split off", releasing the outboard barrel nut and tension bolt (Figure 26). This is thought to have occurred *after* the inboard bolt had failed and appears to have been the result of a prying load applied by the outboard tension bolt, the prying load resulting from the folding side brace pulling outboard on the side brace fitting. (Note the photograph is upside-down relative to the normal position in the aircraft).

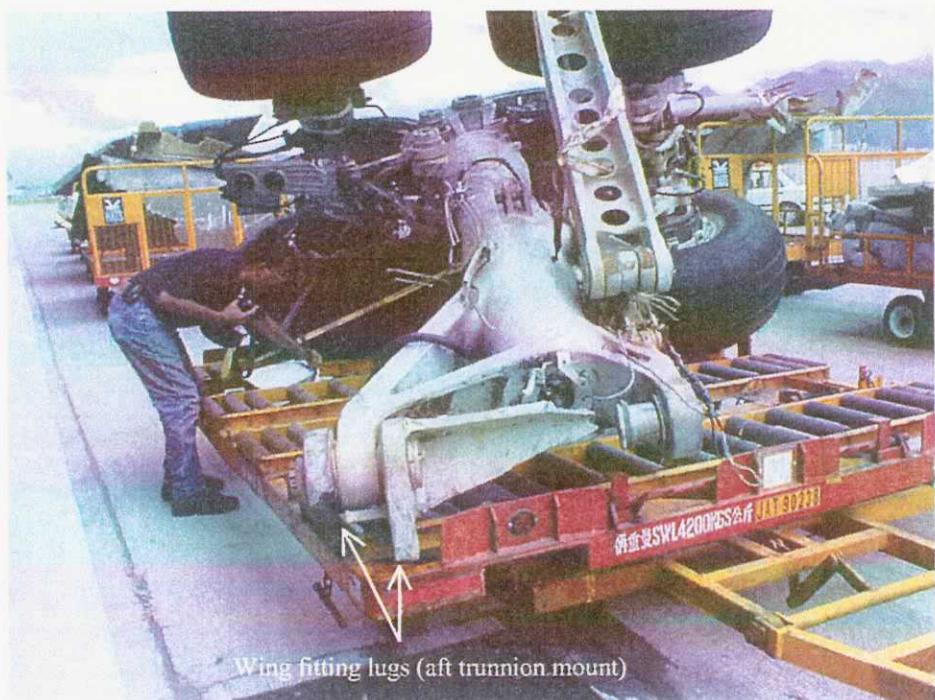
Figure 31. Right main landing gear assembly

cracked off as a result of the gear rotating outboard (Figure 31). This separated the right main landing gear from the aircraft. The contact area on the aft trunnion arm is shown in Figure 32. A photograph of the wing fitting, showing the mating area for the two aft trunnion support lugs, is included as Figure 33.

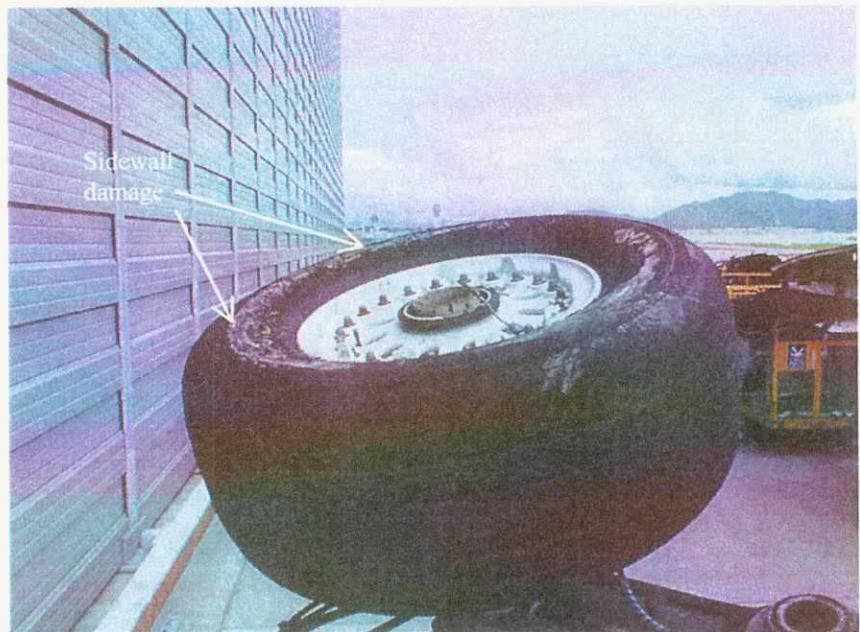
Figure 34. Inboard aft tire from the right main landing gear

Substantial sidewall abrasion was noted on the inboard sidewall of the aft inboard tire on the right main landing gear truck (Figure 34). This evidence further supports the theory that the gear rotated outboard putting the inboard sidewalls of the inboard tires in contact with the ground.
