**Statens haverikommission**  
Swedish Accident Investigation Board

## ***Report RL 2005:20e***

### **Incident involving aircraft LN-RPL at Gothenburg/Landvetter Airport, O county, Sweden, on 7 December 2003**

Case L-59/03

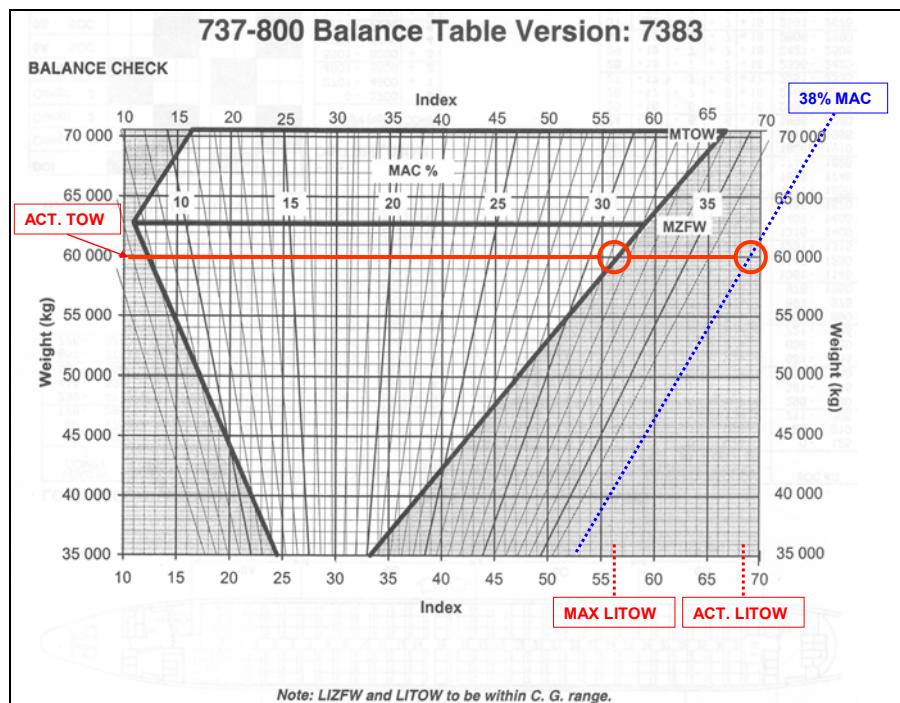
Actual start mass and centre-of-gravity position prior to takeoff from Göteborg/Landvetter Airport (LITOW<sup>5</sup>) is marked on the diagram below.

It can be seen from the diagram that the aircraft's centre-of-gravity-position was approx. 38 % MAC, which is approx 6.6 % MAC aft of the aft certified CG limit for the actual takeoff mass, 59 285 kg. The deviation represents more than 1/4 of the certified CG span. (See also 1.18.1.)

According to the loadsheet the pilots received prior to takeoff, the aircraft's centre of gravity was at 25 % MAC. Based partly on this information, the stabiliser trim position was set to 4.5 units, with flap position no. 1
