**AAIU Synoptic Report No: 2005-018**

**AAIU File No: 2004/0040**

<b>Aircraft Type and Registration:</b>	B737-800, EI-CSA	
<b>No. and Type of Engines:</b>	2 x CFM 56-7B	
<b>Aircraft Serial Number:</b>	29916	
<b>Year of Manufacture:</b>	1999	
<b>Date and Time (UTC):</b>	21 July 2004 @ 13.40 hrs	
<b>Location:</b>	Approach to Skavsta Airport, Sweden	
<b>Type of Flight:</b>	Public Transport	
<b>Persons on Board:</b>	Crew - 6	Passengers - 184
<b>Injuries:</b>	Crew - Nil	Passengers - Nil
<b>Nature of Damage:</b>	None	
<b>Commander's Licence:</b>	Airline Transport Pilot's Licence	
<b>Commander's Details:</b>	Male, aged 38 years	
<b>Commander's Flying Experience:</b>	5,000 hours approximately (of which 1,500 were on type)	
<b>First Officer's Flying Experience:</b>	700 hours (of which 400 were on type)	
<b>Information Source:</b>	Reports received from the Operator and Pilots. AAIU Field Investigation.

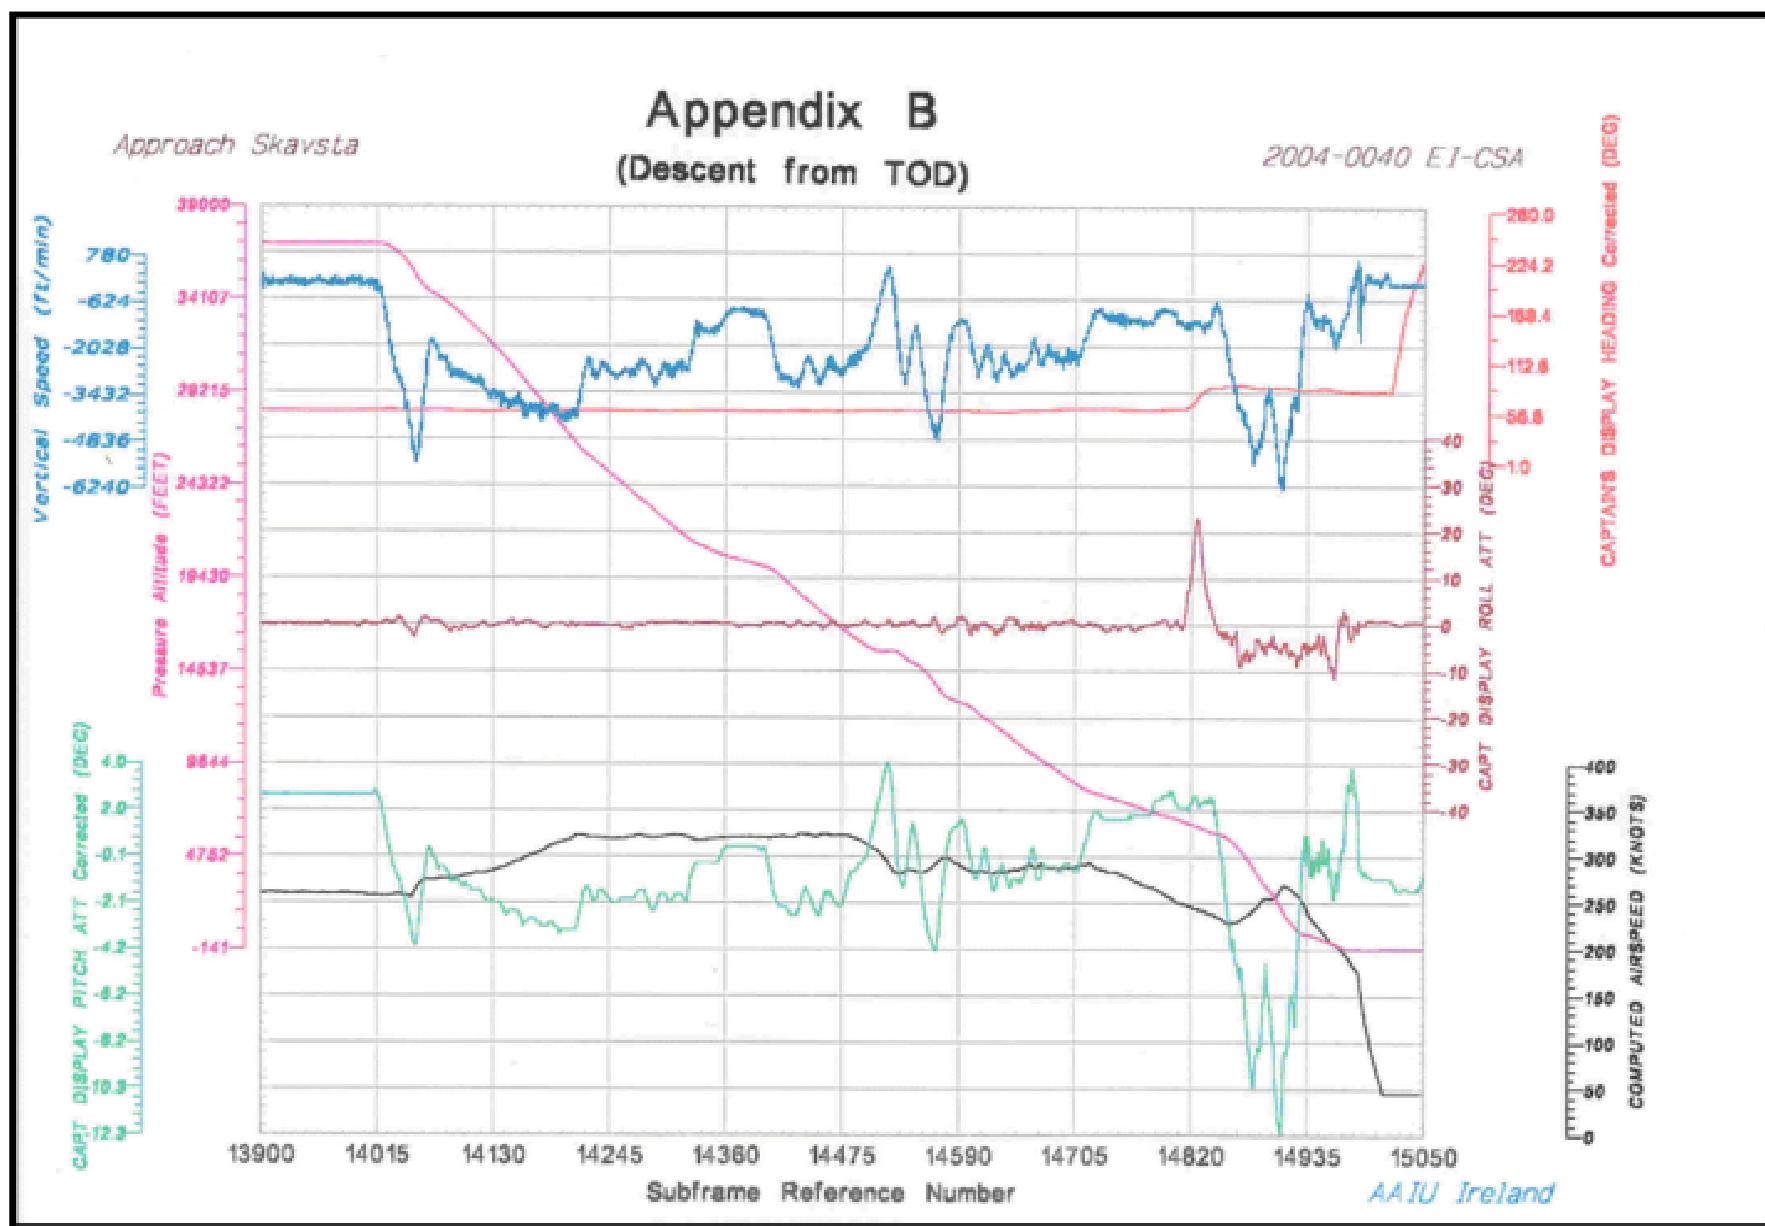
Appendix B  
(Descent from TOD)

Nose down pitch reached 12.3° which, in turn, with the use of side slip contributed to excessive Rates of Descent (ROD), up to 6,200 fpm were recorded, and excessive speeds for flap deployment (**Appendix B and Appendix C**). These, in turn, led to GPWS alarms sounding which were ignored by the PF, as were the speed and height warning inputs from the PNF. All of the foregoing led to an unnecessarily high speed landing. In his written statement the PF attempted to address his behaviour over that fifteen minute period. He stated, *inter alia* "*I cannot understand what possessed me to continue the approach, I have replayed these events in my mind hundreds of times and, at no instance, do I arrive at the decision I took. I became fixated and lost sight of the big picture. It was only at such a late stage that the events taking place around me actually penetrated my mind; but by then I found myself in the landing roll*" and "*I cannot understand myself how it was possible for me to show such poor judgement. I can only imagine that certain personal stresses and tiredness affected my ability to think rationally. I do not offer this as an excuse but merely an insight into my deficiency for logical thought*".
