Report RL 2003:32e

***Incident involving aircraft HB-JAY
and SE-ISR at Stockholm/Arlanda
airport, AB County, Sweden, on the
16th of December 2002***

Dnr L-102/02

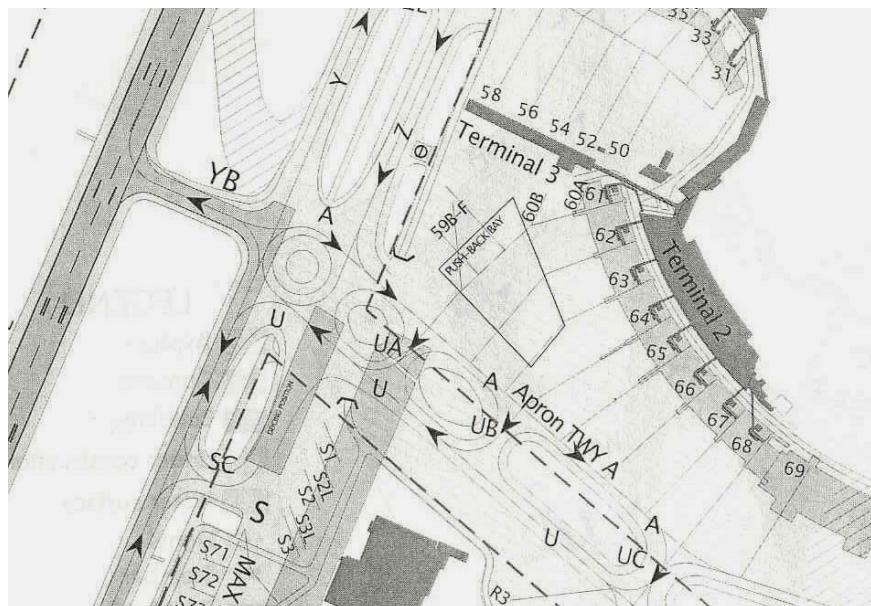
During this time the aircraft SE-ISR, with flight number SKX 300, landed on runway 01L. After landing the aircraft left the runway via exit YD. When the pilots contacted GND for taxi directions they received the instructions "*Express 300, morning, taxi to Sierra 75 hold before Alfa*". This clearance was acknowledged. They continued taxiing via taxiway ZH and Z southbound towards the S 75 parking stand. While taxiing the pilot in command requested that the first officer shutdown the left-hand engine. As the aircraft approached terminal 3, initially the pilot in command did not observe LX 1223, due to an aircraft, which was parked on stand 59. However he did see an aircraft that taxied out from the ramp situated behind the terminal. He also observed that a so-called marshaling vehicle had been pre-positioned and was waiting for them beyond taxiway A, according to the normal routine (See depiction below).

Out-taxiing from Terminal 2 shall, according to the AIP³, take place via taxiway U (see below). In order to shorten the taxi distance for departures from the northern portion of the airport, it is customary that crews request to taxi out via taxiway A, which is often accepted by the air traffic control. The aircraft taxiing out ahead of LX 1223 was cleared to taxi out via taxiway A without having requested this.
