Aircraft Incident Report

Wing-Tip Strike with Building while Taxiing

China Eastern Airlines Flight 5054

A321-211, B2290

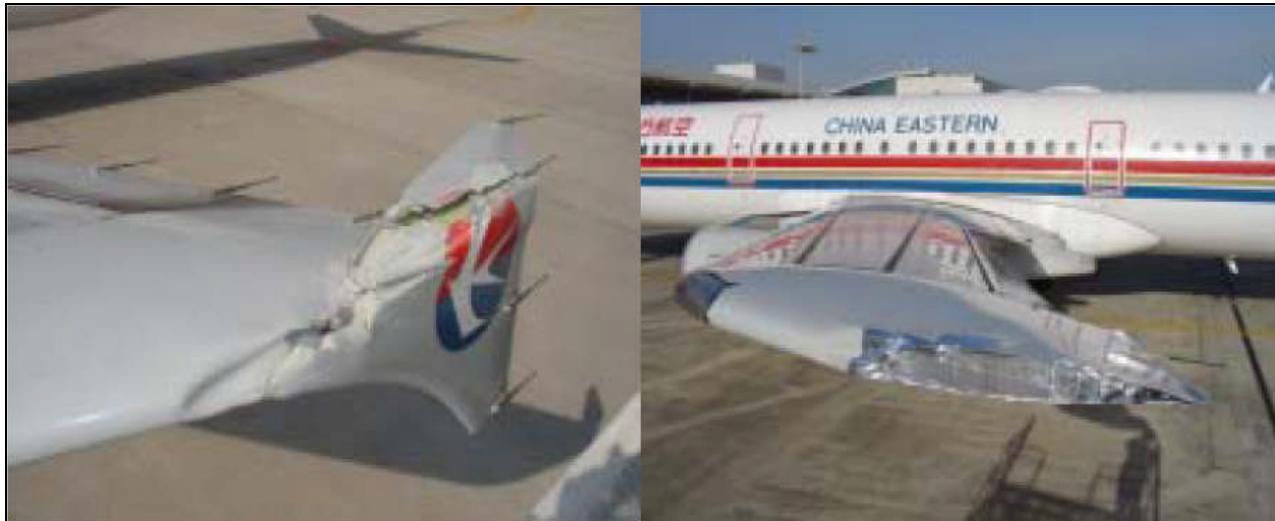
Due to this incident, the left wing tip and wing tip fence⁵ of Aircraft 5054 had impact damage, but there were no injuries to persons.

In the process of the contact of the left Wing Tip and Wing Tip Fence of Aircraft 5054 with the eave of PAR Site of Daegu Airport, left Wing Tip and Wing Tip Fence was damaged as shown in the [Picture 1] but after the engineers specialized in airframe who were dispatched by China Eastern Airlines took necessary actions based on the technical approval of the manufacturer and CDL 6.01.57 P 01 as shown in the [Picture 2], the aircraft received the Special Flight Permission from the General Administration of Civil Aviation of China and departed Daegu Airport at 13:04 on February 23, 2006.

[Picture 1] Picture of damaged left Wing Tip

[Picture 2] Picture after the completion of works

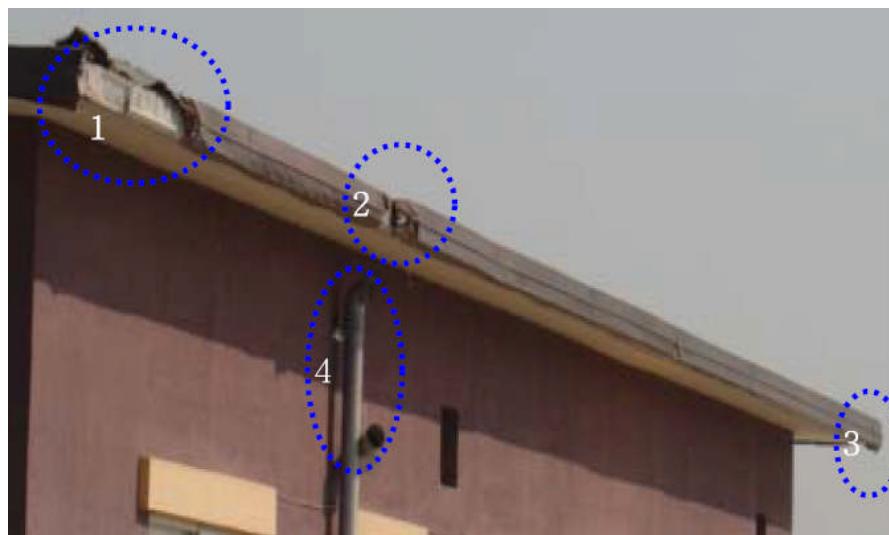
As the left Wing Tip and Wing Tip Fence of Aircraft 5054 contacted PAR Site, 3 places⁷ of roof covered with copper plate and the upper part of ventilation pipe affixed to wall were damaged as shown in the [Picture 3] and there was a trace of scratch under the eave.

[Picture 3] Damaged Parts of PAR Site

⁷ Level of roof damage : 1. Transverse 1.8m, Perpendicular 20cm, 2. Transverse 50cm, Perpendicular 20cm, 3. State of being pulled back upward, 4. Upper part of ventilation pipe

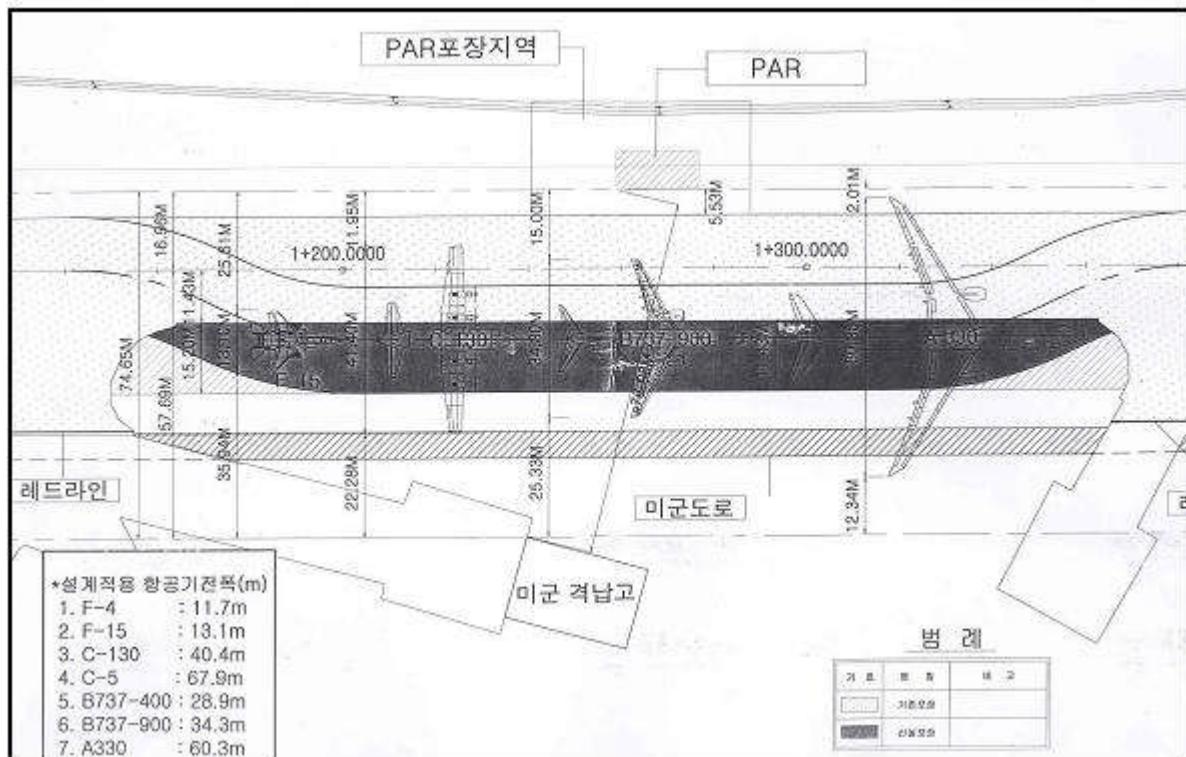
In order to improve the efficiency of civil aircraft operation and to implement the dust-proof pavement¹⁷ work plan for east parallel taxiway, the need for the operation of west parallel taxiway was arisen and therefore Aerodrome Administration Authority expanded a part of the taxiway in front of PAR Site as shown in the [Figure 4] toward west side and constructed curved taxiway¹⁸, which has been used by 50 flights of civil aircrafts for the period from the opening of the taxiway on February 18, 2006 (3 day before the occurrence of the incident) up to the time of incident.

[Figure 4] Curved Taxiway in front of PAR Site

At the time of the incident, the yellow color of the centerline which was indicated as yellow solid line on the existing straight taxiway was erased using concrete scratching off method as shown in the [Picture 4] but the erased portion was not turned into the color of other pavement surface and therefore the trace was still remaining in the form of white solid line.

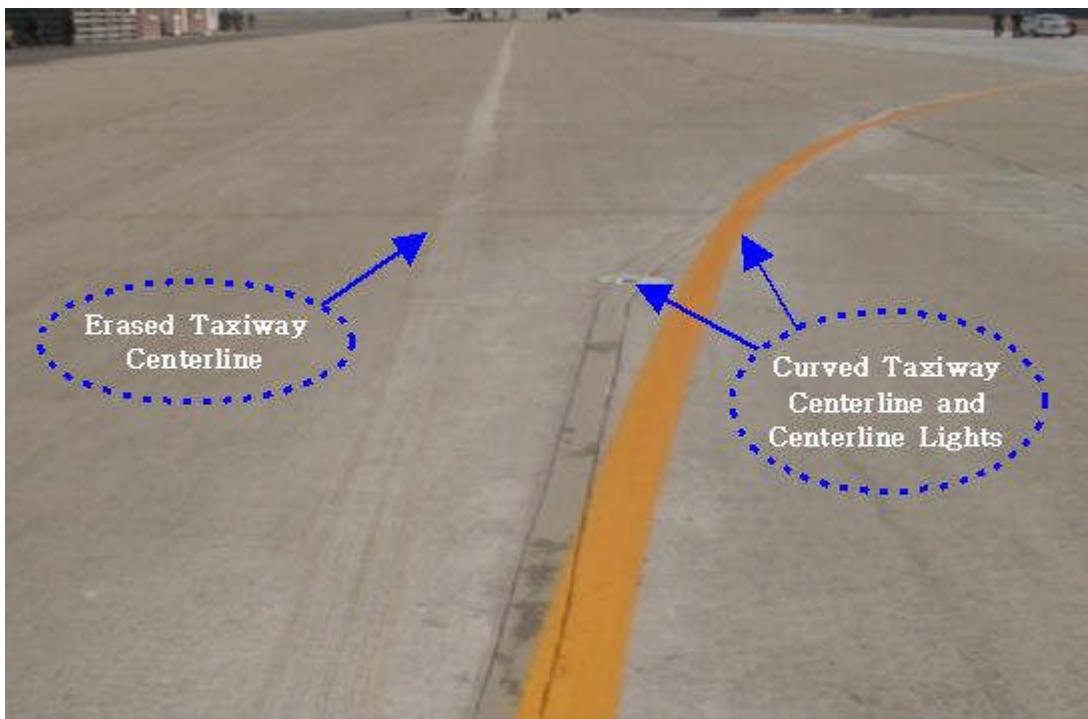
[Picture 4] Trace of existing straight Taxiway Centerline and newly installed curved Taxiway Centerline

According to the Standard¹⁹ on Airport Marking in the Advisory Circular²⁰ of Federal Aviation Administration, the markings on the pavement surface which is no longer necessary should be completely eliminated using the spraying of sands, chemical method or other method so that the possibility of pilots' misunderstanding should be eliminated. In the "Aerodrome Painting (Gonggyu 9-27)" of ROKAF regulation, there was no stipulation on the detailed method for the elimination of markings on the pavement surface.

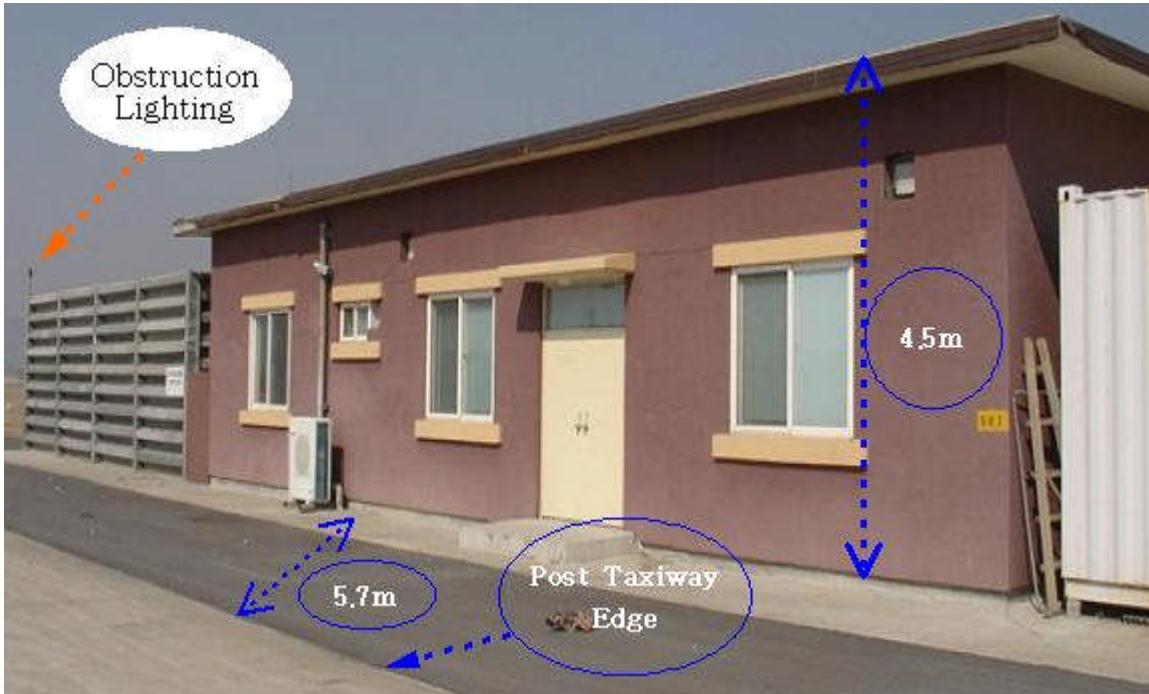
PAR Site and PAR Antenna protection wall located near the edge²² of west parallel Taxiway was located at a place which is 37.3m away from the curved Taxiway Centerline and 12m away from the straight Taxiway Centerline with one set of Obstruction Lighting as shown in the [Picture 5].

[Picture 5] Obstruction Lighting

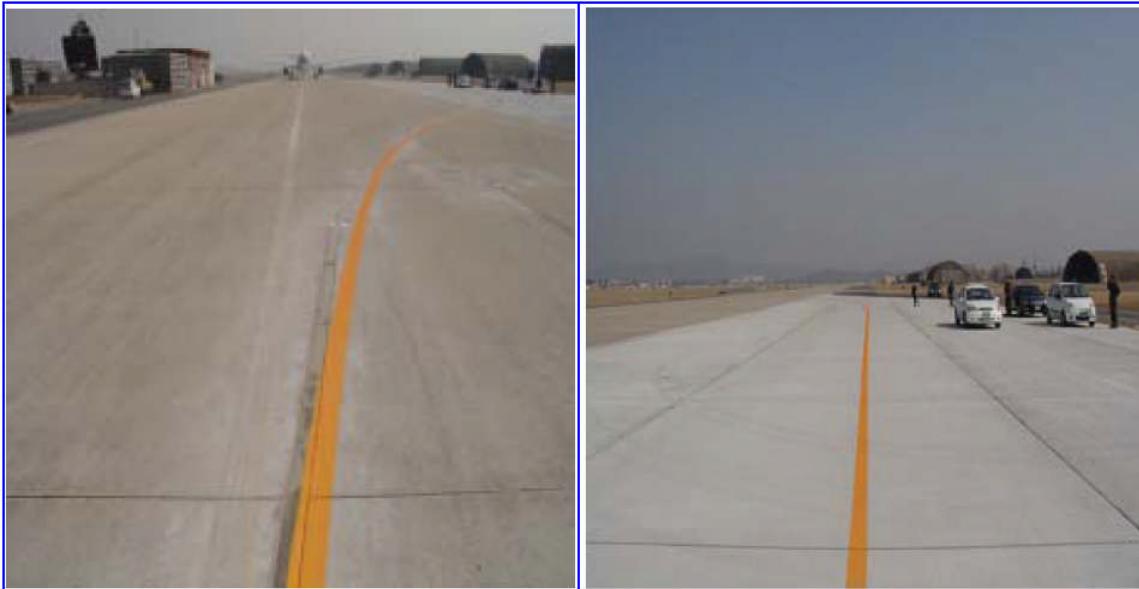
They say that there was still the traces of erased centerline on the unused taxiway but as we can see from the [Picture 6], it is judged that there was no problem at all in distinguishing the newly painted yellow centerline on the newly installed curved taxiway and the erased centerline.

[Picture 6] Yellow Centerline of the Curved Taxiway

Accordingly, even though there was no problem for the flight crew of Aircraft 5054 to distinguish the yellow centerline and to make the aircraft taxi along the curved taxiway, it seems that they were not on the alert for the Building which had the possibility of potential collision, could not see the newly painted yellow centerline and continued to go along the erased centerline of unused taxiway without any suspicion or verification as they were making negligent flight exchanging non-essential conversations.
