Tail strike during take-off

Boeing 737-800, registration PH-HZB,
Rotterdam Airport, January 12th 2003

The Hague, November 2006, project number 2003004

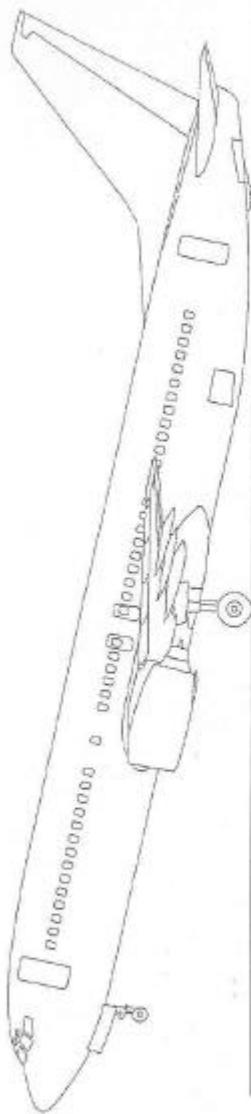
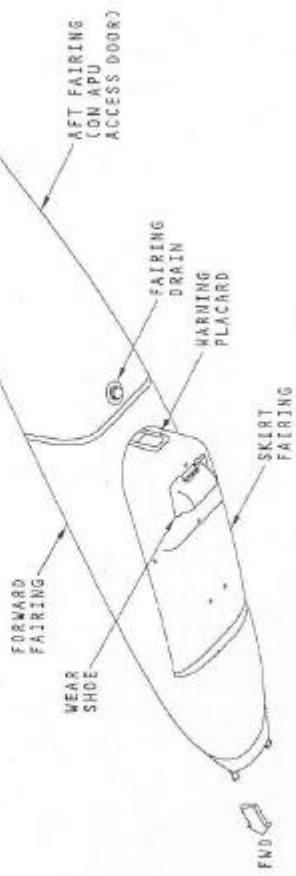
APPENDIX B: TAIL SKID, BOEING 737-800

The aircraft sustained damage to the lower fuselage area in front of the tailskid, to the tailskid and to the nose gear. The damage was initially assessed by the Transavia airlines technical department at Rotterdam and at a later stage by a Boeing survey team in co-operation with the Transavia airlines technical department. The nose landing gear had a small impact mark on the inner cylinder of the shock strut. A small dent was also found in the aft bulkhead.

The wear shoe of the aircraft was found at the beginning of runway 24. The four bolts of the wear shoe were detached from it. See appendix B for the position of the wear shoe on the tail skid of the Boeing 737-800.
