AVIATION SAFETY REPORT
Aviation Occurrence Investigation AO-2007-023
Final

Runway excursion
Sydney Kingsford Smith Airport, NSW
14 July 2007
ZK-PBF
Boeing Company 737-8FE

Report No.	Publication date	No. of pages	ISBN
AO-2007-023	18 February 2009	20	978-1-921602-12-2

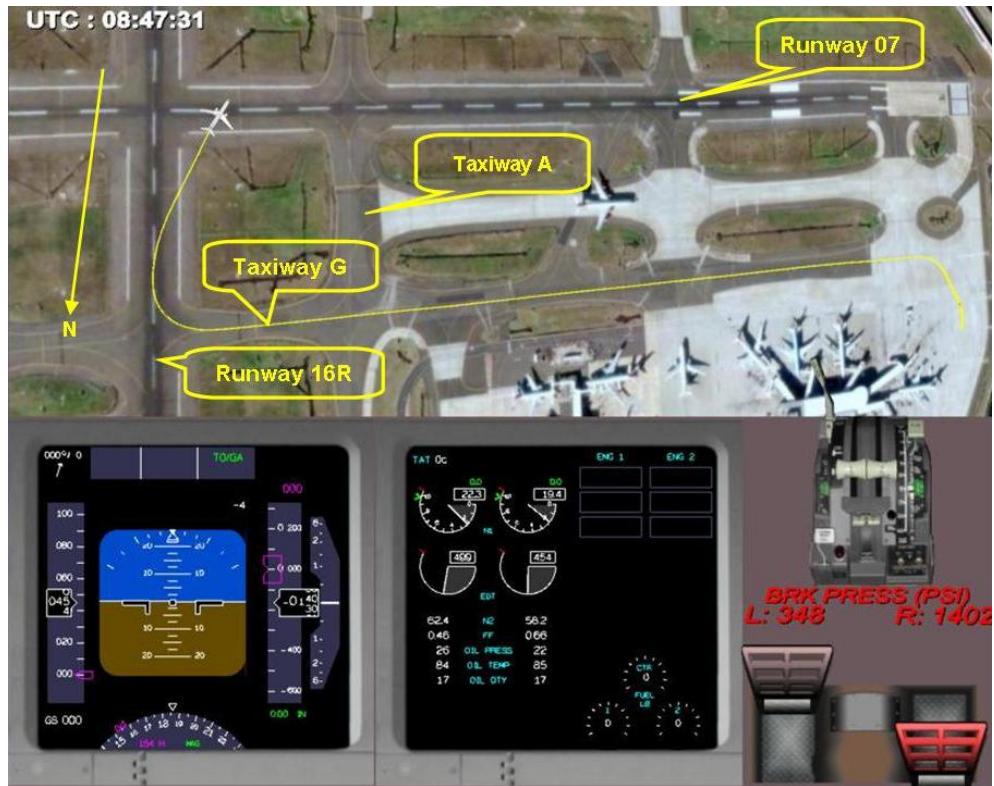
Figure 1: Aircraft path from commencement of taxi to stop

Approximately 20 seconds before the aircraft entered runway 16R, as the aircraft crossed taxiway 'A' (Figure 1), a take-off clearance was issued by air traffic control.

The PIC retarded the thrust levers to the idle position. Just prior to this, the left engine N₁ had reached the take-off setting of 98% RPM and the right engine N₁ a maximum of 64% RPM. The aircraft reached a maximum groundspeed of 30 kts before slowing. The aircraft departed runway 16R and came to rest on crossing runway 07.

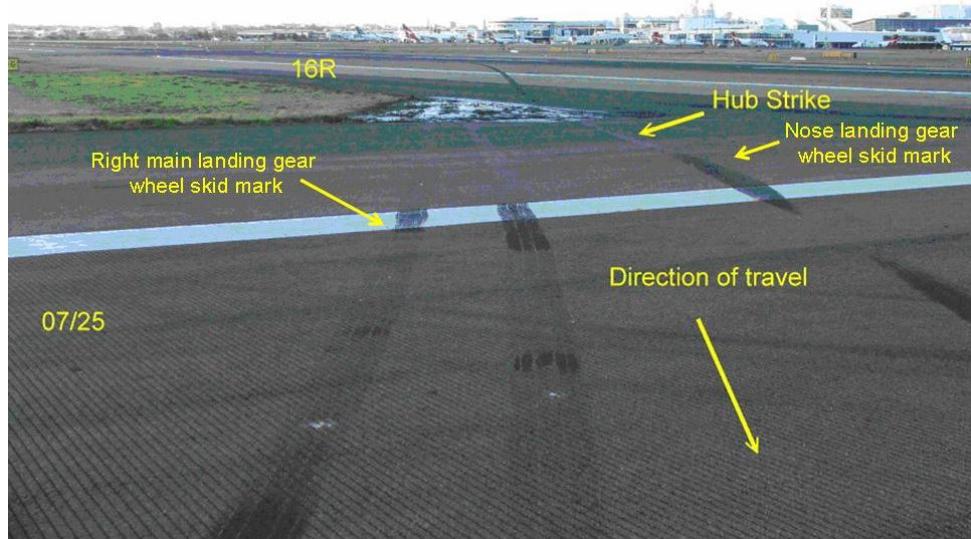
Figure 2: Skid and tyre marks from the aircraft nose and main tyres

The aircraft decelerated in a direction approximately 25 degrees to the right of the runway 16R heading. The right main landing gear and the nose landing gear departed runway 16R to the right onto grass near the intersection of runway 07, and then returned from the grass onto tarmac and stopped on runway 07. The left wheel brake was applied at approximately 20% from the time the thrust levers were retarded. However, the right wheel brake was applied at 95% to 100% from the time the aircraft nose wheel departed the runway onto the grass. The right main landing gear passed over the muddy surface on the corner between runway 16R and runway 07 as the aircraft decelerated.

Steering input from a tyre is effective if the steering wheel's rolling direction is close to the vehicle's travelling direction, but steering forces from the nosewheel are reduced once a steering tyre starts to skid. The large nosewheel deflection (up to 78 degrees) possible through the use of the nosewheel steering wheel, combined with the direction of travel of the aircraft as a result of the asymmetric thrust from the engines, led to the nosewheel skidding and directional control of the aircraft being lost.

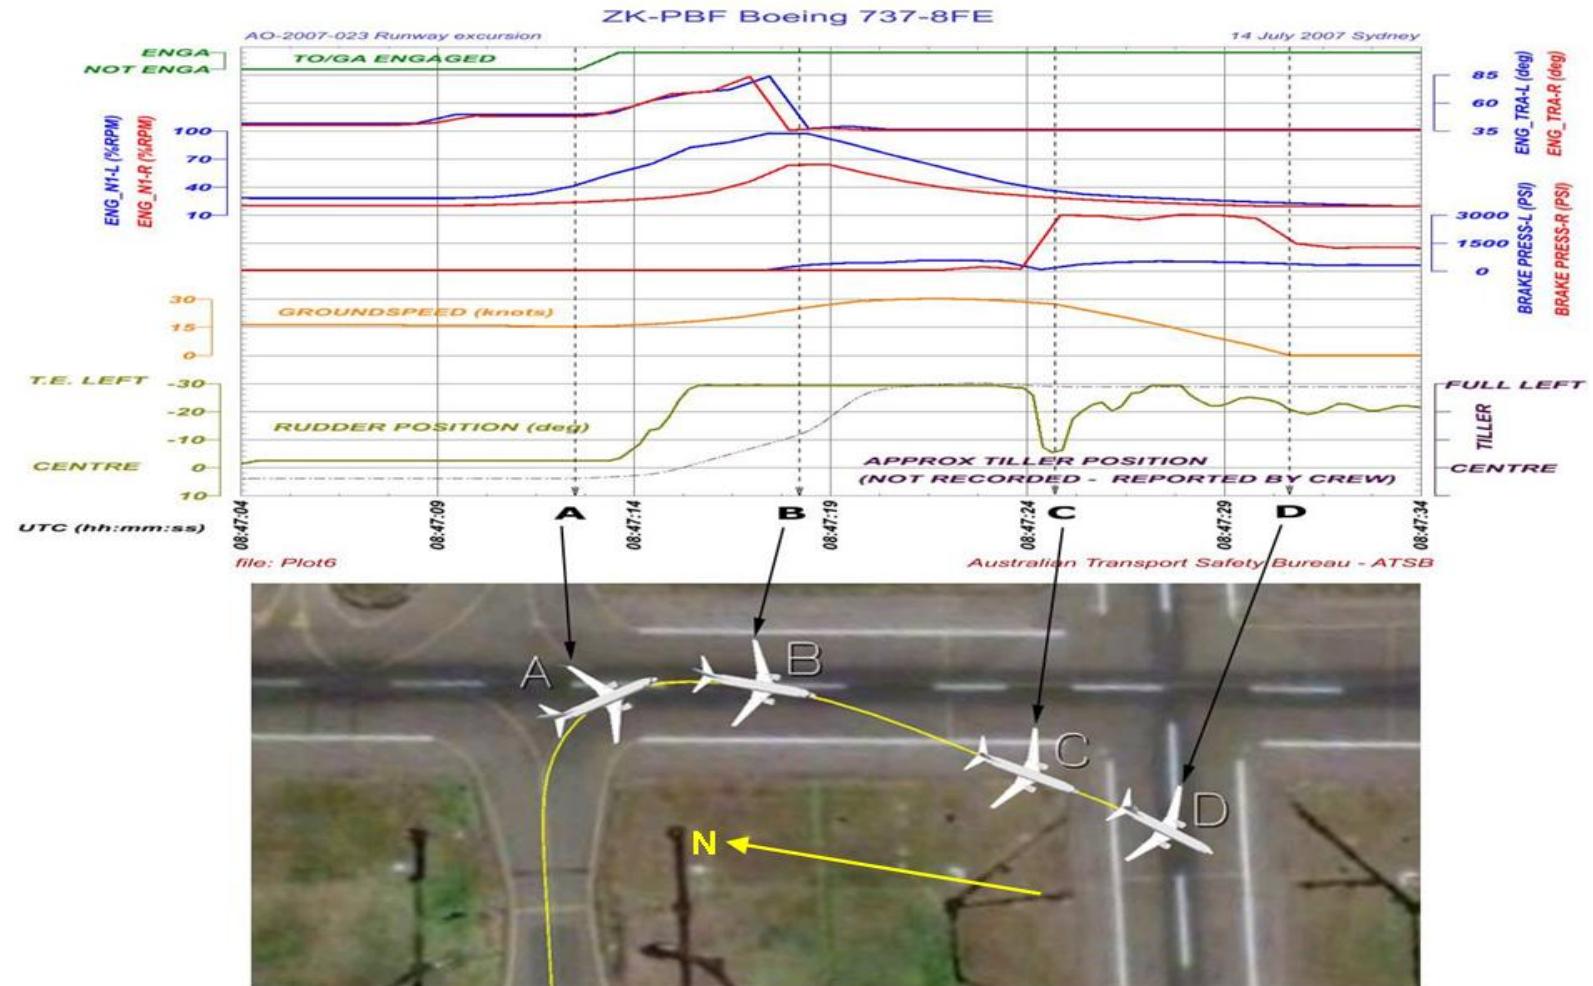
Figure 3: FDR readout from taxi on taxiway 'G' until the aircraft stopped

The aircraft stopped on runway 07 on a heading of 186°M and with the nosewheel deflected 78 degrees to the left. Figure 3 shows the FDR data from the time the aircraft taxied from taxiway 'G' onto the runway until the aircraft came to rest on runway 07.

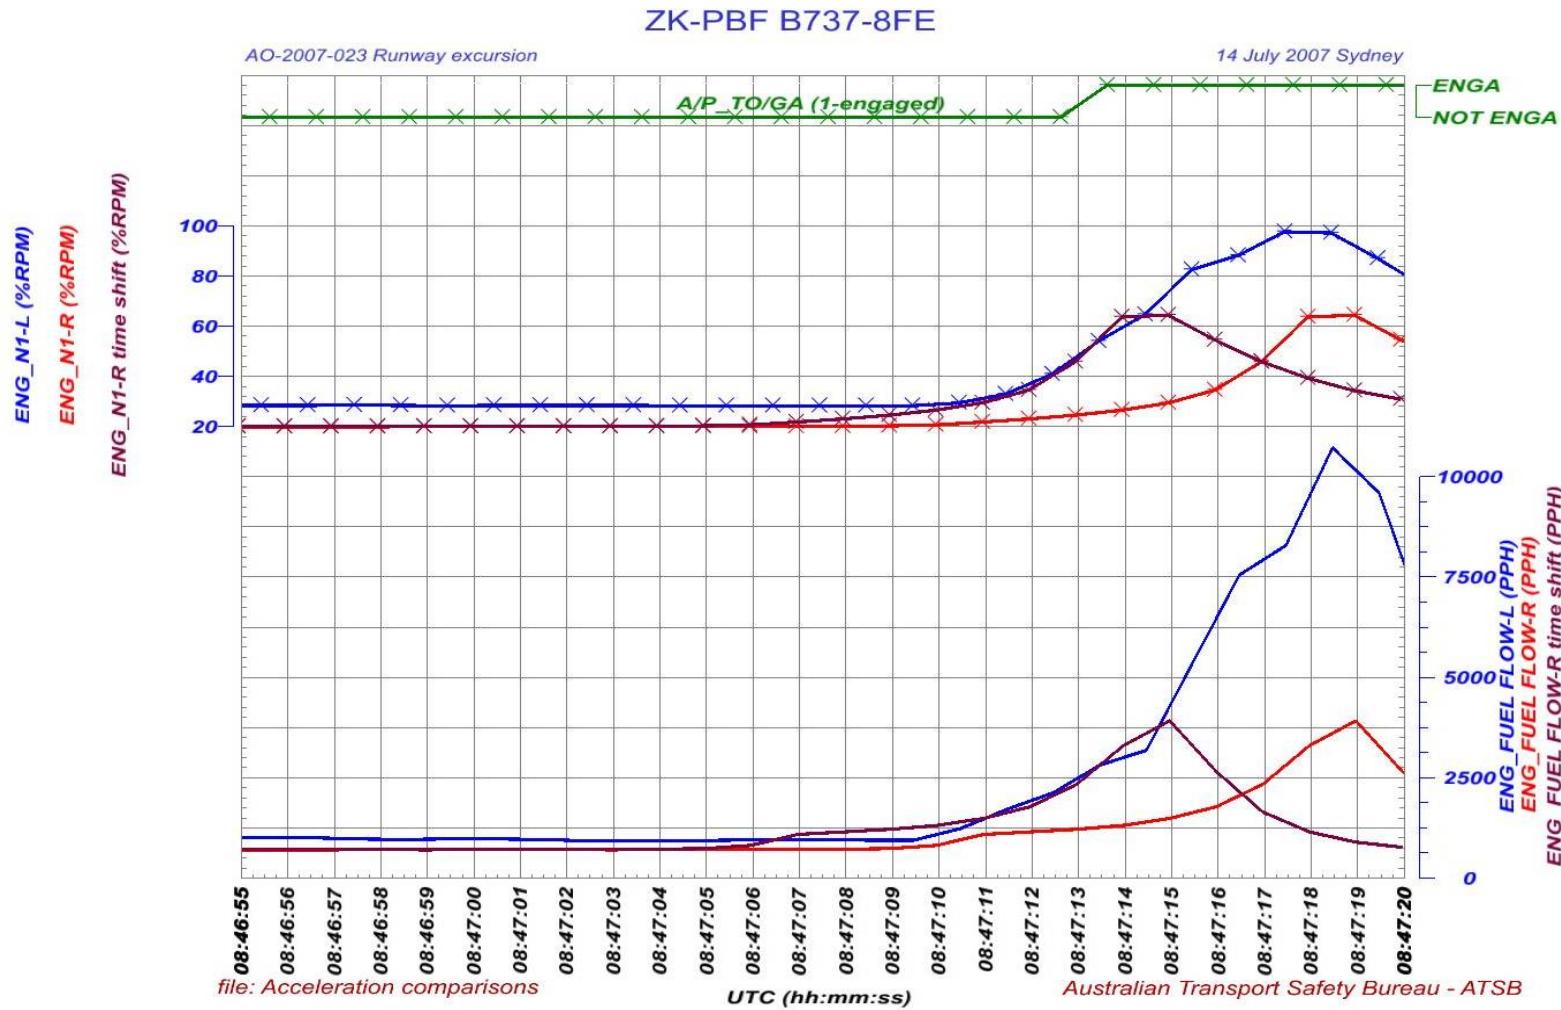
Figure 4: FDR readout of the 25 second period during the engine acceleration period showing recorded values of engine fuel flow and fan speeds, comparing the different engines' acceleration characteristics

The slopes of the blue and brown lines during the acceleration phase depicted in Figure 4 are approximately the same. This indicates that, if both engines had accelerated from the same N_1 setting, their thrust would have remained symmetrical.

Just prior to the thrust on both engines being reduced, when N_1 for each engine was 64% and 98% respectively, the left engine's thrust would be about three times the right engine's thrust, which can also be seen from the respective engine fuel flows depicted in Figure 4.

- After TO/GA was engaged, the left engine accelerated more rapidly than the right engine, resulting in asymmetric thrust. The left engine then reached 98% N₁ as the right engine reached 64% N₁.
