# **Investigation Report No. u2005**

concerning the accident  
to the Beechcraft B90 King Air aircraft, registration G-OJRO  
operated by Trans Euro Air under flight number TRJ 927P  
on 27 September 2007  
at Zurich Airport

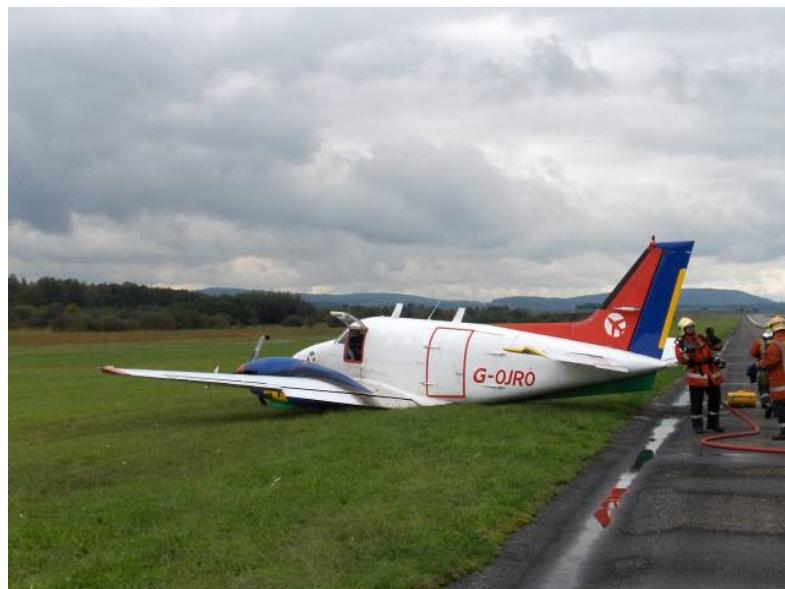
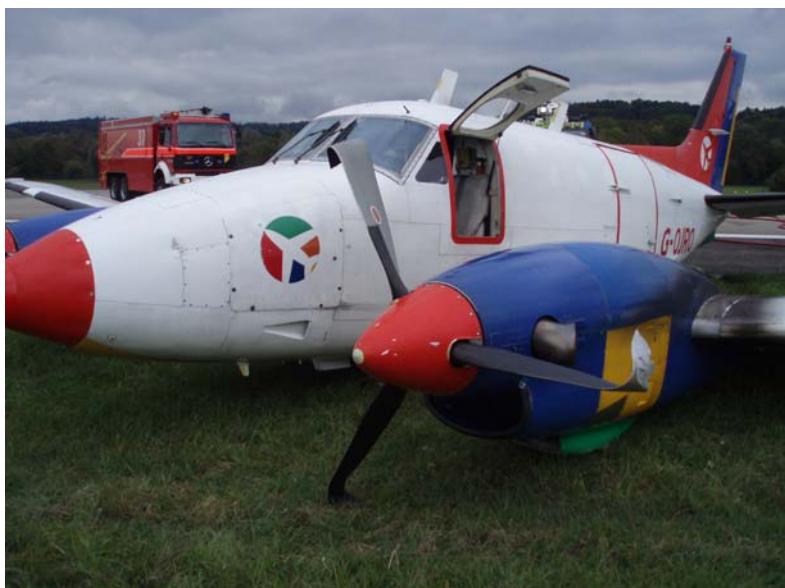
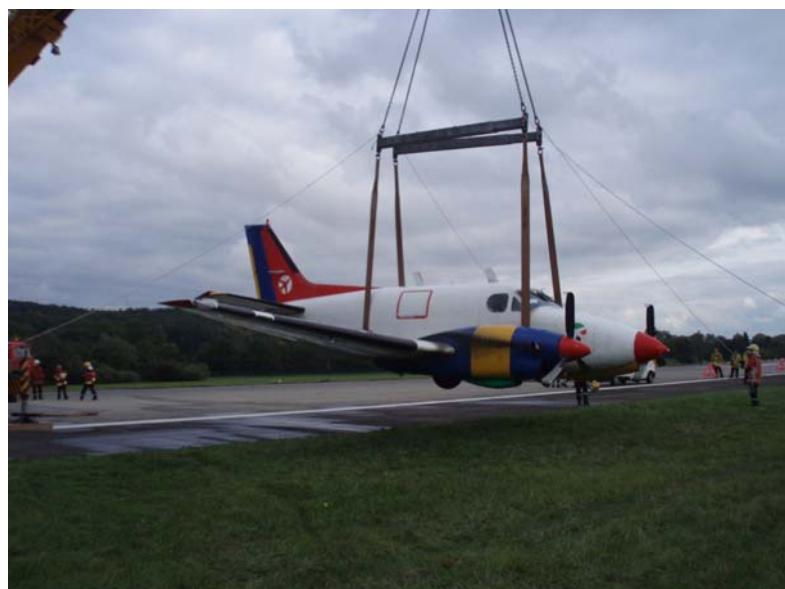
Annex 1

The aircraft then drifted slightly to the left and a little later to the right, before crossing the right edge of the runway after 615 metres. In the process, a runway lamp was torn off. The aircraft then rotated 90 degrees to the right about its vertical axis and came to a standstill five to six metres from the runway edge (see Annex 1).

Apart from the badly deformed propeller blades, the aircraft exhibited no major external damage. There was no leakage and about 600 l of kerosene were defuelled before further investigations.

The aircraft after landing

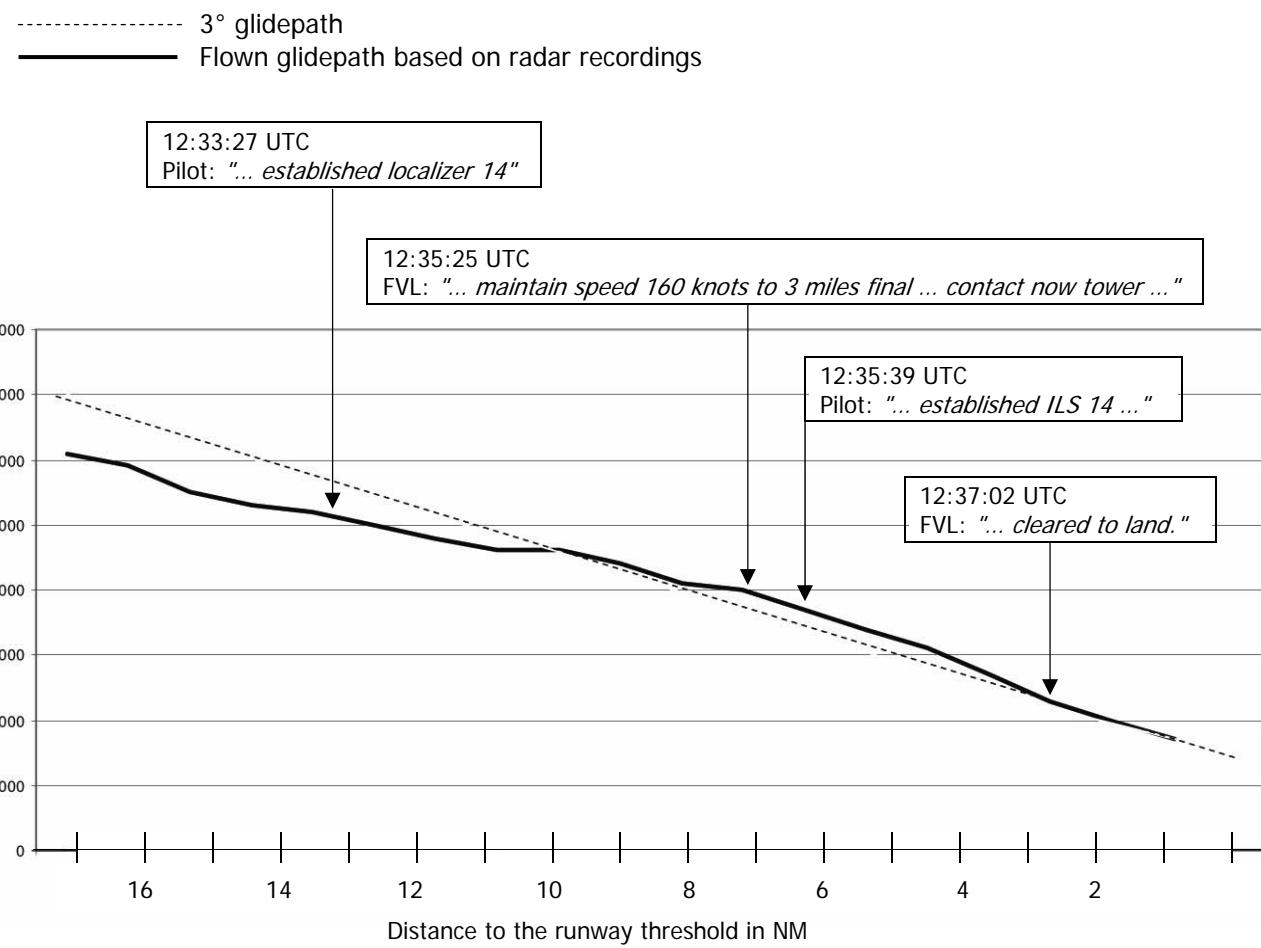
## Approach profile G-OJRO

According to radar recordings, at approximately 3 NM the aircraft was on the glidepath at a speed of approximately 160 kt and at a height of approximately 1000 ft above the ground. The pilot then reduced speed for landing. He intended to make a so-called 'long landing'<sup>1</sup>, in order to be able to leave the runway without delay after landing. The pilot was unable to recall afterwards whether he had heard the acoustic warning for non-extended landing gear at any time during the approach.

The recording of the flight path based on the radar data allows the conclusion that the approach took place approximately on the nominal glidepath. In the given configuration of the aircraft, this would have required a power setting which should have caused the landing gear warning tone to sound, at least occasionally. The fact remains that this warning did not generate an adequate reaction from the pilot.

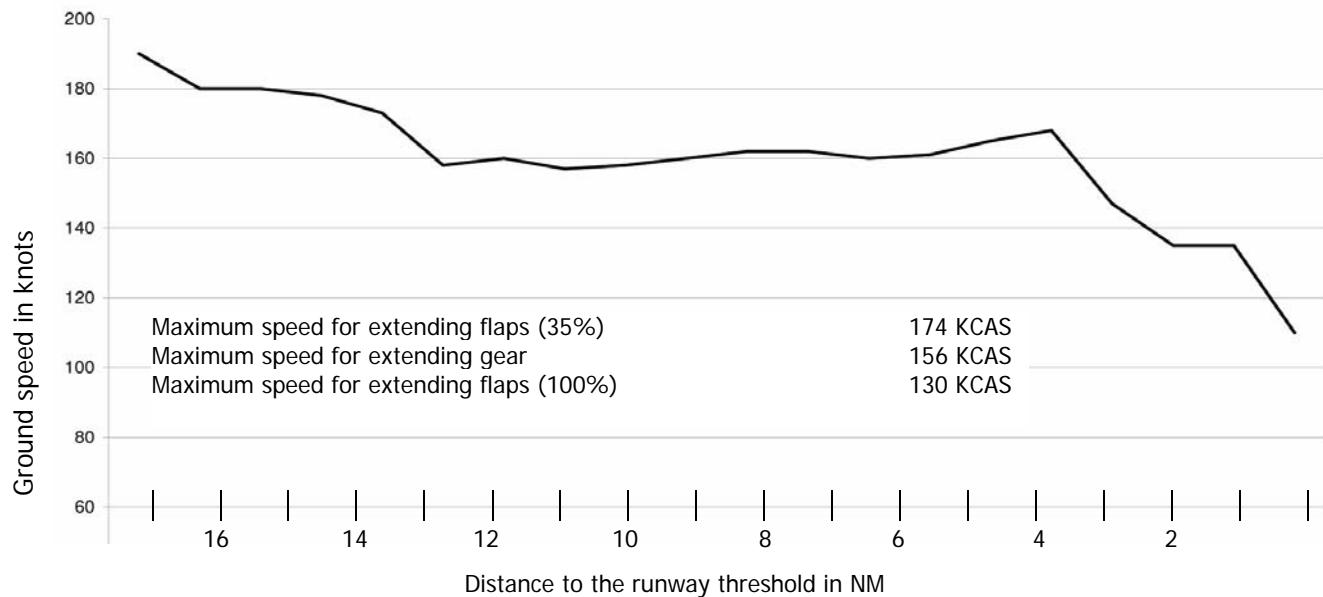
Speed during the approach (ground speed)<sup>1)</sup>

<sup>1)</sup> In the current prevailing wind, the speed indicated in the cockpit was 3 to 4 knots higher
