Investigation Report

EX006-0/05
January 2007

Type of occurrence: Serious incident
Date: 14 August 2005
Location: Hanover
Aircraft: Transport aircraft
Manufacturer / Type: Embraer / EMB-145 EP
Injuries to persons: One person with minor injuries
Damage: Minor damage to aircraft
Other damage: Crop damage
Information Source: Investigation by BFU

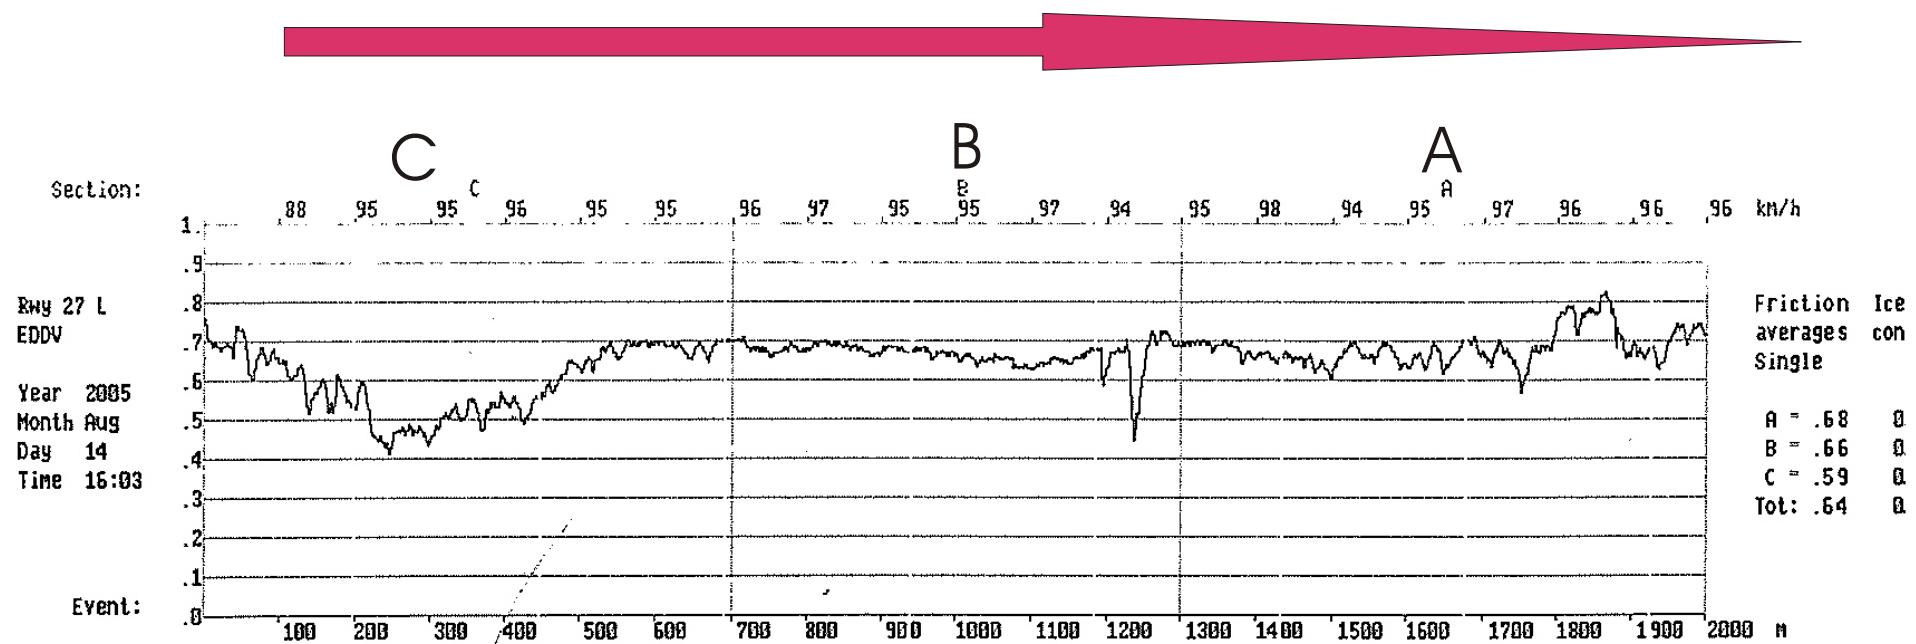
Brakingaction measurement

At the time of the landing it was raining. The runway was wet and showed patches of standing water. At 17:03 hrs, after the occurrence, braking action was determined. In the first third of runway 27L braking coefficients varied between 0.40 and 0.70. In the middle third and the last third of the runway braking coefficients were between 0.60 and 0.70 (good) (see Appendix 3).

The braking coefficients determined about 15 minutes after the landing show good braking conditions at the time of the survey. However, since it had stopped raining at that time the coefficients do not reveal anything about the braking conditions at the time of the Embraer's landing.

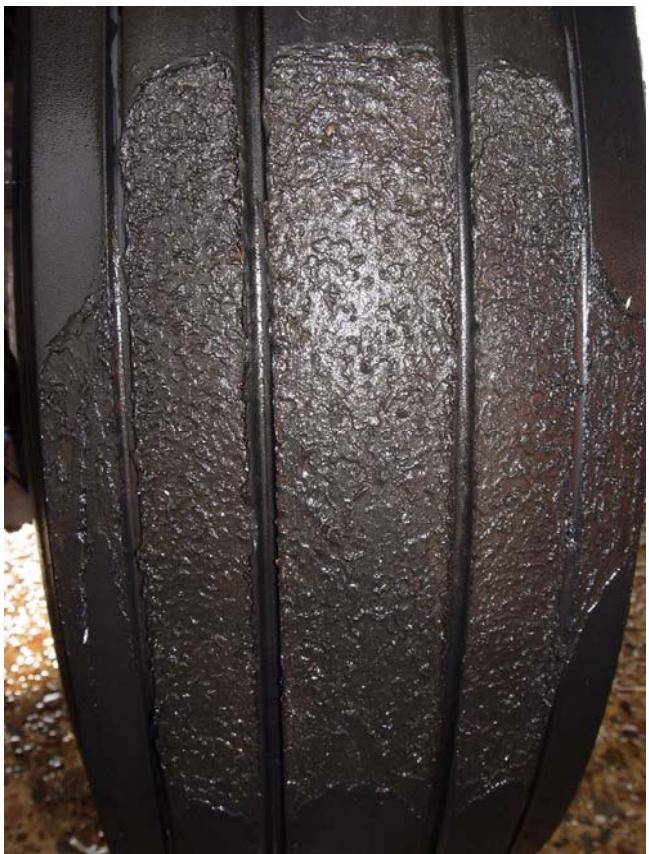
All four tyres of the main landing gear showed traces of rubber reversion hydroplaning, a certain form of aquaplaning.

This kind of aquaplaning can already occur on damp runways. Rubber reversion hydroplaning is caused by friction-generated heat which produces superheated steam at high pressure. High temperature causes the rubber to revert to its uncured state which forms a seal around the tyre area. This seal traps the high pressure steam. This can already occur below the usual aquaplaning speed.

Marks of Rubber Reversion Hydroplaning
on the tire

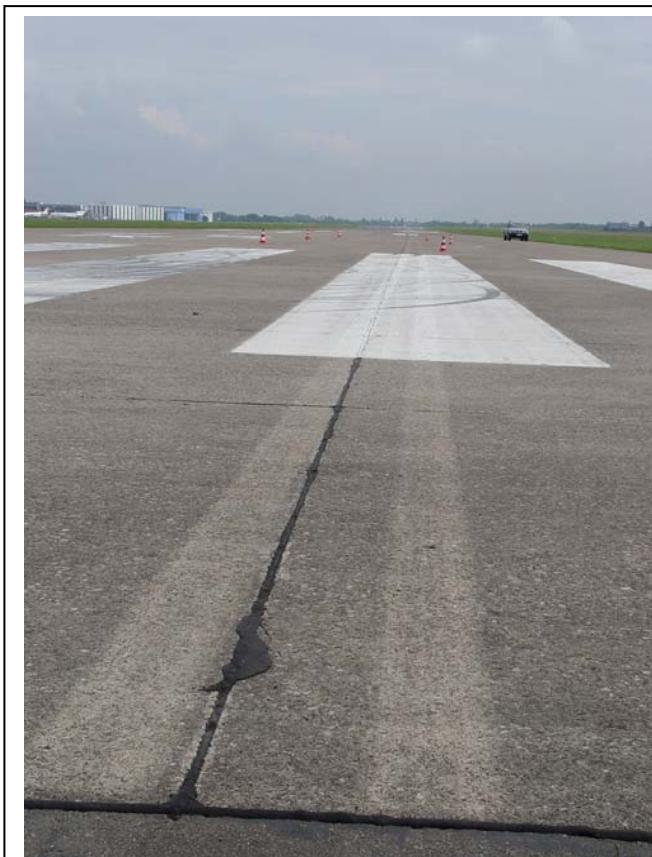
All four tyres had left about 400-meter-long bright traces on the runway which were definitely caused by rubber reversion hydroplaning. Furthermore, melted-away rubber was found on the runway (see Appendix 5).

The traces on the runway and the melted-away rubber on all four tyres of the main landing gear indicate aquaplaning. Of special interest are the last approximately 800 m prior to the end of the runway. All four main landing gear tyres left bright marks which look like they might originate from steam blasting. These tyre tracks in connection with the marks on the tyres themselves indicate a rare form of aquaplaning the so called rubber reversion hydroplaning. In this case it occurred when the emergency brake was activated, the anti-skid system was deactivated and the tyres locked.

Marks of Hydroplaning on the runway

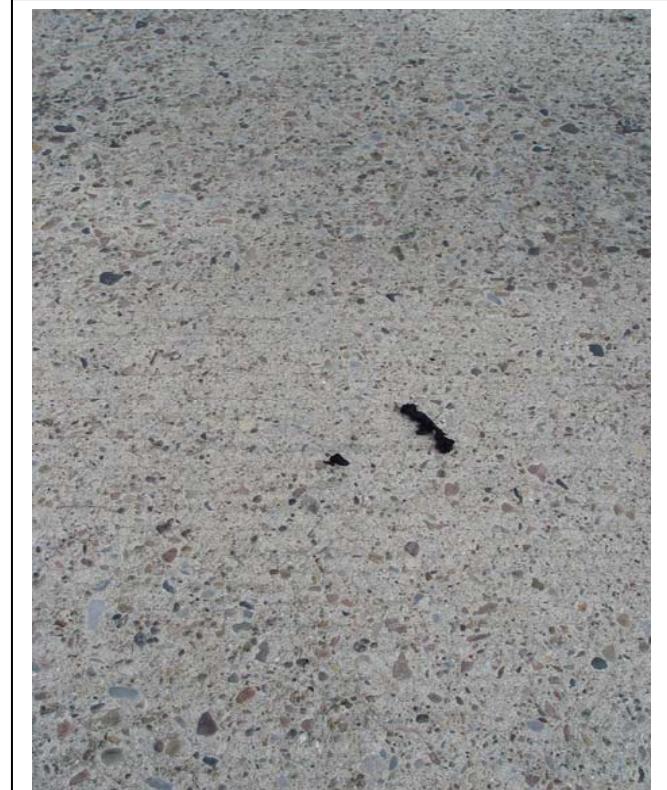
Rubber damped from tire
