Investigation Report

EX001-0/05
April 2007

Type of occurrence:	Serious incident
Date:	1 March 2005
Location:	Frankfurt / Main
Aircraft:	Transport aircraft
Manufacturer / Type:	Embraer / ERJ 170
Injuries to persons:	No injuries
Damage:	Slightly damaged
Other damage:	Approach lighting
Information Source:	Investigation by BFU

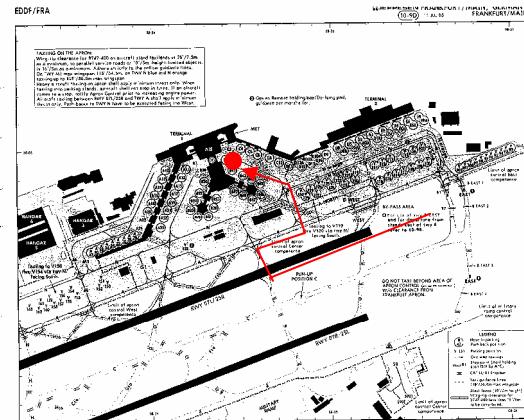
Taxiway to Gate B2

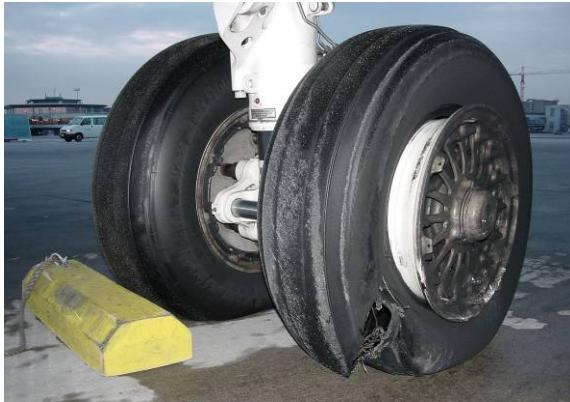
The airplane suffered significant damage on the main landing gear, the fuselage underside and the right-hand flap (see photos).

Right-hand main landing gear

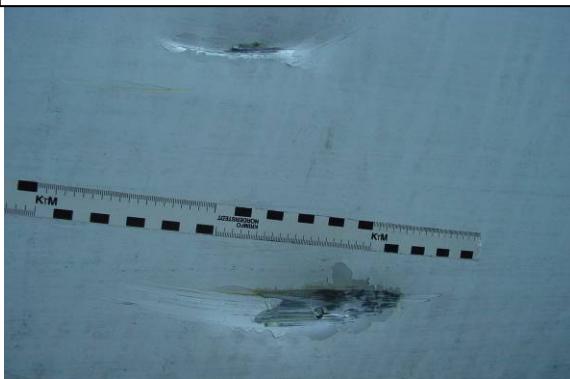
Right-hand fuselage underside

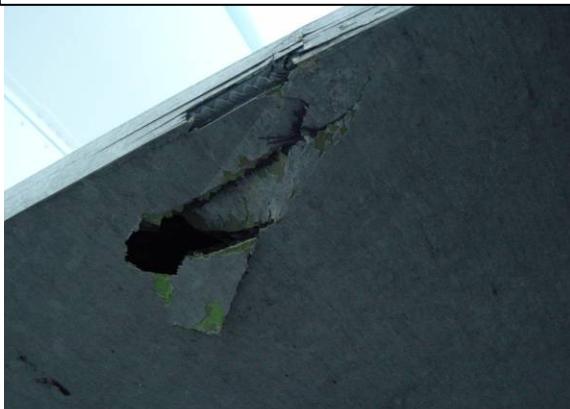
Right-hand flap trailing edge

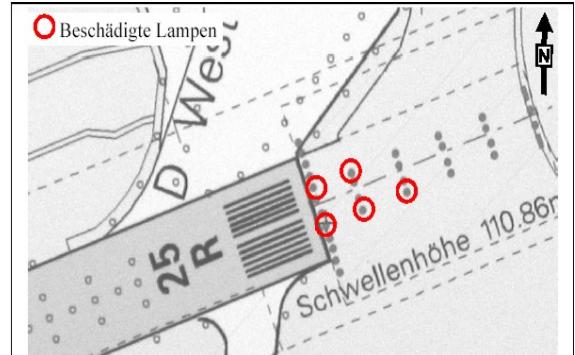
Five lights of the approach lighting were either destroyed or damaged (see photos).

Destroyed or damaged approach lighting

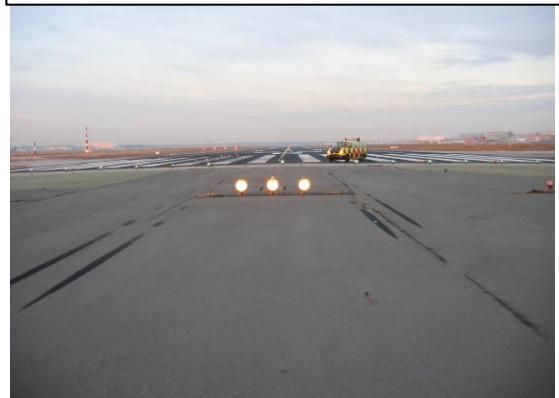
The airplane's initial contact with the ground occurred about 60 m prior to the threshold of runway 25R. The airplane was precisely on the runway's extended centre line.

Touchdown marks and two missing approach lights (right and left)

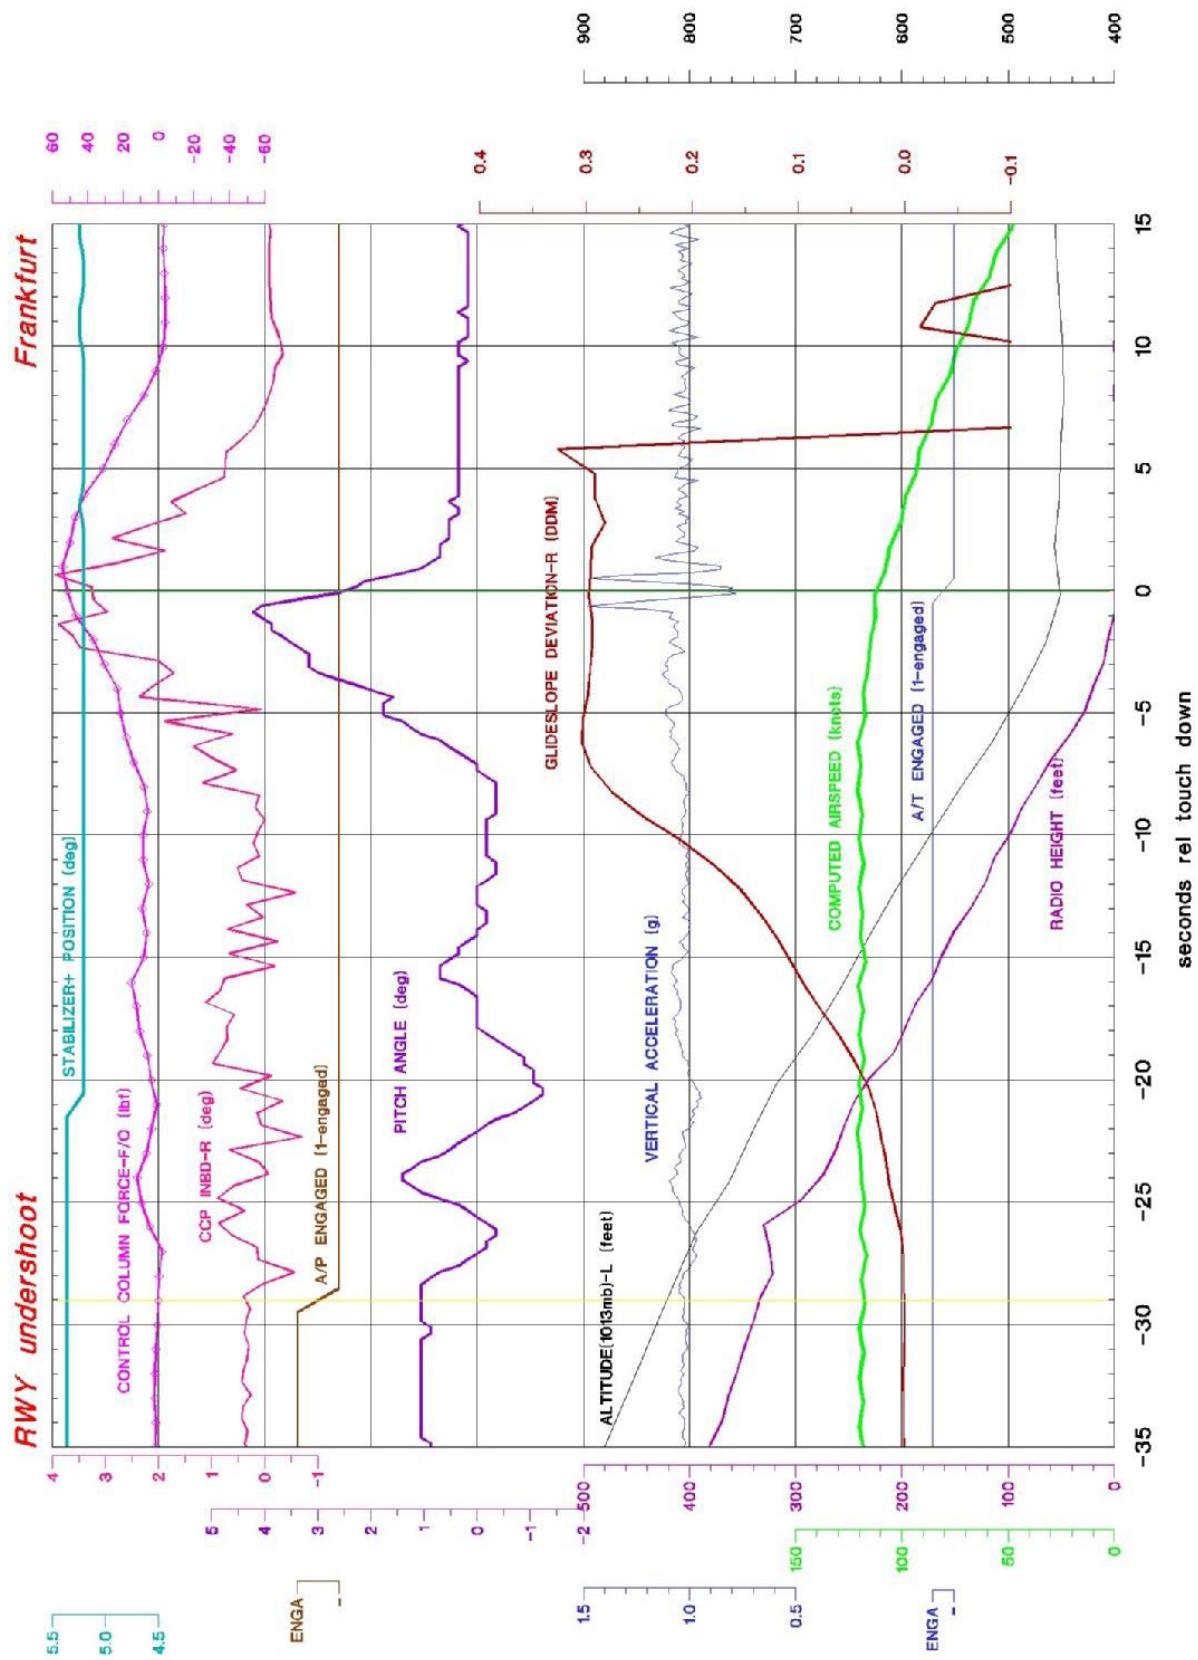
Appendix 1

- The autopilot was disengaged 29 seconds prior to touchdown in an altitude of about 340 ft. The co-pilot controlled the airplane manually after that.
- Indicated airspeed (IAS) was constant 120 kt.
- 27 seconds prior to touchdown the airplane was moved below the 3° glide slope through control inputs from the right-hand control column. Pitch moved from +1° to an average of about 0°.
- For 25 seconds the airplane travelled below the ILS glide slope.
- Five seconds prior to touchdown the flare out began. Speed decreased and pitch increased to +4.3°.
- During the entire approach until touchdown autothrust was engaged.
