**Air Accidents Investigation Branch**

**Report on the accident to  
Gates Learjet 25B, EC-CKR  
at RAF Northolt, Middlesex  
on 13 August 1996**

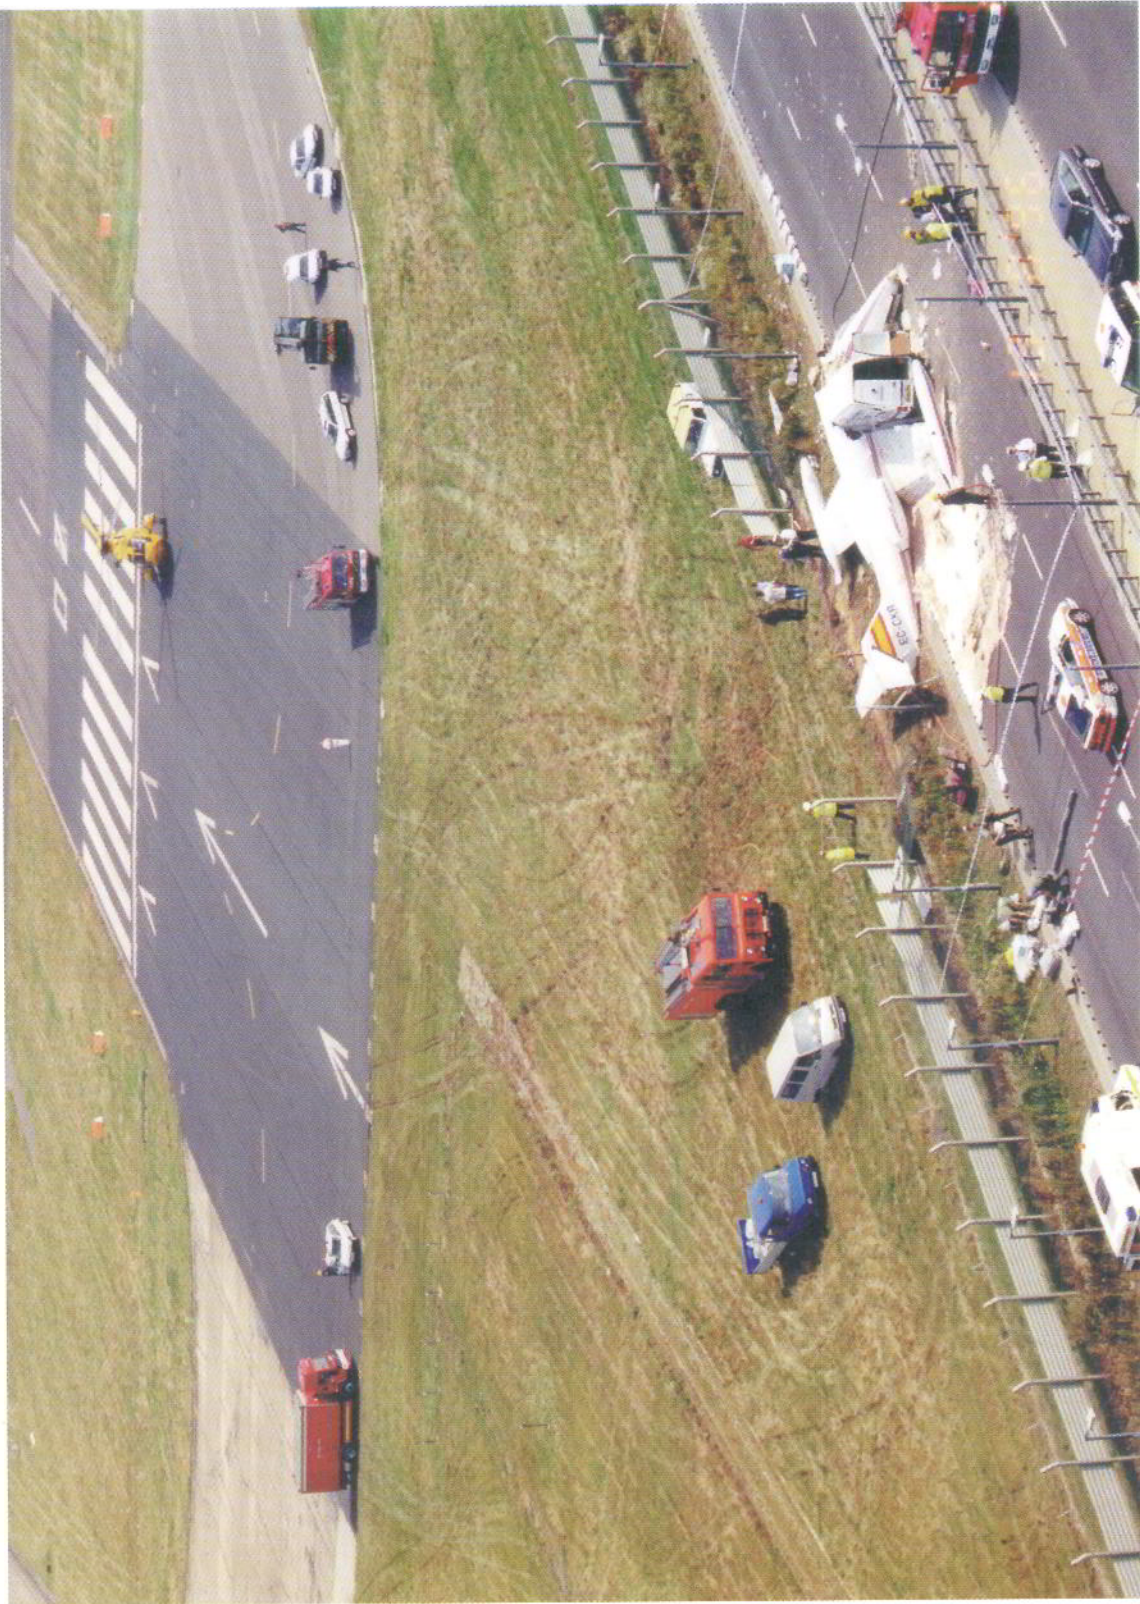
**LEARJET ON THE A40 DURING RESCUE**

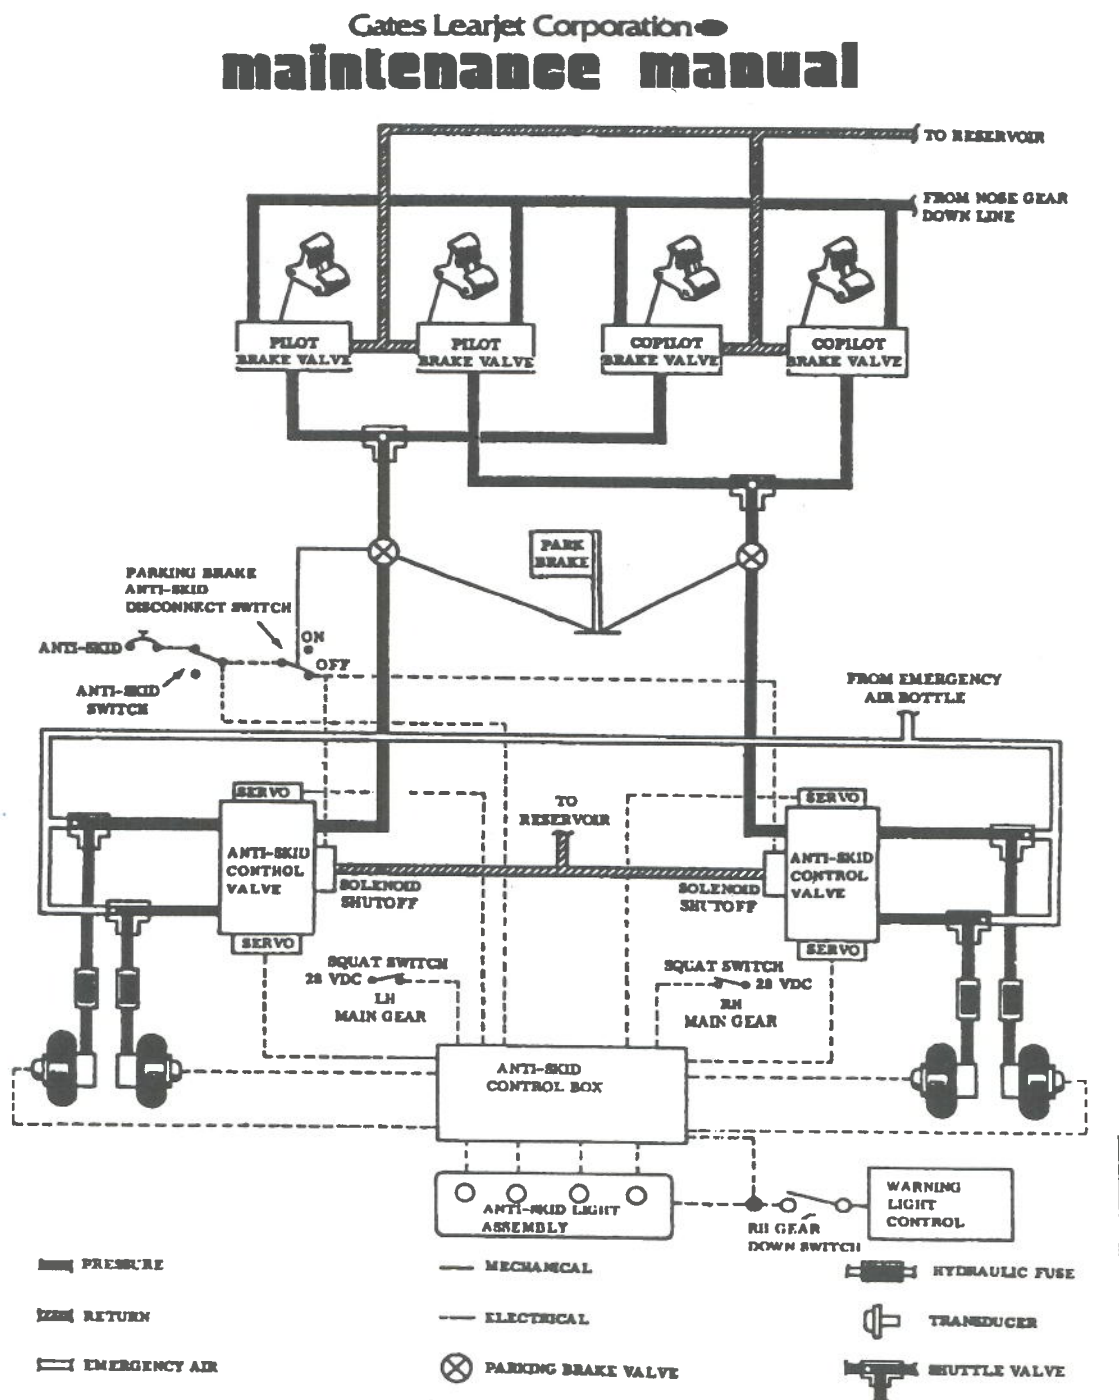
Brake System Schematic  
Figure 1 (Sheet 1 of 2)

Strip examination of all the brake packs showed that they had been affected by corrosion which had occurred after the aircraft was foamed, the left outer pack was most affected and light corrosion had occurred between the pistons and bores of that unit. It was considered that under normal brake pressures from the emergency air bottle (300 psi, below which the bottle must be re-charged) the brake packs would have functioned normally on test, even with the corrosion. The remaining portions of the pneumatic emergency brake line were tested and found satisfactory. The emergency air bottle indicating gauge was reading about 1/2 of full scale deflection (FSD); the gauge has an FSD of 500 psi. This pressure is regulated to a maximum of 600 psi and this is supplied to a modulating valve controlled by a braking lever on the right-hand side of the pedestal. The lever is normally locked with frangible locking wire. On inspection the locking wire was found to be broken, and the lever operated correctly, eventually discharging the remaining air. No defect was found in the pneumatic emergency braking system, and it was sufficiently charged, even after the accident, to operate the brakes.

The hydraulic supply pressure for the brakes is taken from the nose landing gear extend line. This system, and all the hydraulic components in the nose, the foot motors, parking brake and shuttle valves between the pilot's and co-pilot's pedals were functionally tested as a complete subsystem. It was found that with the nose landing gear extend line pressurised, system hydraulic pressure could be directed to the left and right brake lines as required by operating the brake pedals. The two dual anti-skid control valves are mounted one in each main landing gear bay. These were flow checked in the unpowered condition to establish that braking was not lost in the event of anti-skid system or electrical system failure. The shuttle valves and hydraulic fuses were flow checked and visually examined, it was evident that no failure had occurred in any part of the braking system which would have prevented brake pressure being applied to any of the brake packs.

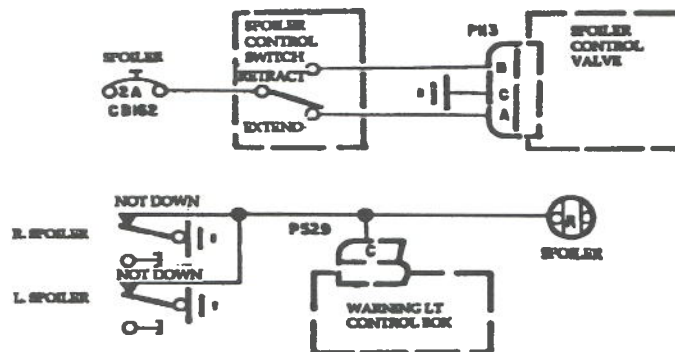
Spoiler System Electrical Control Schematic  
Figure 1

In photographs taken a few minutes after the accident, the spoilers were retracted. The spoilers, like the flaps, are controlled from an electrical switch on the flight deck. The system is shown in diagram form in Appendix 3. This operates a control valve on the wing, which directs hydraulic pressure to the extend or retract side of the spoiler actuators. The spoiler actuators contain mechanical locks which prevent the spoilers extending unless hydraulic pressure is available. The spoilers can run back without hydraulic pressure and the last part of the retraction movement will cause the mechanical locks to re-engage as the spoilers fair with the wing but this requires additional forces to be applied to the spoilers to overcome the forces in the lock mechanisms. Although these forces are minor, the spoilers will not enter the locks under inertial forces unless they are caused to fall back rapidly. It was found that they fell back freely when there was little fluid in the system, but quite slowly when the system contained fluid. Initial attempts to extend the spoilers by pressurising the extend line were unsuccessful as a fitting in the extend line had been broken adjacent to the top attachment of the right main landing gear retraction jack. This had occurred during the gear collapse, as the aircraft entered the road. The bay in which the extend line was broken, which is at the centre line of the aircraft and behind the right gear, is normally completely enclosed, access being via a cover plate. Although testing spilled fluid in the bottom of the bay, elsewhere it was clean and the cover plate and retraction jack fitting, which had been removed earlier, were not contaminated by fluid, thus indicating that the extend line had not been pressurised when it was fractured by the collapse of the landing gear. With the extend line repaired, the spoilers functioned normally.

On the flight deck, the spoiler switch guard had been distorted sideways and forward. This damage appeared to be due to the force exerted by a hand or foot while the crew were being helped out of the damaged nose section. As a result of this distortion the switch would not latch in the EXT (extend) position, to the rear. After removal of the switch from the pedestal it was found to latch correctly, but the toggle mechanism had a rough feel. Continuity and insulation

The spoiler switch obtains its electrical power from the 28V DC buss bar via a 2 ampere circuit breaker CB162. This was not tripped and electrical continuity was established from the 28V buss bar to the switch. The switch supplies 28V DC to either the extend or retract solenoids in the spoiler control valve. The valve was tested both electrically and with hydraulic pressure and functioned normally. Although the electrical wiring between the spoiler switch and the spoiler control valve was cut or broken in several places, it was possible to establish that the spoiler control system had been serviceable during the landing roll.

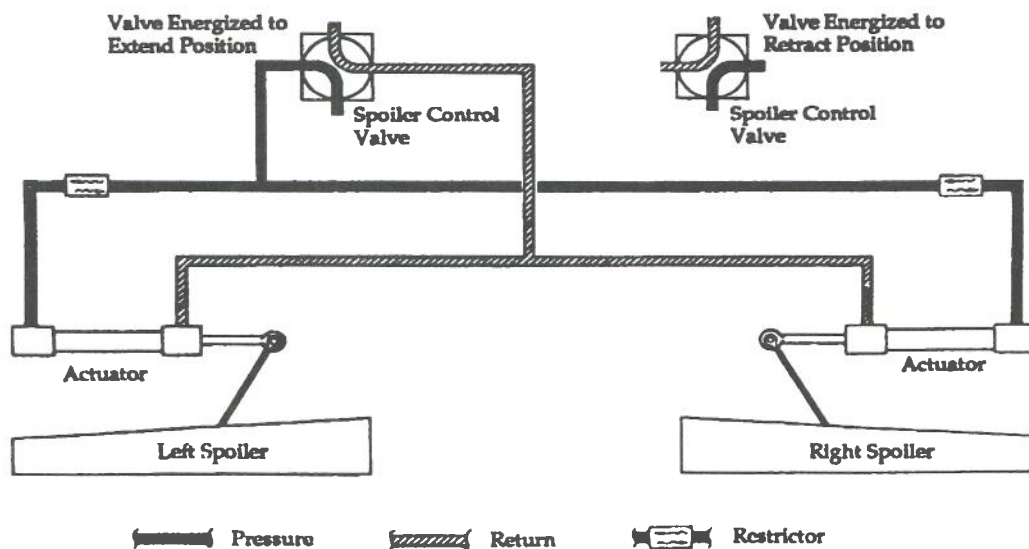
Spoiler System Hydraulic System Schematic  
Figure 2

Checks were conducted on the spoiler system to discover how likely it was that the spoilers could have retracted during or soon after the overrun. Prior to these tests the extend line had been repaired by installing a new fitting to replace the one broken by the collapse of the landing gear. The spoiler control valve was electrically checked and refitted to the aircraft. Because the wing and fuselage were separated, a hydraulic reservoir was constructed and fitted directly to the servo valve return port. A hydraulic hand pump and pressure gauge were fitted directly to the servo valve pressure port. The system was filled with hydraulic fluid to specification OM15, an acceptable substitute meeting the requirements of MIL-5606. The system was electrically energised, bled, and function tested satisfactorily. The spoilers were then extended fully using the hand pump, and the system shut down electrically and the pressure released at the pump. The spoilers remained fully extended 24 hours later. This test was to confirm that the repaired system performed in the same manner as an undamaged aircraft.

The tests showed that, even with the spoiler extend line broken, the spoilers could retract only quite slowly and that this was insufficient to allow them to re-enter the internal locks and to fair fully with the wing profile. Further, once the spoilers had partly retracted, internal stiffness prevented further retraction due to gravity, even after many hours. The electrical status of the servo control valve made some difference to the rate of retraction but only in that, with the valve in the null de-energised position, the retraction tended to be slower. Following each test significant and sustained pressure was required to fully retract each spoiler.

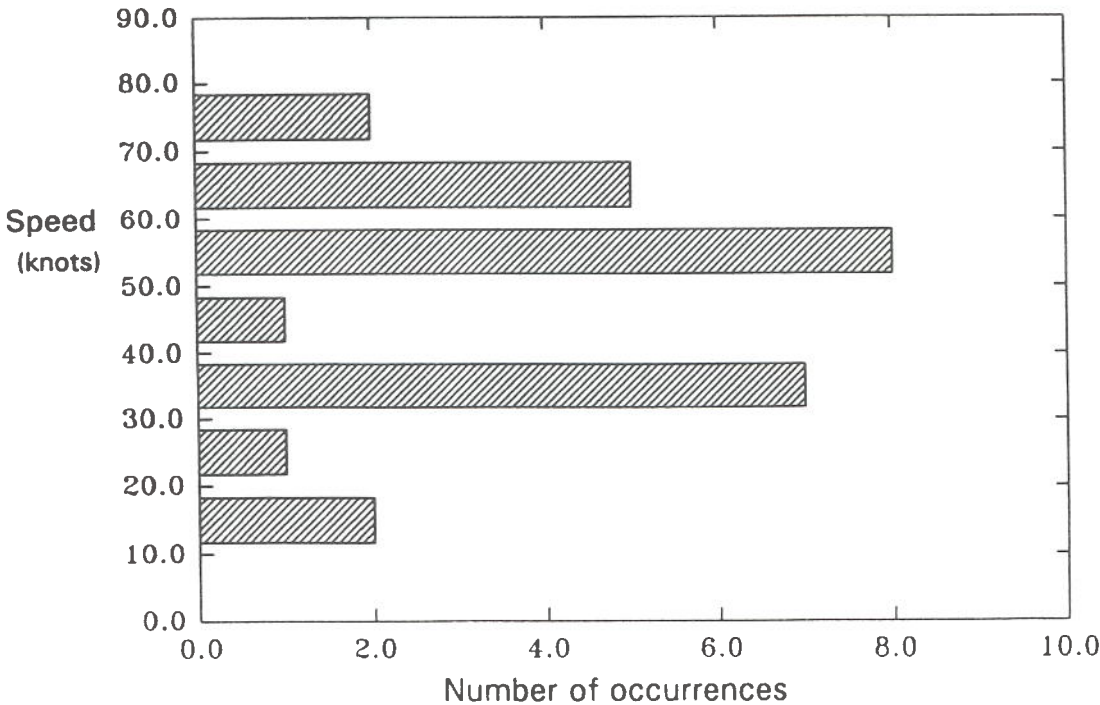
Runway Exit Speeds During an Overrun

The diagram above was published in the above report, prepared by the Federal Aviation Administration Technical Center, Atlantic City NJ. The data was drawn from National Transportation Safety Board and International Civil Aviation Organisation sources and the work was credited to David, 1990. The data indicates that there have been few instances when aircraft have left the runway at more than 70 knots, and none found where the speed exceeded 80 knots.
