Air Accidents Investigation Branch

**Report on the accident to
Cessna 550 Citation II, G-JETB
at Southampton (Eastleigh) Airport
on 26 May 1993**

This investigation was carried out in accordance with
The Civil Aviation (Investigation of Air Accidents) Regulations 1989

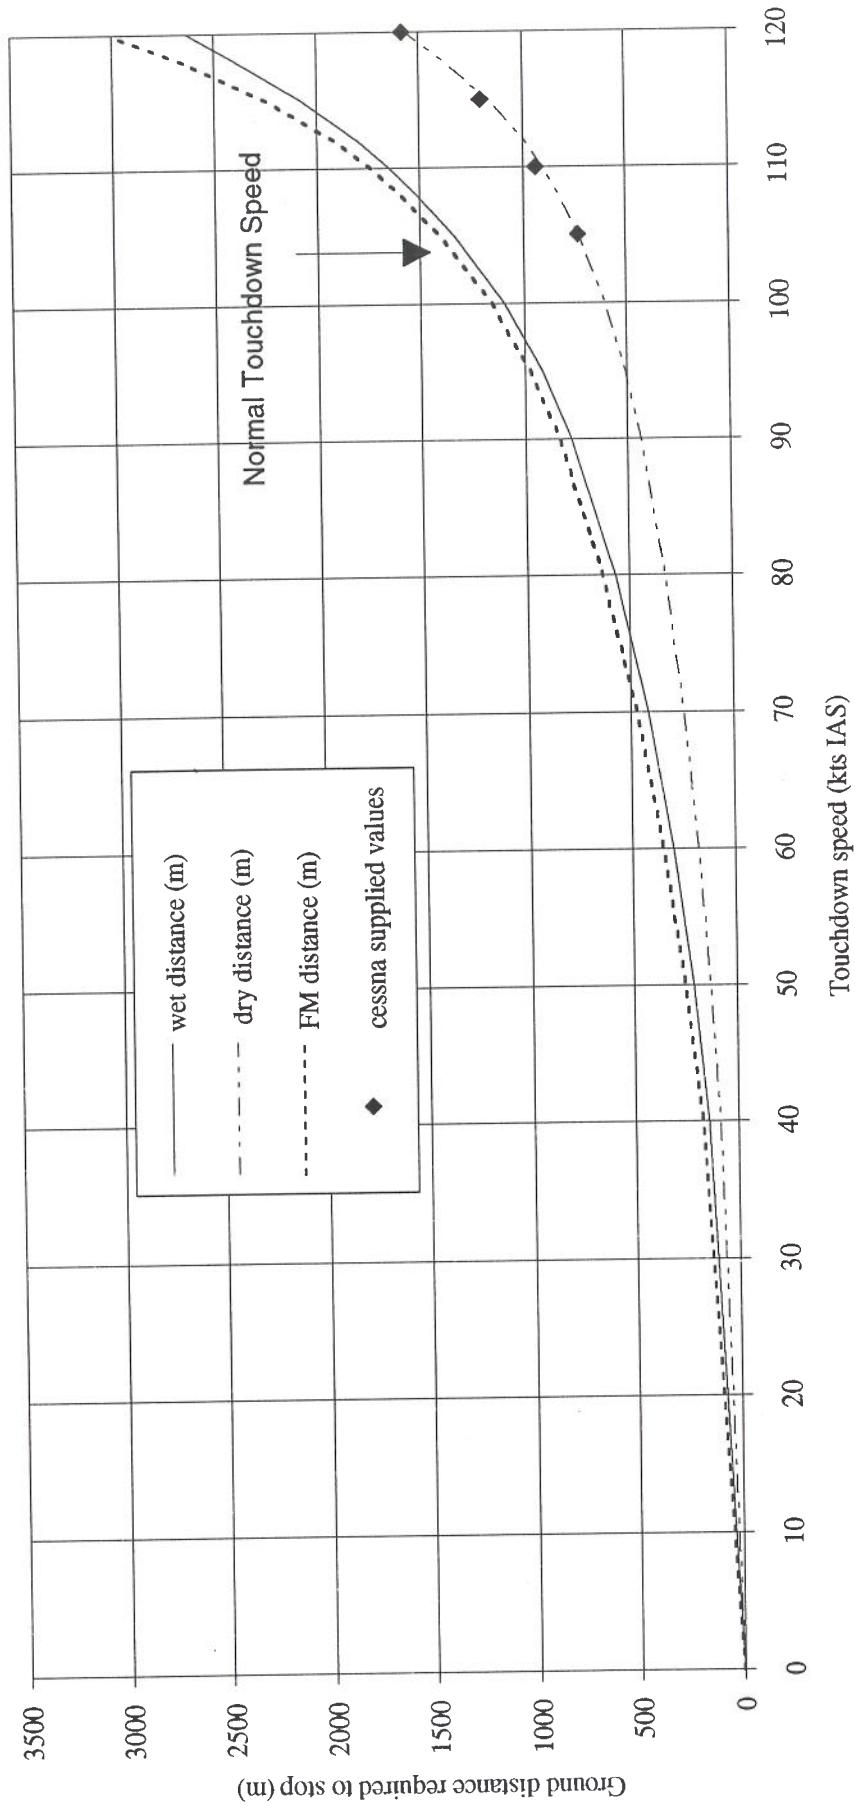
Figure C-2

Appendix C, Figure C-2, shows landing ground roll as a function of touchdown IAS in the conditions pertaining at the time. From this it can be seen that, for a touchdown speed of between 105 kt and 115 kt IAS, the distance required to reduce to 50 to 60 kt IAS is between 600 metres and 1,000 metres on a dry runway, and between 1,100 metres and 1,800 metres for a wet runway.

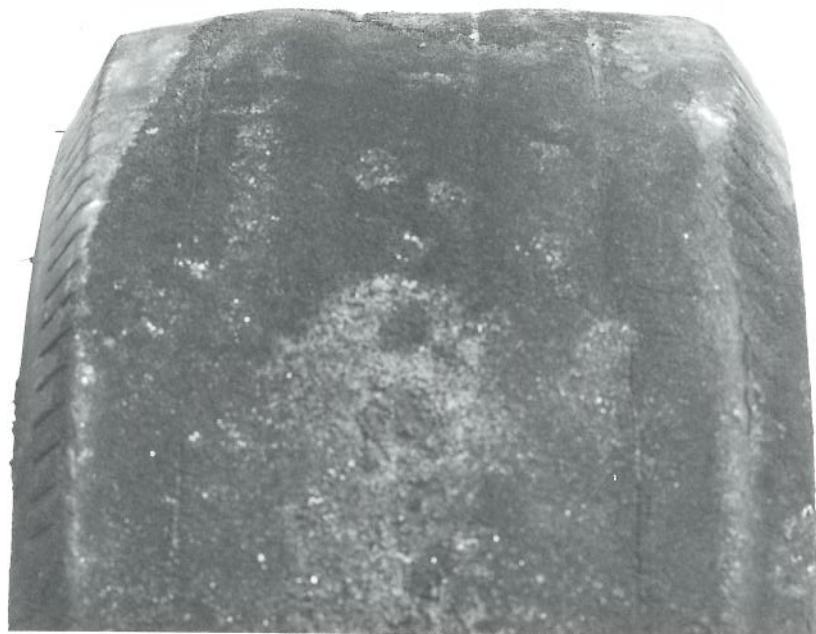
LEFT TYRE

The left tyre had suffered considerable fire damage, although it was apparent that it had been in a more advanced state of wear than the right. It was noted on one of the few unburnt sections that the radial grooves on the sidewall of this tyre were shorter than those on the right, due to the tread wearing down to beyond the ends of the grooves. This observation resulted in an estimate of the tread groove depth remaining being no more than 1 to 2 mm at the time of the accident.

The worn condition of the left tyre is more difficult to quantify in terms of its effect on the stopping distance of the aircraft. Allowing for the effects of the fire, the amount of tread groove depth remaining was assessed as being no more than 1 to 2 mm, and was probably worn in excess of the limits described in Airworthiness Notice No 5. Research into hydroplaning has indicated that there is a marked reduction in braking action when the tread depth is below 2.5 mm. In addition, the hydroplaning speed would have been around 94 kt from consideration of the typical tyre pressures. Thus, as the tread grooves filled with water in the deeper puddles on the runway, there would have been a tendency for hydroplaning, resulting in a reduction in wheel RPM followed by the anti-skid system releasing brake pressure. In such conditions, it is the most worn tyre that is the dominant influence on the braking action.

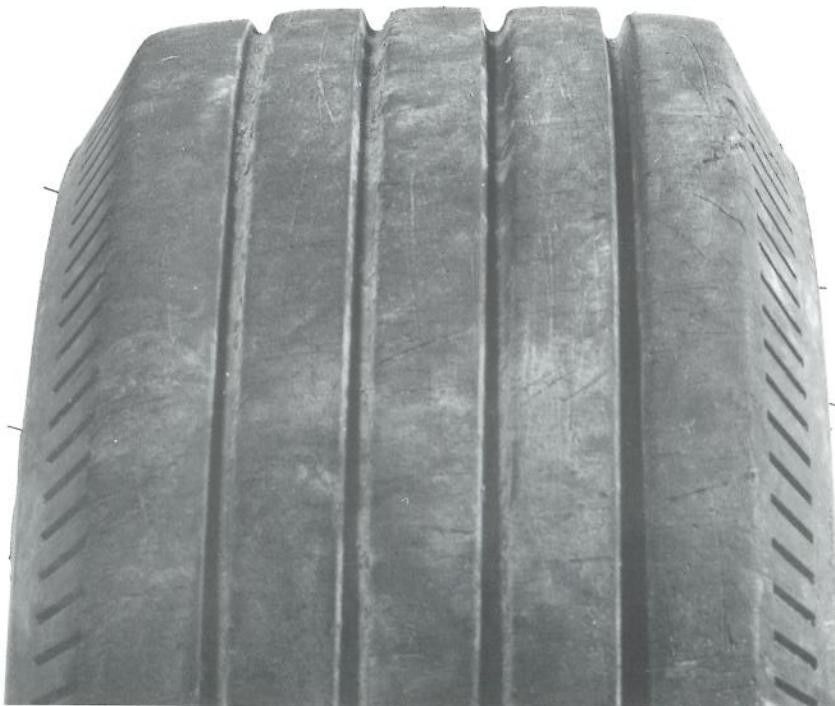
RIGHT TYRE

Photographs of the mainwheel tyres are presented at Appendix D. The right tyre had escaped the worst effects of the fire due to the right leg becoming detached. The examination, which was conducted in the presence of a representative of the tyre manufacturer, showed that this tyre had been in good condition, with no evidence of it having been run in an under-inflated condition. As is typical with this type of aircraft, the tyre had worn slightly more on the inboard side, such that the depth of the tread grooves varied from approximately 5 mm to 8 mm across the tyre width.
