Saab-Scania SF340B, G-LGNG

| AAIB Bulletin No: 8/2004 | Ref: EW/C2003/09/03 | Category: 1.1 |
| INCIDENT | | |

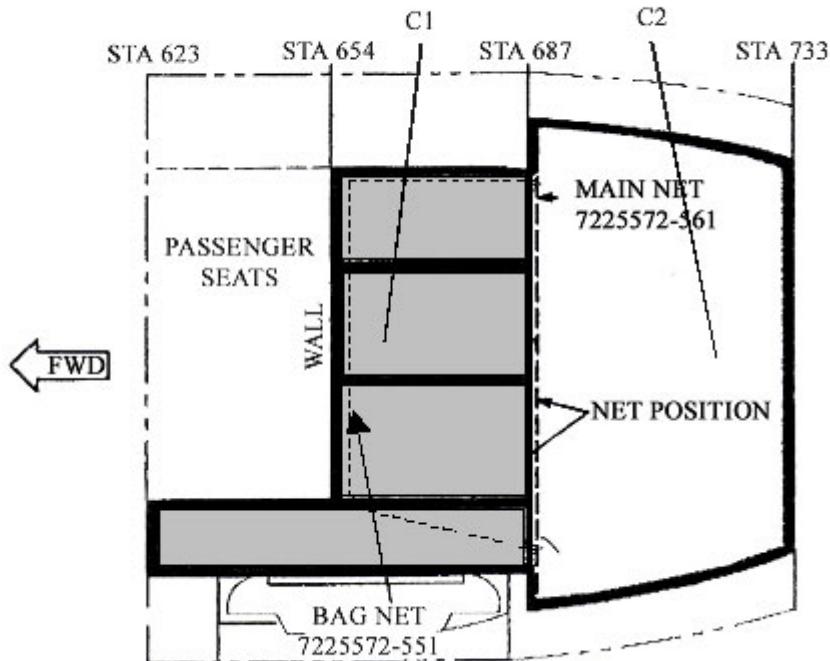
Figure 1: Saab 340B Aft Cargo Hold Layout

G-LGNG is a Saab 340B with a seating capacity of 36. There are two cargo compartments, C1 and C2, located to the rear of the passenger cabin and both can be accessed via a large cargo door on the left of the aircraft. Passenger baggage is not containerised and is normally loaded loose into each compartment. The maximum load for unsecured cargo in C1 is 510 kg, while the maximum load permitted in C2 is 385 kg; the maximum combined load for C1 and C2 is 860 kg. G-LGNG was unique in the operator's fleet in that hold C1 was 'L' shaped to permit a row of passenger seats to be positioned aft of fuselage Station 623, Figure 1. The aircraft in the rest of the operator's fleet had rectangular C1 holds that extend from Station 623 to Station 687. Thus, although the maximum load for C1 and the maximum combined load are slightly reduced in G-LGNG, the position of the CG for a fully laden aircraft is likely to be further aft in G-LGNG than in the other aircraft in the operator's fleet.

There were also discrepancies in the loading of the baggage. The load control officer had produced a Loading Instruction (LI) which indicated to the baggage loading staff where the bags should be located in the aircraft holds. The LI issued for the accident flight required 30 of the 43 bags to be loaded in hold C1 and the remainder to be loaded in C2. Unfortunately the computer software that produced the LI did not fully recognise the limited volume of hold C1 on G-LGNG. When the loading staff came to put the baggage on the aircraft there was a lack of space in hold C1 and so the aircraft was loaded with 23 bags in hold C1 and 20 in hold C2. There was no attempt to re-calculate the trim after this change in loading and, indeed, since the baggage tags did not provide individual baggage weights it was not possible for the ramp loading staff to calculate the trim change. Some time later a number of suit carriers and oversize cabin baggage were loaded in hold C1. Thus, the actual loading of the aircraft was 294 kg in hold C1 and 430 kg in hold C2, compared to the loadsheet which showed 338 kg in hold C1 and 171 kg in hold C2. This mis-loading placed the CG position 13 units aft of the aft CG limit of 64 units. (For reference, the forward CG limit at the aircraft's landing weight was 23.5 units.)

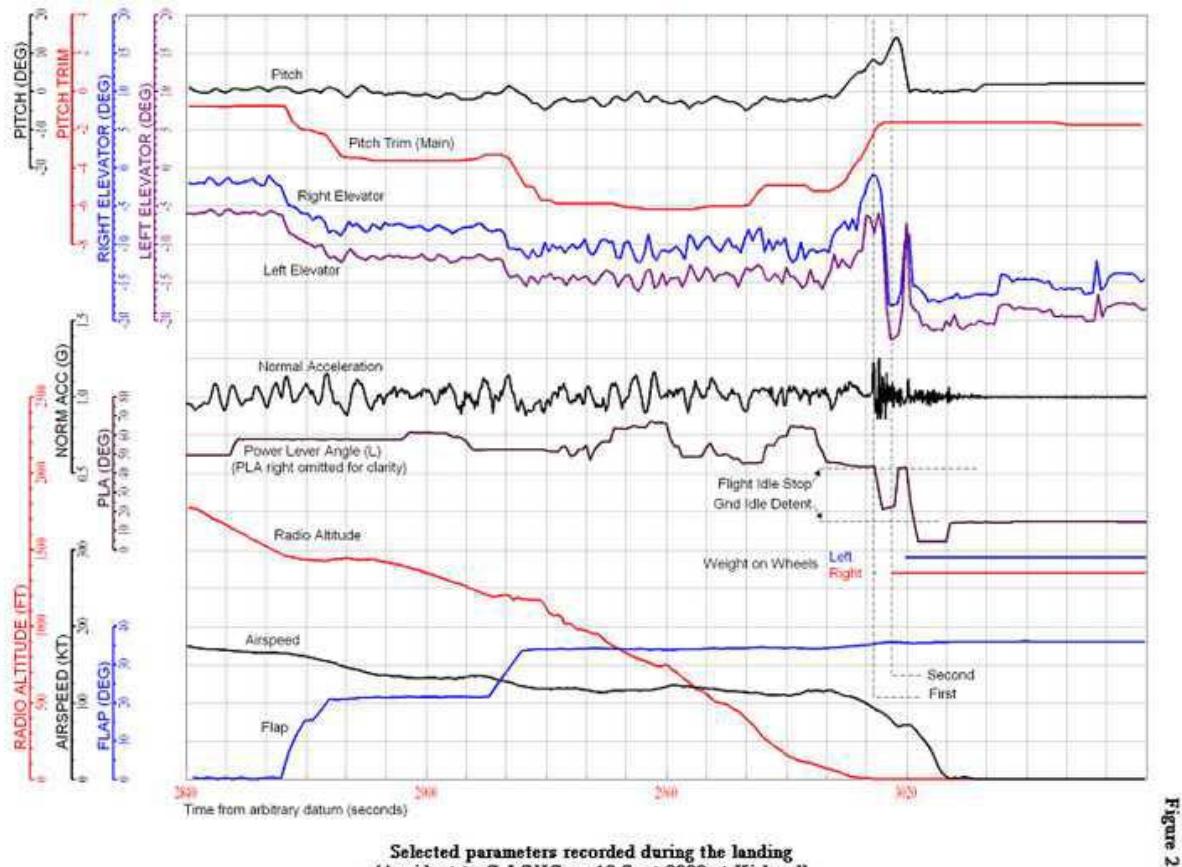
Figure 2: Selected parameters recorded during the landing

Settings of 15° of flap and a pitch trim of -1.0° had been selected prior to the departure. At an airspeed of 113 kt nose-up elevator was applied and pitch attitude began to increase at a rate of just over 3.5°/sec. Less nose up elevator was applied and, by 34 feet agl, pitch attitude stabilised at approximately 13.7°.

At 69 feet agl the power levers were moved toward FLIGHT IDLE and engine power reduced to 10-15% torque, the flare was initiated and airspeed began to reduce from 115 kt. Progressive application of nose up trim at an average rate of 0.32°/sec (normal operating rate 0.4°/sec) was recorded during the touchdown sequence. Less nose down elevator was also applied and the pitch attitude of the

aircraft increased from -2.0° to $+8.4^\circ$ by the time that the first contact with the runway surface was made. At this first contact the pitch trim setting was increasing through -2.4° . An airspeed of 93 kt and a normal acceleration peak of 1.2g was recorded. Both power levers were retarded below the FLIGHT IDLE stop to within 4° of the ground idle detent.

Pitch attitude momentarily reduced before increasing sufficiently for the oleos to extend (and possibly for the aircraft to become momentarily airborne) for a period of less than three seconds. Elevator position progressively changed to full nose down during this period whilst pitch trim stabilised at -1.6° . By the time of the second and final touchdown/oleo compression, pitch attitude had increased to 13.4° nose up. One second later, pitch attitude reached a maximum nose up value of 14.06° and this is considered to be when the rear of the aircraft contacted the ground. Airspeed at that time had decayed to 71 kt. Both power levers were then advanced to the FLIGHT IDLE stop (42°) for several seconds, the aircraft began to pitch forward and the nose gear made contact with the runway three seconds later, with less nose down elevator being applied to reduce the rate of de-rotation. REVERSE was selected and the remainder of the rollout was uneventful; the aircraft was brought to a halt on the runway.
