Investigation report

B1/2008L

Airliner veering off the runway at Lappeenranta airport on 31 January 2008

SAAB 340B

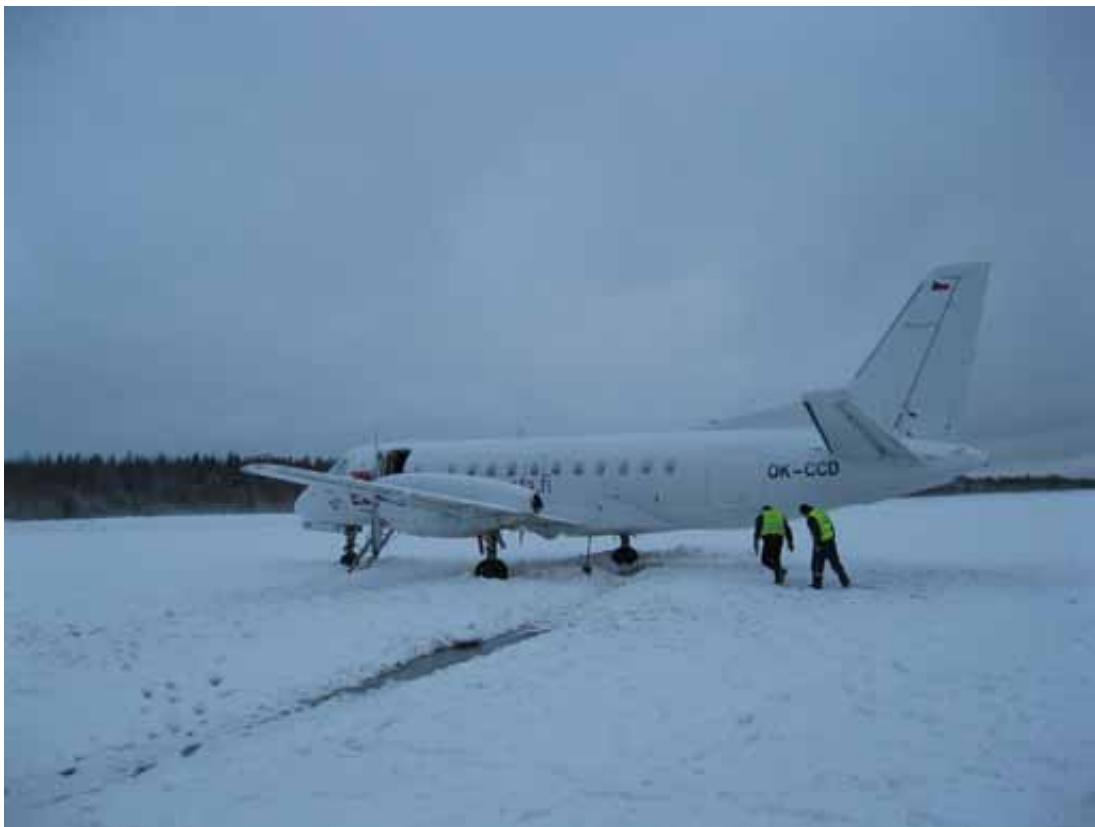
The aircraft touched down approximately 750 m from the threshold and approximately 10 m left of the centre line. After touchdown the aircraft bore slightly to the left of the centre line. During the landing roll the aircraft slowly turned to the left and skidded off the runway, coming to rest at approximately 1300 m from the threshold. In all, the aircraft turned approximately 100 degrees to the left from its original heading and its tail was over the line of the runway edge lights.

Figure 1. The aircraft off the runway

The incident was caused by the aircraft veering off the cleared section of the runway during the landing roll. The right engine failed after reverse thrust was applied. This caused unsymmetrical braking, resulting in the aircraft turning to the left and skidding off the runway.

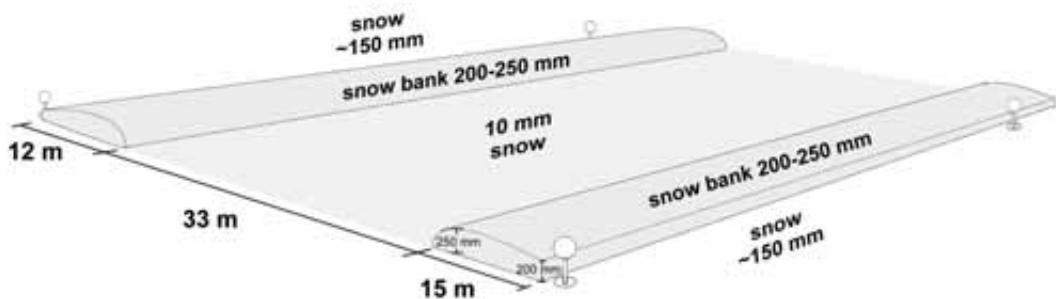
Prior to the occurrence Sweepers 1 and 2 had cleared the runway at a width of 33 m. In the landing direction the runway was cleared 15 m to the right of the centre line and 18 m to the left of the centre line. Snow was approximately 10 mm deep at the cleared area and the snow banks were approximately 200–250 mm high. Outside the line of runway edge lights on the runway strip snow was approximately 150 mm deep, rising to ca. 300 mm farther beyond. The deposits were established on the basis of runway observations and photos taken at the time of the occurrence. However, the aircraft was not informed of the height of the critical snow banks prior to the occurrence.

Figure 2. Snow on the runway
