Jun10/ATSB103

Turbulence event, VH-QPI 58km N of Kota Kinabalu, Malaysia 22 June 2009

Abstract

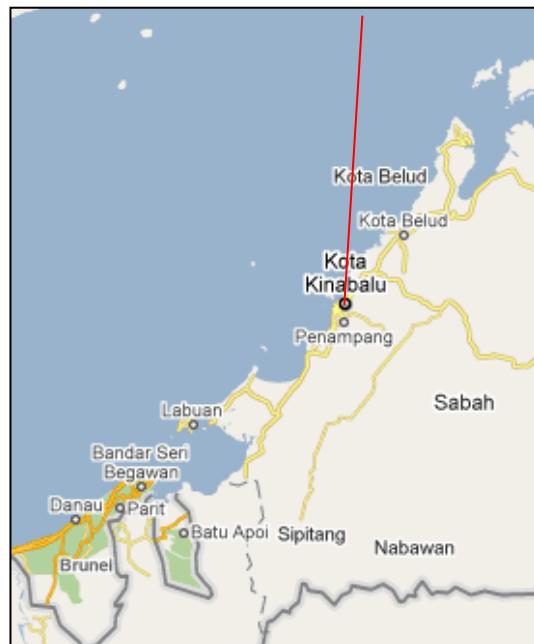
Figure 1: Malaysian Borneo with inbound track to Kota Kinabalu in red.

206 passengers and 13 crew, departed Hong Kong on a scheduled flight to Perth, Western Australia. Two hours and 10 minutes after takeoff, while tracking towards Kota Kinabalu at flight level (FL)² 380, the aircraft encountered an area of severe turbulence (Figure 1).

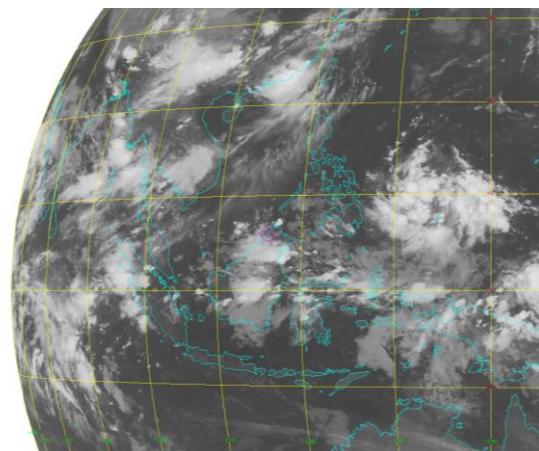
Figure 3: Infra-red satellite image at 0230 of the South-east Asia region.⁸

Infrared satellite photography from 0030 to 0230 on 22 June 2009 showed the presence of convective activity covering the majority of the north-eastern part of the island of Borneo, including the approaches to Kota Kinabalu (Figure 3).

The rapid changes in wind speed and direction during the recorded disturbance were consistent with the aircraft encountering severe turbulence. The variation in the air temperature at that time was consistent with the pilot reports that the aircraft entered cloud. The pilot reports of the noise of particles striking the aircraft was consistent with the cloud comprising ice crystals, and was supported by the recorded data, which shows that the air temperature was between -46 °C and -52 °C, temperatures at which water can only exist in ice form.

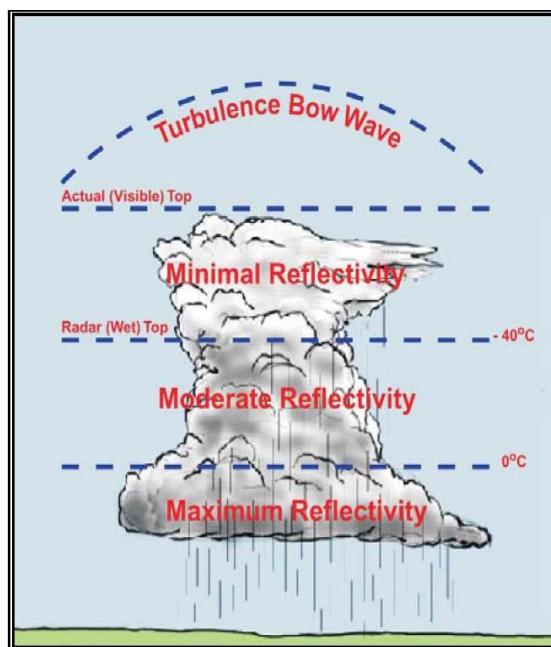
Figure 4: Thunderstorm Reflectivity Levels.¹²

In the case of a cumuliform cloud, with its potentially extensive turbulence as a result of associated up and downdrafts, water droplets can be in different states, sizes and amounts depending on their location in the cloud (Figure 4). In that context, the radar reflectivity of cumuliform cloud is:

- greatest in the lower portion, where there is a significant proportion of moisture in the liquid state
- moderate in the middle section, between the freezing level and around -40°C , where water exists as either supercooled droplets¹¹ or ice crystals – the presence of ice crystals reducing the radar reflectivity
- minimal in the top layer, above the height consistent with a temperature of -40°C , where water exists entirely as ice crystals.
