ATSB TRANSPORT SAFETY REPORT
Aviation Occurrence Investigation AO-2008-007
Final

Hard landing
Darwin Airport, Northern Territory
7 February 2008
VH-NXE
Boeing Company 717 – 200

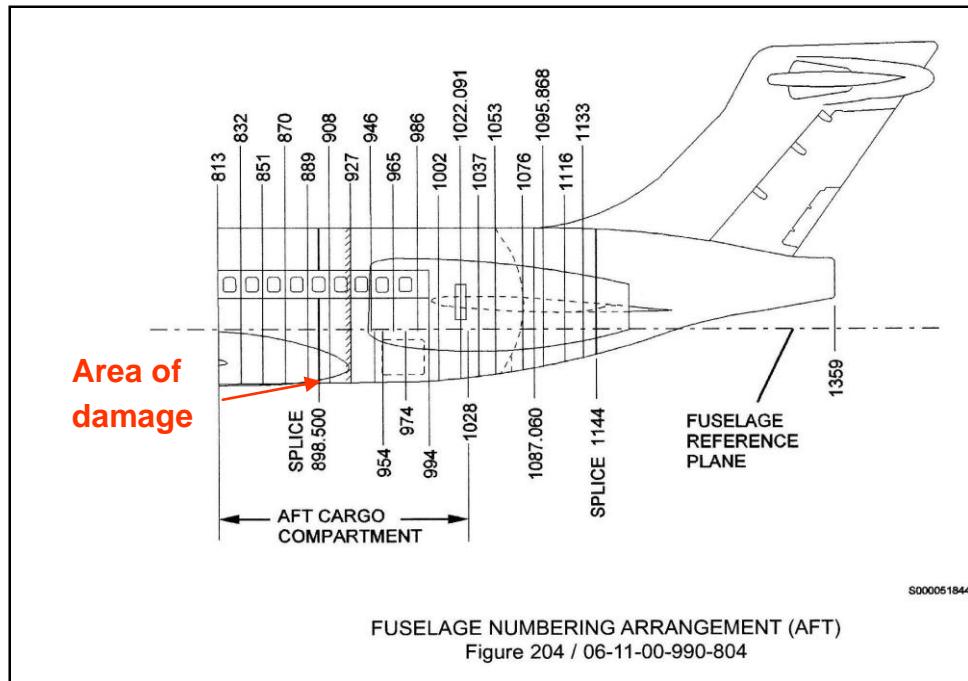
The damage to the aircraft included several creases to the fuselage skin above the wing area and to the underside of the fuselage behind the wing (Figures 2 and 3). Several longerons⁹ in the rear cargo area were also damaged. The left main landing gear was removed and inspected in response to minor damage to the upper wing above the landing gear assembly. The outer left main landing gear tyre was also damaged.

Figure 2: Rear of the aircraft showing the area of damage

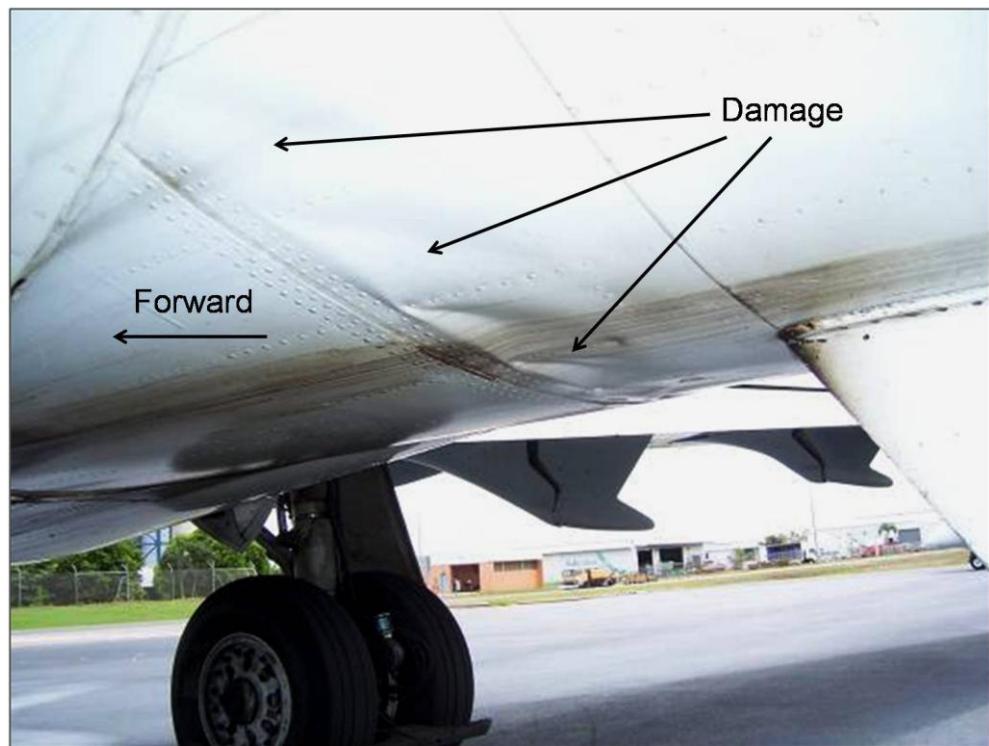
Figure 3: Damage to the rear underside of the aircraft

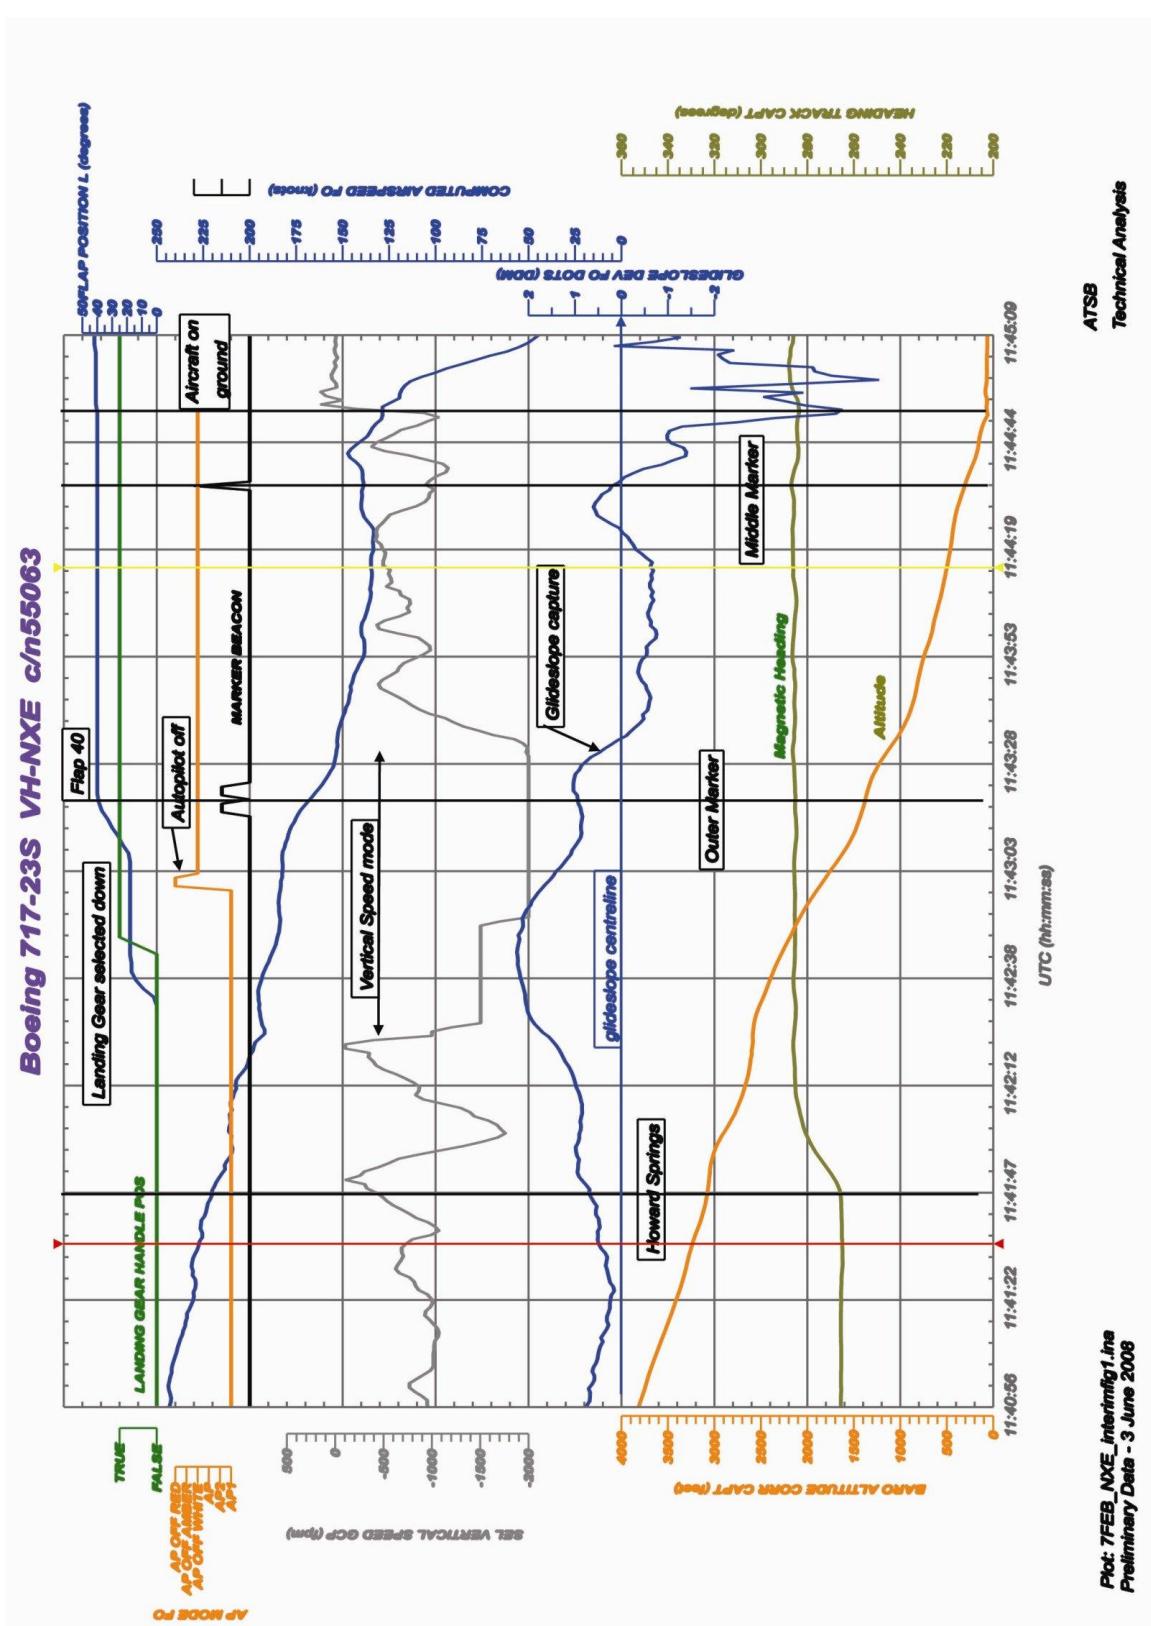
APPENDIX A: FLIGHT RECORDER DATA – APPROACH

Flight data recorder (FDR) information indicated that at 2111:47, NXE flew over the Howard Springs NDB at 3,100 ft above mean sea level (AMSL), at a computed airspeed of 220 kts and with the aircraft's autopilot engaged (Appendix A). The aircraft was above the glideslope at that time and the autopilot did not capture the glideslope. The copilot reported attempting to descend the aircraft onto the glideslope using the autopilot's 'vertical speed' mode.

The FDR data showed that 10 seconds after overflying the Howard Springs NDB, the aircraft's rate of descent (ROD) increased to over 1,000 ft/min for a period of 13 seconds, of which 3 seconds were at the maximum recorded ROD of about 1,600 ft/min. The aircraft's speed varied between 209 kts and 211 kts during that time. The FDR data showed that from this point on during the approach until touchdown, the wind direction varied between 098° and 194° true (T) and that the wind speed varied between 4 and 12 kts. There was no indication of any significant turbulence during the approach.

At 2112:30, the aircraft was 6.7 NM (12 km) from the runway at a speed of 194 kts and about 350 ft above the glideslope at 2,544 ft when the ROD again increased to over 1,000 ft/min. The crew commenced extending the wing leading edge slats and trailing edge flaps at that time. At 2112:47, the crew selected the landing gear down and, 12 seconds later, the copilot disconnected the autopilot. At that time, the aircraft was at 1,893 ft, with a descent rate of 1,900 ft/min.

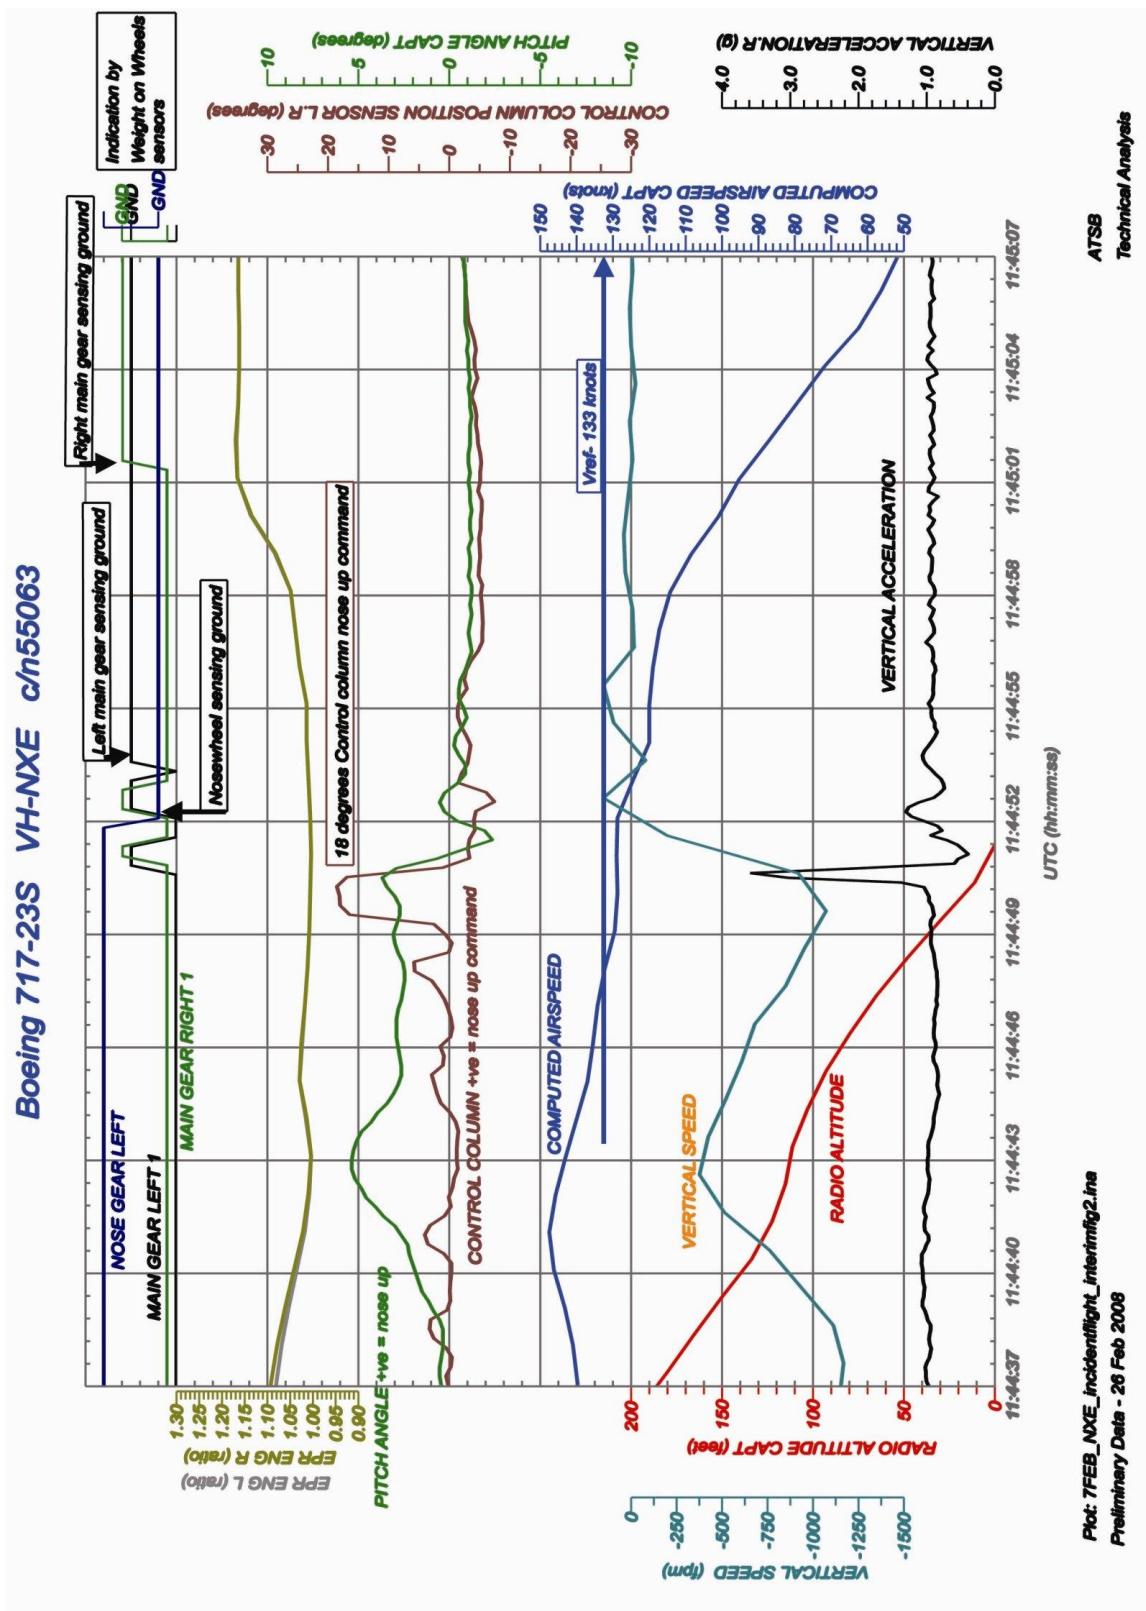
APPENDIX B: FLIGHT RECORDER DATA – SHORT FINAL

Four seconds before touchdown, at 82 ft radio altitude, the aircraft's ROD again increased and the copilot recalled hearing the synthesised altitude callouts from the aircraft's radio altimeter system. At 33 ft radio altitude, the FDR recorded a ROD of 952 ft/min, at the same time as an abrupt, nose-up command was applied to the control column, and the autothrottle retarded the engine thrust to IDLE.

At 2114:51, the aircraft landed heavily on the left main landing gear at 128 kts, with a recorded vertical force of 3.6 g⁷ resulting in damage to the aircraft (Refer page 5 Aircraft damage) The touchdown was within 300 m of the runway threshold, to the left of the runway centreline, and with a ROD of 1,072 ft/min. The relevant FDR information, from a radio altitude of 180 ft until after touchdown, is provided in Appendix B.

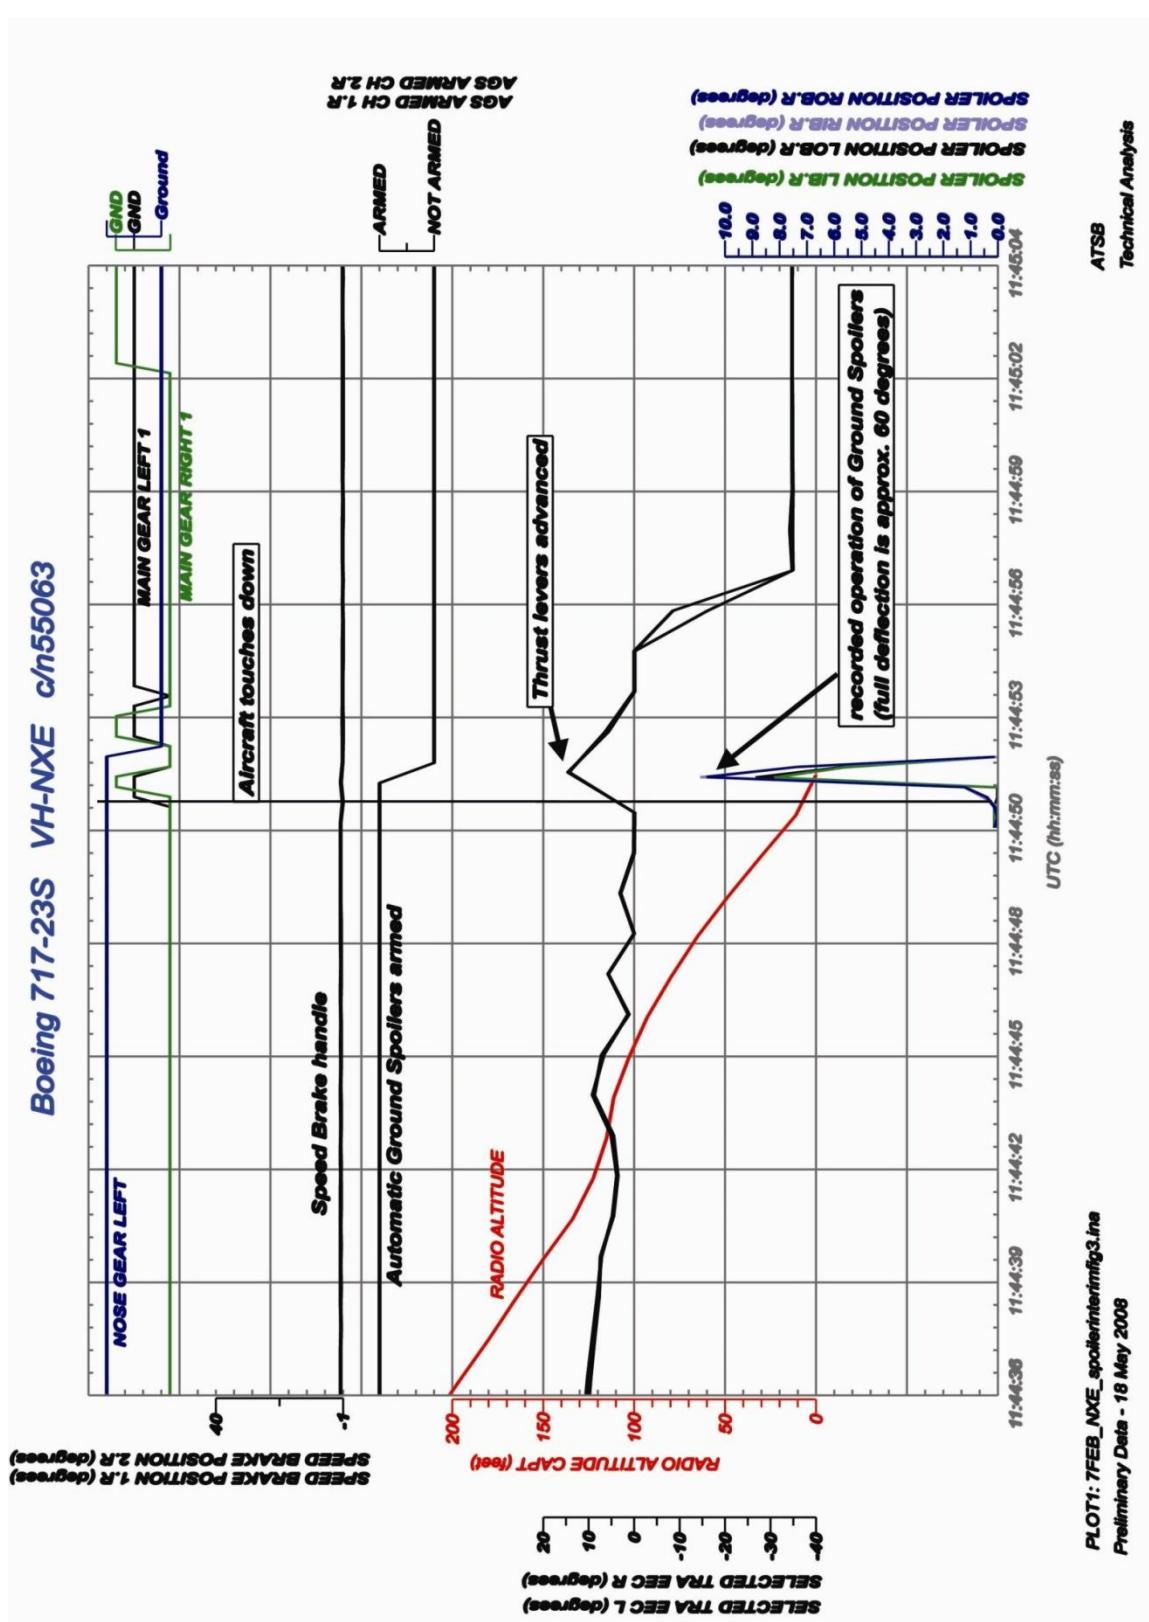
APPENDIX C: FLIGHT RECORDER DATA – SPOILERS

The recorded information showed that, following touchdown, the ground spoilers⁸ partially extended and then retracted (Appendix C). The spoiler retraction was due to the thrust levers being momentarily advanced beyond the position at which the

- After touchdown, the thrust levers were advanced, inadvertently cancelling the deployment of the ground spoilers and resulting in unstable conditions while transitioning from flight to the ground.
