AVIATION INVESTIGATION REPORT
A08Q0171

RUNWAY EXCURSION

AIR FRANCE
BOEING 747-428 F-GITC
MONTRÉAL/PIERRE ELLIOTT TRUDEAU
INTERNATIONAL AIRPORT, QUEBEC
26 AUGUST 2008

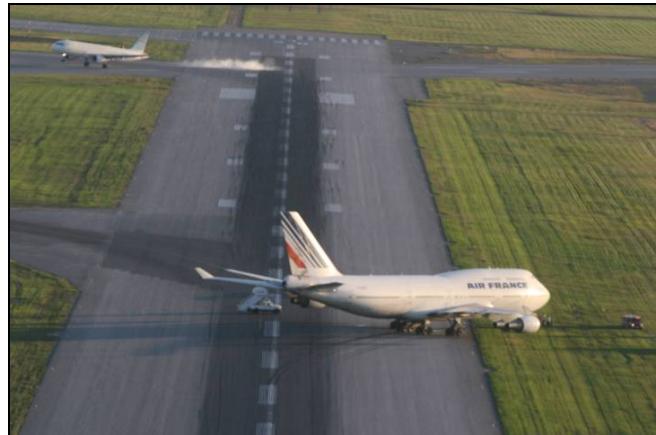
At approximately 45 knots, as the thrust reversers were stowed and the autobrake disengaged, the aircraft veered to the right. A combination of forward nose wheel tiller and full left rudder inputs were used in an attempt to stop the turn. However, the rate of turn increased rapidly. Maximum brake pressure was then applied and the aircraft came to a complete stop at 2148 on a heading of 277°M, with the nose wheels 26 feet off the right side of the runway surface (see Photo 1).

Photo 1. Aircraft on the right side of the runway.

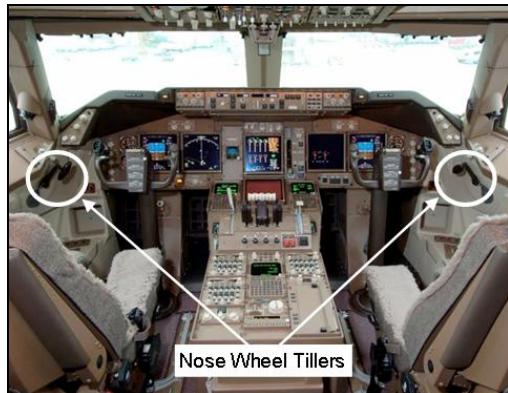
A hydraulically powered nose wheel steering is controlled by a tiller for each pilot to provide the primary low-speed steering of the aircraft on the ground (see Photo 2). A tiller movement of 150° clockwise will turn the nose wheels to the maximum steering angle of 70° to the right.⁸ A pointer on the tiller indicates the position relative to the neutral/centred position. A caution label is also located near the pointer, advising personnel not to hold or turn the tiller while towing the airplane (see Photo 3).⁹

Photo 2. Location of the tillers

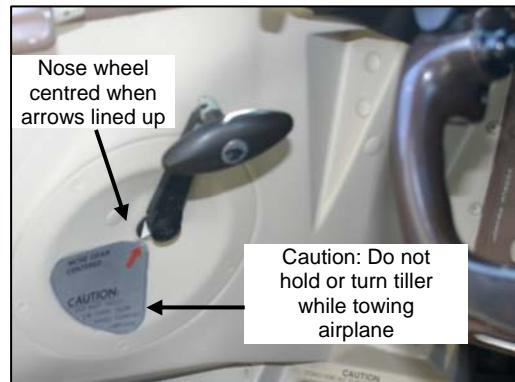
Photo 3. Close-up of left-hand tiller

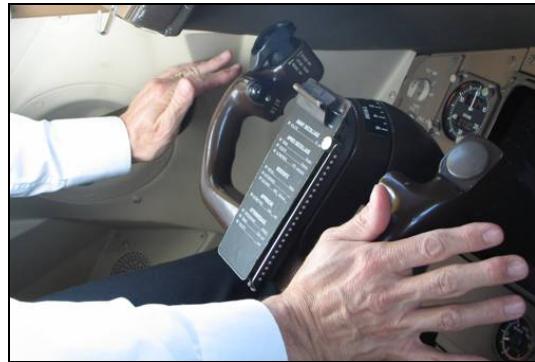
The forward displacement of the pilot's arm when pushing the control column to a near full forward position is equivalent to a forward movement of 50 to 60° of the tiller (see Photo 4), resulting in a 25 to 30° nose wheel deflection to the right.

Photo 4. Tiller and control column forward

Although the initial nose wheel tiller input can not be explained, the arm's angular position corresponds to an equivalent angular position it had when it was on the control column one second earlier. It is possible that the PF inadvertently pushed the tiller forward thinking it was the control column.

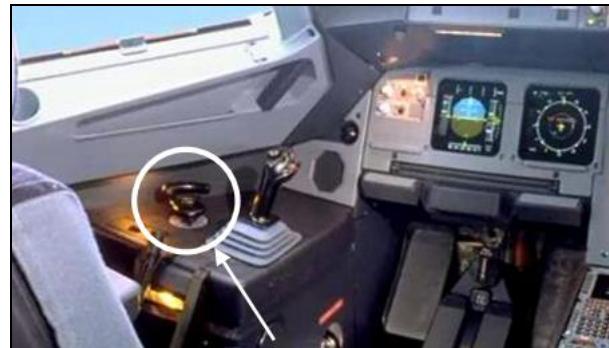
The aircraft previously flown by the captain, an A320, was equipped with nose wheel tillers located at knee height for both pilots (see Photo 5). The tillers operate on a horizontal plane with a left-right movement to turn the aircraft on the ground. The usual handling of either tiller is to lower the arm, grasp the top of the handle, and move the tiller by moving the wrist. The position of the nose wheel tiller on the A320 aircraft is lower and further outboard in relation to the tiller on the B744.

Photo 5. A320 Nose wheel tiller

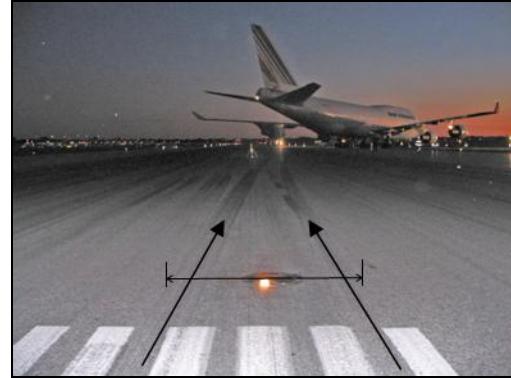
The nose wheel skid marks commence in a straight line on the runway centreline and remain on the centreline markings and centreline lighting over a distance of approximately 600 feet. The skid marks then move towards the right edge of the runway, resulting in a total skid distance of approximately 1160 feet (see Photo 6). The nose wheels came to rest 26 feet past the right edge of the runway.

Photo 6. Nose wheel skid marks

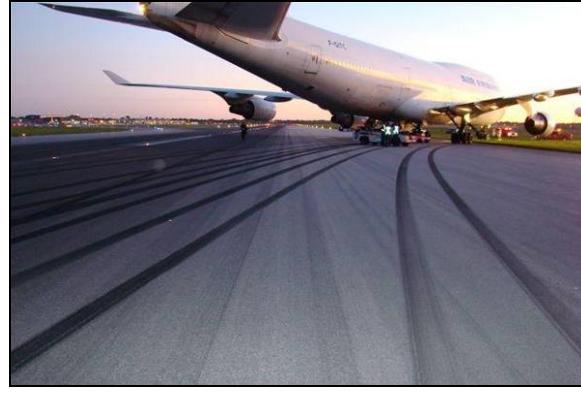
The main landing gear tire skid marks commence approximately 800 feet after the nose wheels began to skid, and continued for approximately 210 feet. The right main landing gear tires stopped 9 feet from the edge of the runway (see Photo 7).

Photo 7. Main gear tire marks (heavy braking)

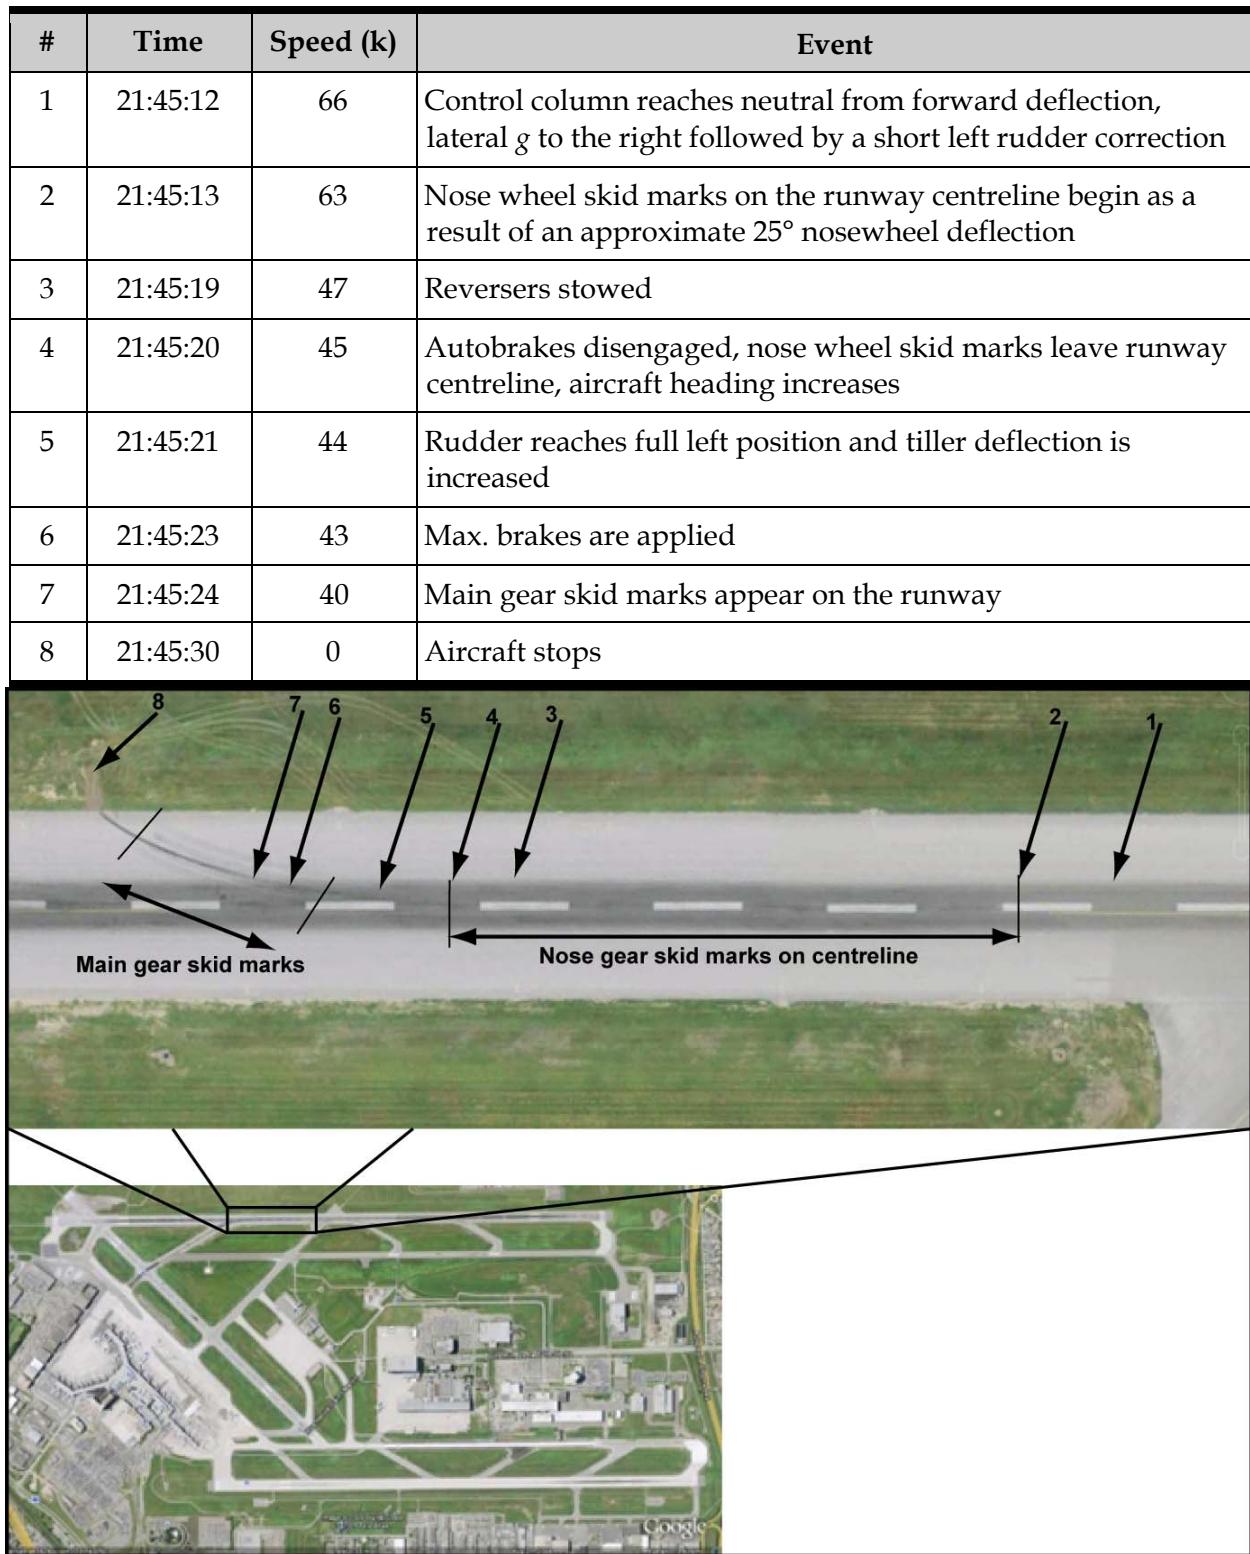
Longitudinal g data from the DFDR corresponds to the measured skid marks on the runway surface and help to establish the timeline. In addition, lateral g DFDR information at the time the skid marks begin, combined with a slight right turn and momentary rudder deflection to the left; all confirm the synchronization of DFDR data and the runway skid marks. The synchronization of DFDR data and runways skid marks produces the following sequence of events (See Figure 1):

Figure 1. Landing rollout events
