INCIDENT

Aircraft Type and Registration:	DHC-8-402 Dash 8 Q400, G-JEDM	
No & Type of Engines:	2 Pratt & Whitney Canada PW150A turboprop engines	
Year of Manufacture:	2003	
Date & Time (UTC):	3 March 2009 at 1820 hrs	
Location:	10 nm north-east of Southampton Airport, Hampshire	
Type of Flight:	Commercial Air Transport (Passenger)	
Persons on Board:	Crew - 4	Passengers - 61
Injuries:	Crew - None	Passengers - None
Nature of Damage:	None	
Commander's Licence:	Air Transport Pilot's Licence	
Commander's Age:	38 years	
Commander's Flying Experience:	4,100 hours (of which 413 were on type) Last 90 days - 100 hours Last 28 days - 27 hours	
Information Source:	AAIB Field Investigation

Synopsis

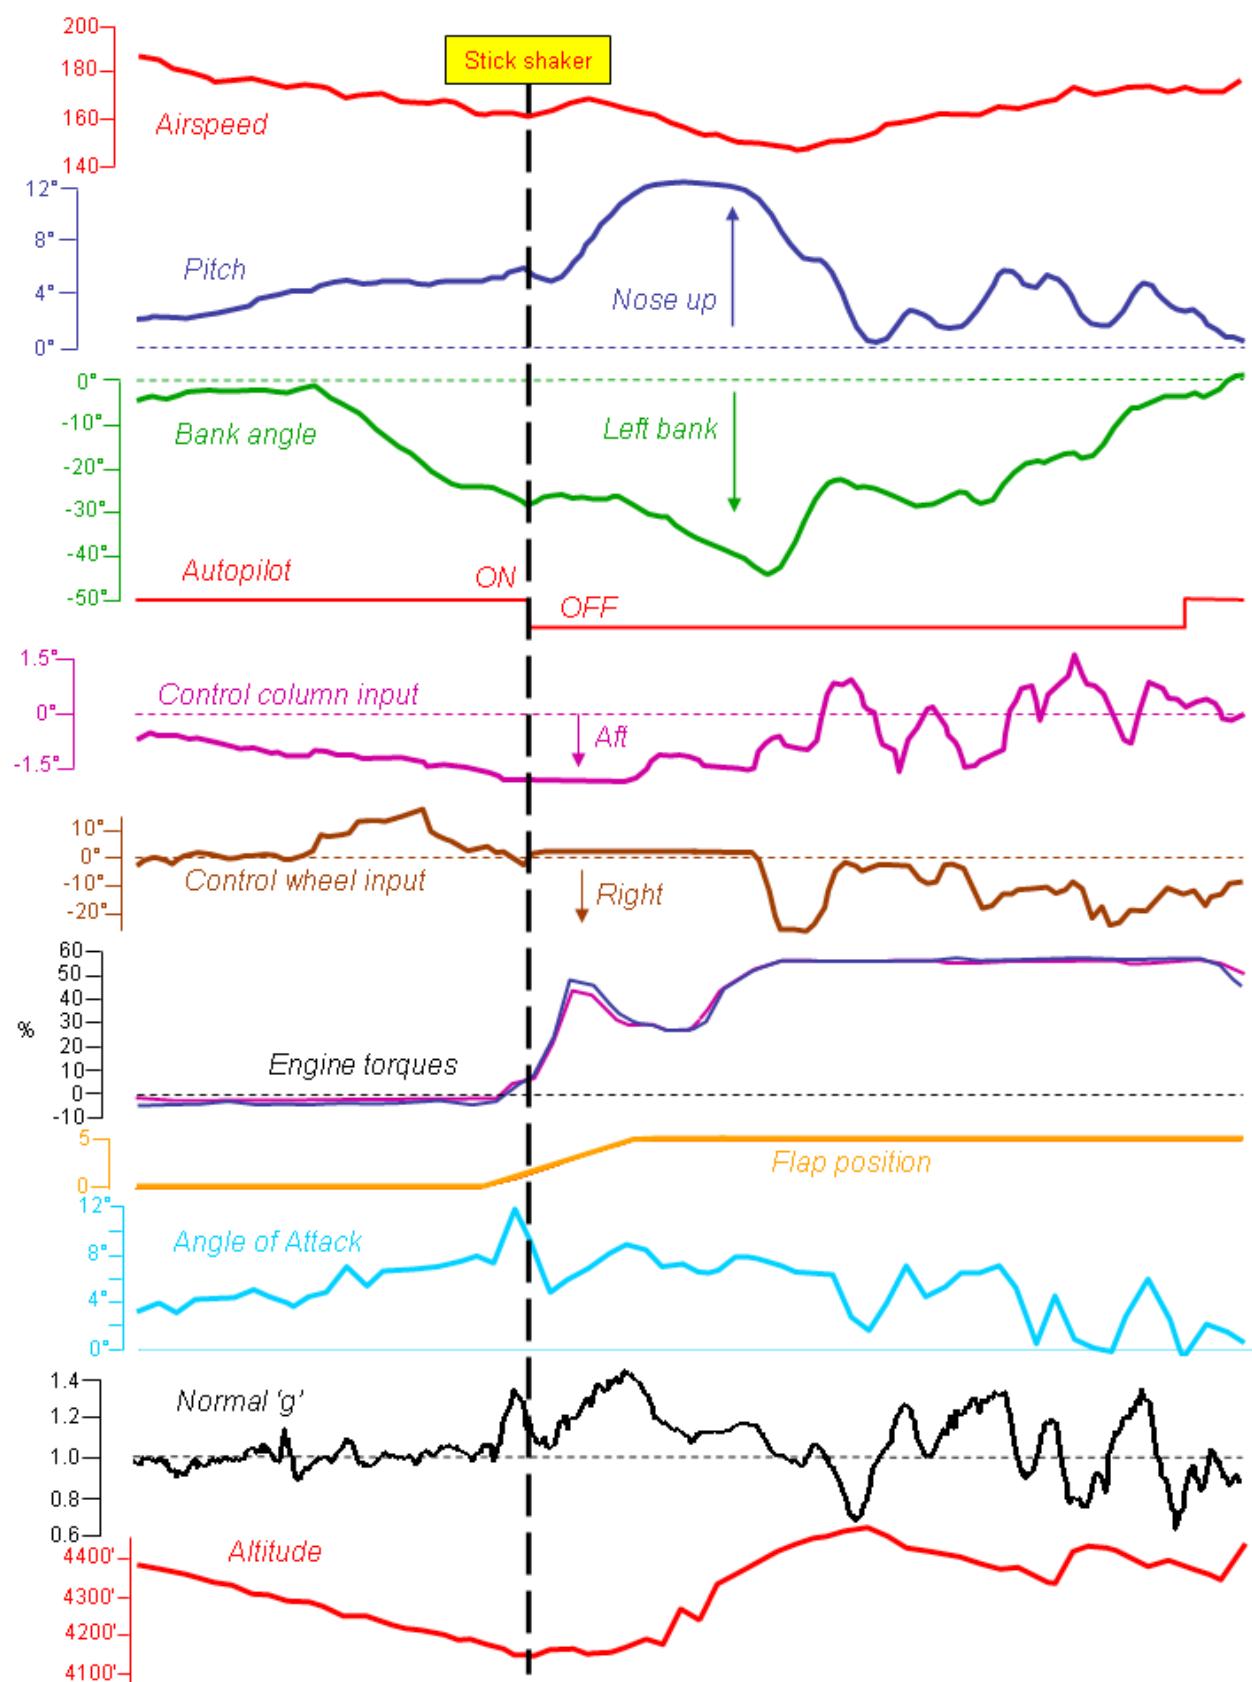
**Figure 1**

FDR information for the whole flight had been downloaded by the aircraft operator and was available for analysis. Figure 1 shows relevant flight data from the time of the incident.

About five seconds after the turn was established, there was an increase in the level of turbulence, indicated by increasingly large normal 'g' spikes. Near the peak of one such fluctuation, which recorded 1.36 'g', both stick shakers activated and the autopilot disengaged. Airspeed was 161 kt and the angle of attack, which had been at about 7° immediately beforehand, rose to between 10 and 12° for between one and two seconds. The aircraft's pitch attitude was 6° nose up.

The angle of bank remained unchanged for about five seconds, as the aircraft began to pitch further nose up at a rate of approximately one degree/second. Bank angle then began to increase, and was increasing through 34° as a maximum pitch of 12.5° was reached. The angle of bank reached a recorded maximum of 43.6° , coincident with the lowest recorded airspeed of 147 kt. The REF SPEEDS switch was selected OFF at between 153 kt and 147 kt³, shortly before the minimum speed was reached and approximately 10 seconds after the stick shaker had activated.

Relevant FDR parameters over a 65 second period surrounding the stick shaker event (simplified)

However, from the angle of attack and other data with a higher sampling rate, it is likely the stick shaker was active for only about one second, possibly less. The airspeed continued to reduce below that at which the stick shakers activated but, by then, the flaps had travelled to 5° and the angle of attack, although still fluctuating, was less.
