**Report 99-005**

**ATR 72-212 ZK-MCC and Boeing 737-219 ZK-NAT**

**airspace incident**

**26 July 1999**

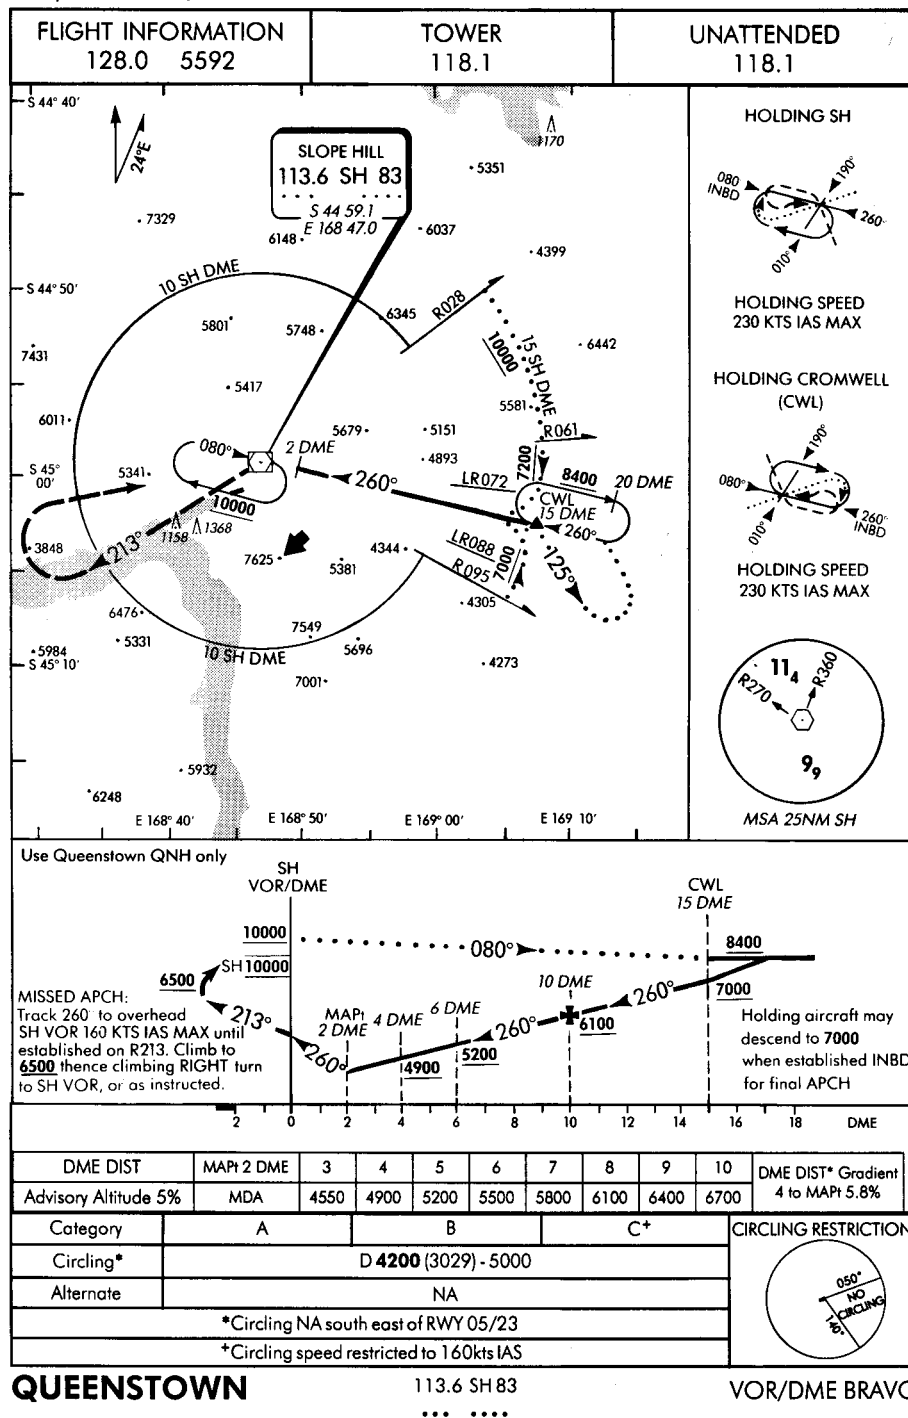
**Figure 2**  
**Queenstown VOR/DME Bravo Approach Chart**  
**Effective 15 September 1999**

- 1.1.6 At 1215 hours NZ 639 turned inbound from the arc and commenced the VOR/DME Bravo approach (see Figure 2). Because of the weight of the aircraft and its requirement to meet the necessary missed approach criteria the minimum descent altitude (MDA)<sup>5</sup> for the approach was increased by 600 feet to 4800 feet. At 4800 feet the captain of NZ 639 was unable to gain the necessary visual reference<sup>6</sup> and commenced the missed approach procedure at about 1220 hours.

- 1.3.2 In the initial development of the VOR/DME Bravo approach by Airways Corporation, consideration was given to having lower DME steps, down to 5000 feet at about 10 nm to fly to the missed approach point. This would have enabled pilots to get lower earlier and obtain a better appreciation of the conditions on entering the Queenstown basin. Nevertheless, several operators, including Mount Cook Airline, objected to the proposal because this would have required lowering the TMA to control and protect IFR aircraft on approach, resulting in restricted access for low-level VFR transits of the Kawarau Gorge area.
