Investigation Report No. u1934

concerning the serious incident
to the aircraft AVRO 146-RJ100, HB-IXR,
operated by Swiss European Air Lines
under flight number LX 0815
on 26 January 2006
at Zurich Airport

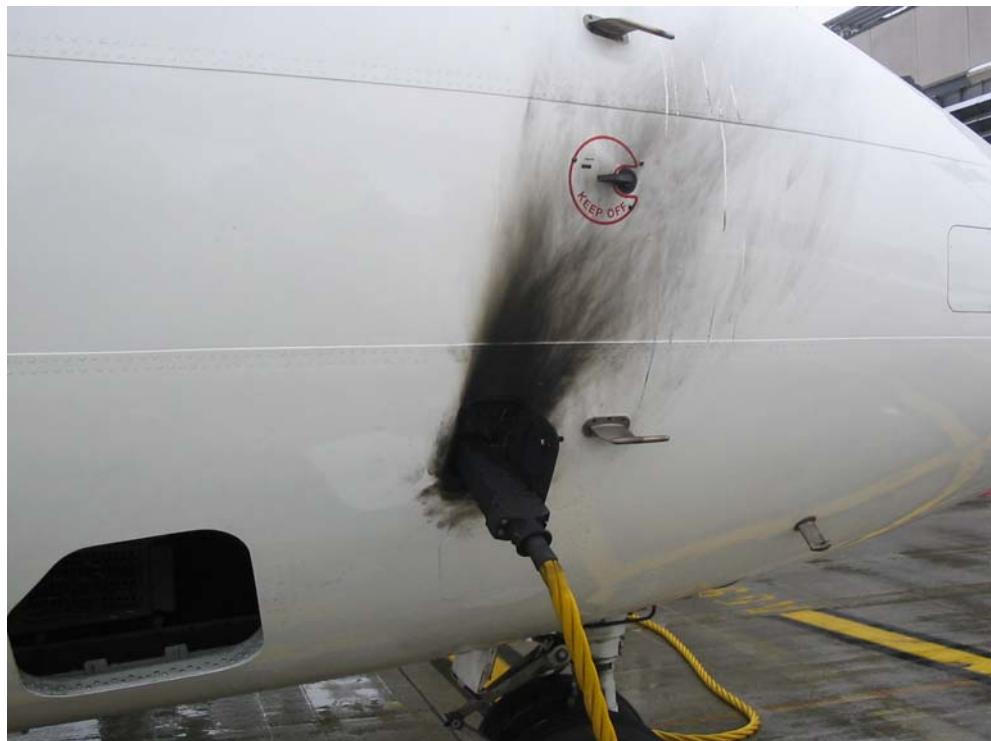
Annex 1: Traces of soot on the surface of the fuselage

On the aircraft, substantial damage was caused to the connector plate of the aircraft-side connection for the external power supply and in its immediate vicinity. Traces of black soot were deposited over the entire area of the connection and on the surface of the fuselage (see Annex 1).

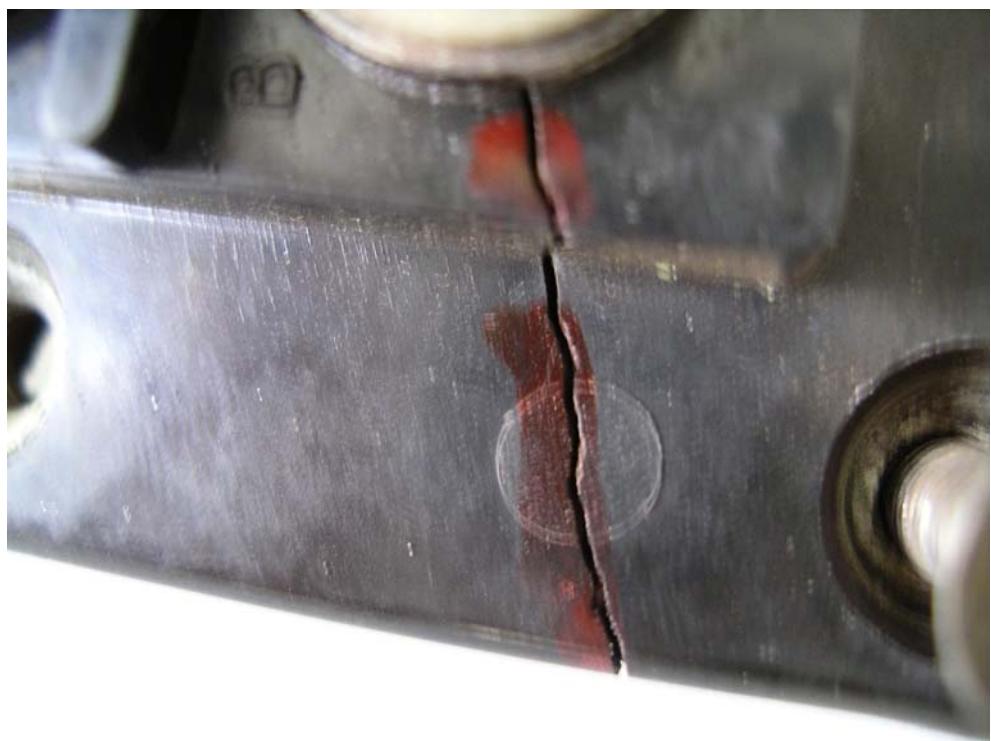
Annex 2: Crack from the contact pin to the edge of the connector plate

The surface of the connector plate itself was badly burnt. Three contact pins for transferring the three-phase alternating current had melted and were found in the dock-side plug. Moreover, the connector plate exhibited a fairly small crack between two contact pins and a larger crack from one contact pin to the edge of the plate (see Annex 2).

A crack was found (see Annex 2) in the aircraft-side connector plate which was removed after the serious incident; parts of it had been burned or had melted.

trast. The fracture surface was normal and macroscopically low in deformation. The fracture origin could be located in the inner area of the two holes. In the centre of the connector plate, in the area of the two holes, about two thirds of the cross-sectional area of the plate had been burned by the short-circuit. The greater the distance from the centre, the less pronounced the thermal deformations.

Although it is not possible to answer with certainty the question of the origin of the crack, it can be assumed that the short-circuit was not caused by the crack.

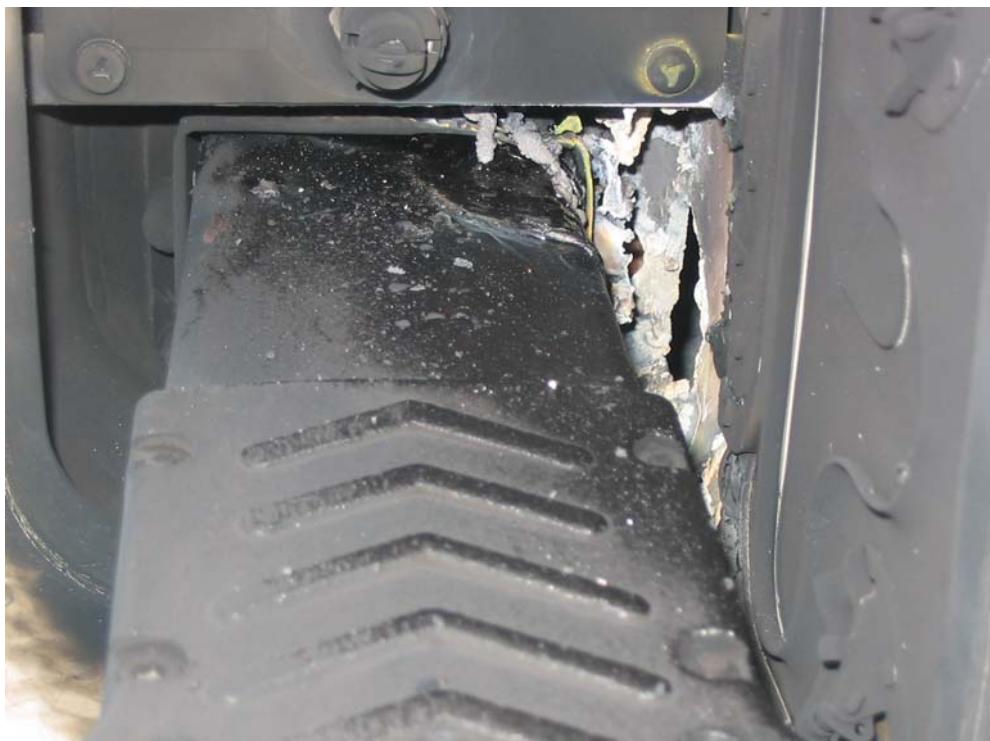
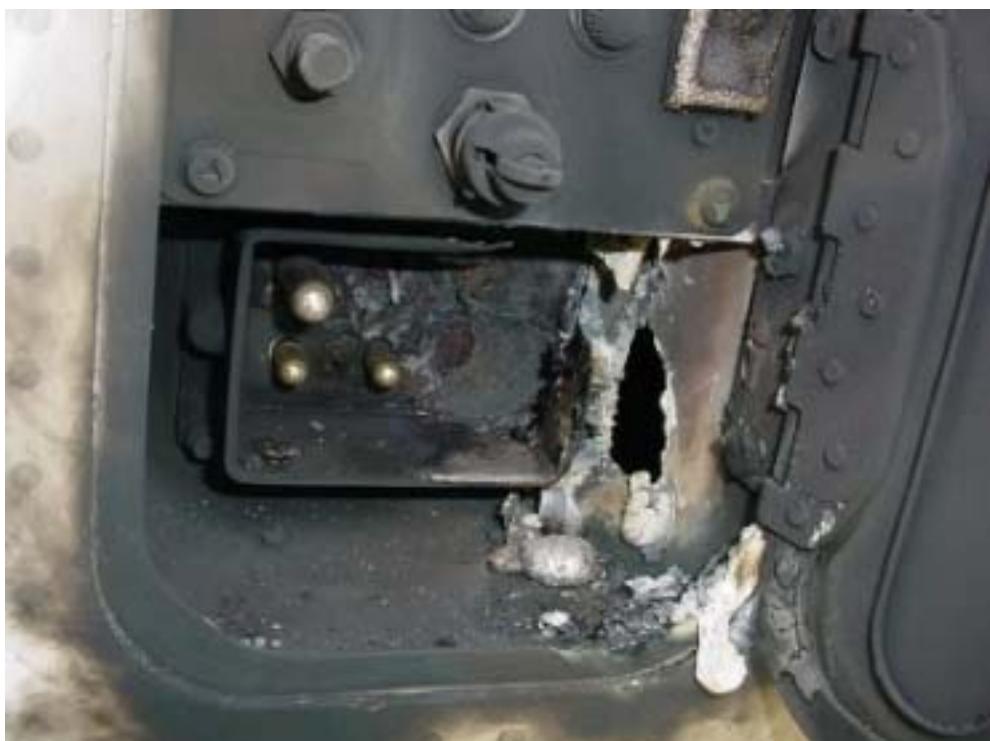
Annex 3: Hole in the fuselage

The connector plate was located in an externally accessible bay in the aircraft's fuselage. The wall of the bay had burned through at one point. This created an opening through which fire and smoke were able to penetrate into the cockpit (see Annex 3).

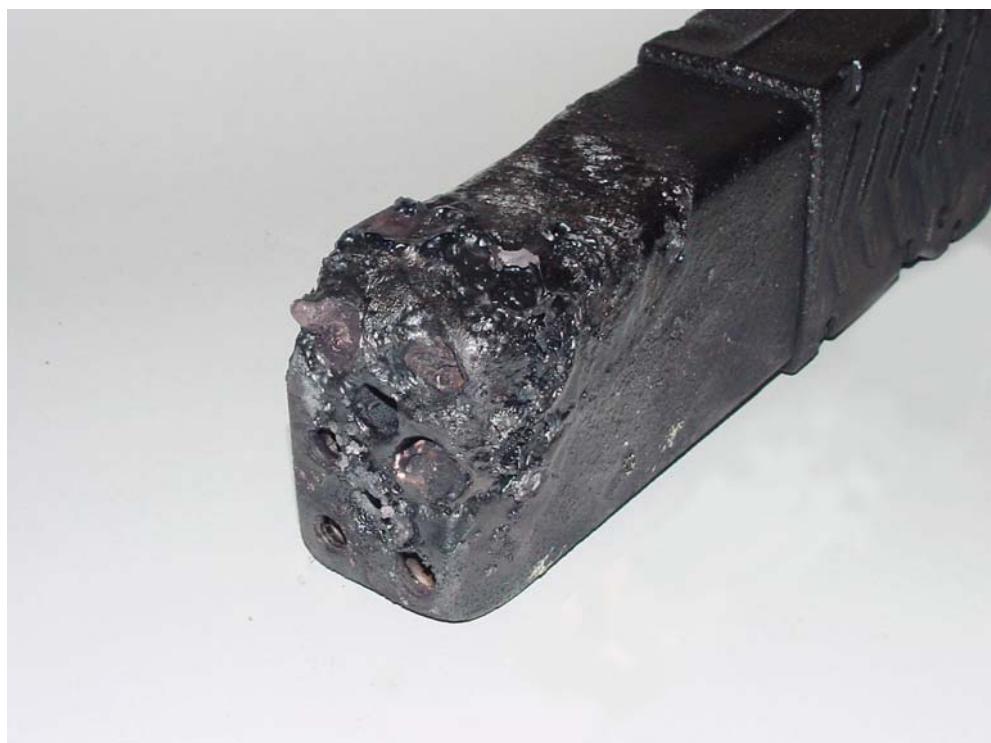
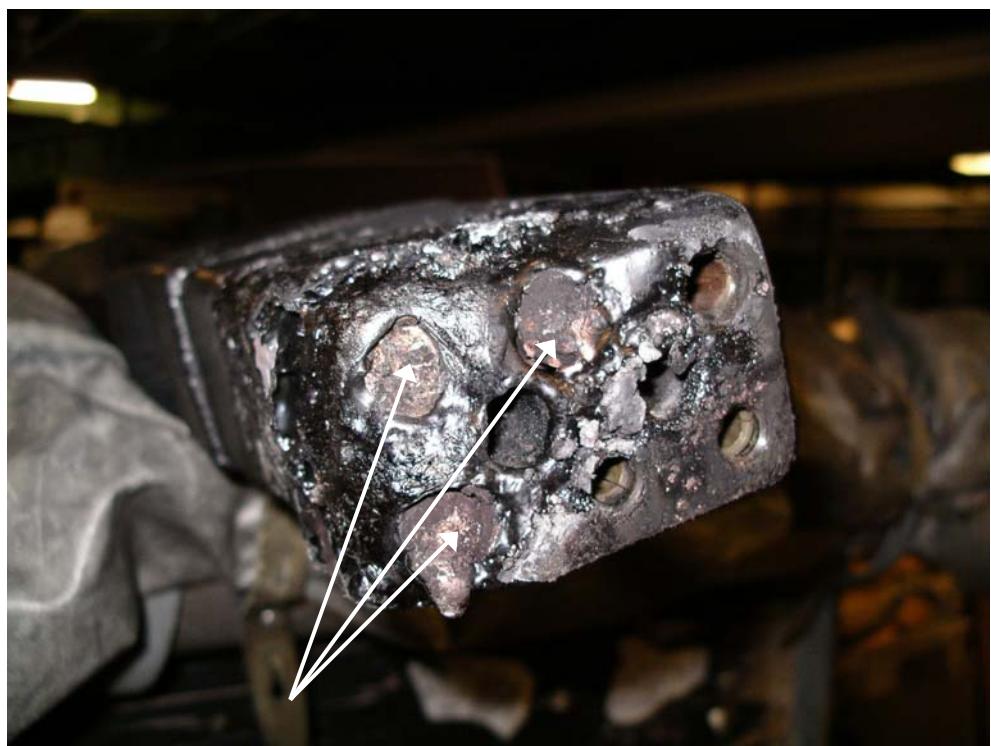
Annex 4: Destroyed dock-side plug

The three molten contact pins of the aircraft-side connector plate

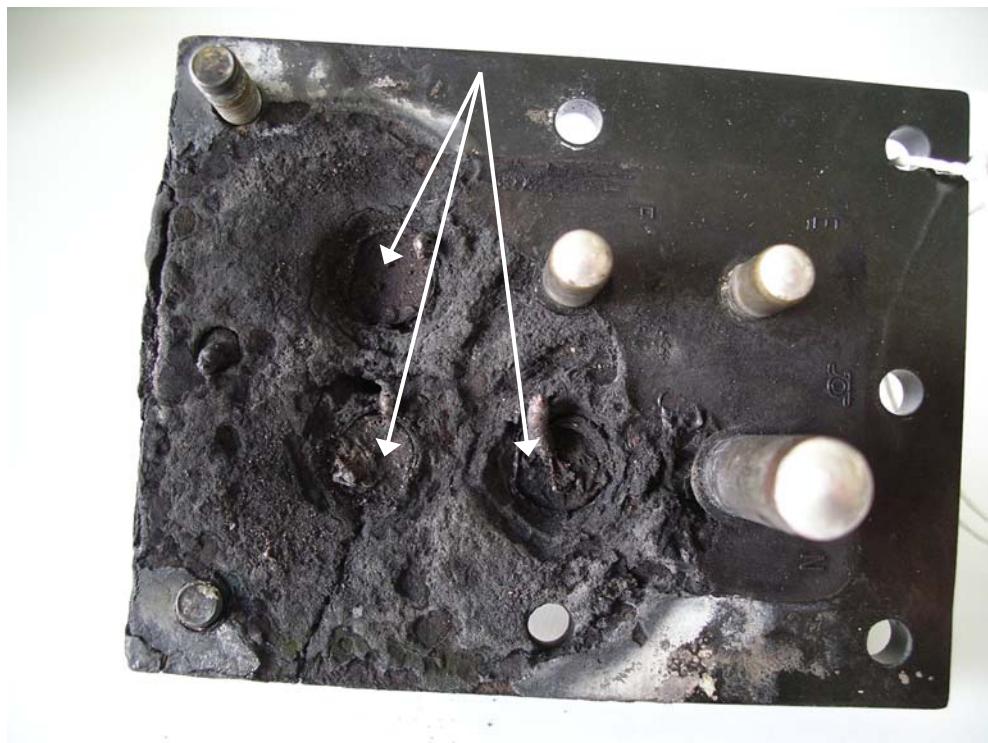
Annex 5: Contact pins on the aircraft-side connector plate

The three phase contact pins have melted away

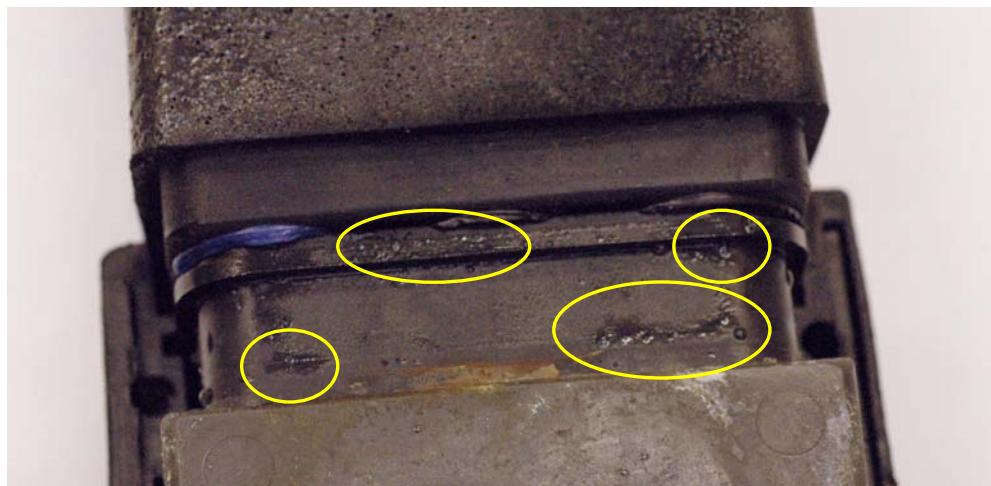
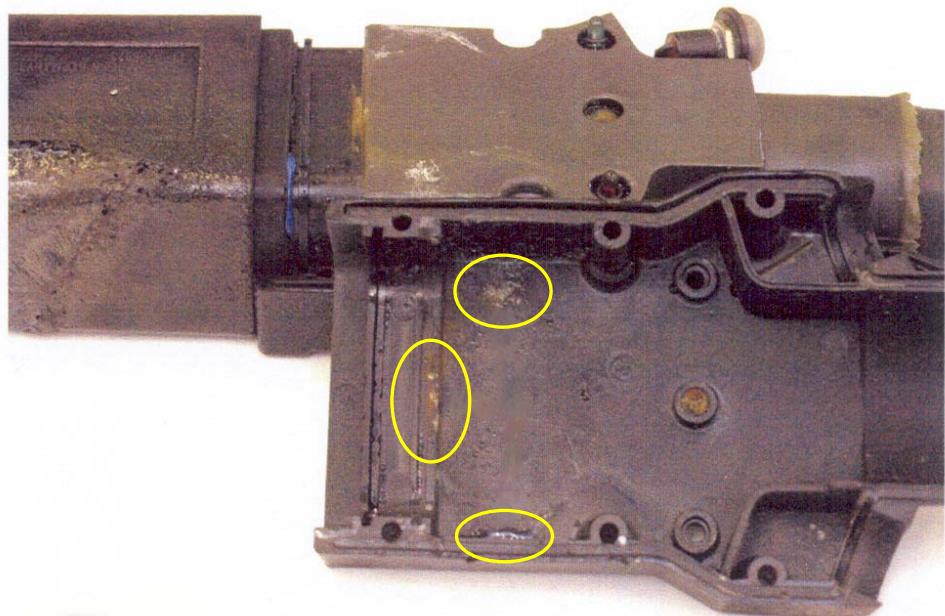
Annex 7: Fluid residues on the dock-side plug

The very badly damaged plug was opened to determine whether de-icing fluid had penetrated it. Fluid residue was found in the jacket and in the plug itself (see Annex 7).

In the scanning electron microscope high levels (>10%) of potassium, carbon, oxygen and silicon were found both in the de-icing fluid and in the fluid residues.

Moreover, considerable levels of copper and zinc were found in the fluid residues.

In the de-icing fluid, as well as in the fluid residues found inside the plug, indications of formates were found as a result of a qualitative chemical analysis. The evaporation residues of both fluids had practically identical elemental compositions.

The fluid residues inside the plug analysed in the course of the investigation exhibited practically identical elemental composition as the de-icing fluid. On the basis of the chemico-physical analysis it can be assumed that the short-circuit was caused by de-icing fluid which had penetrated the plug.

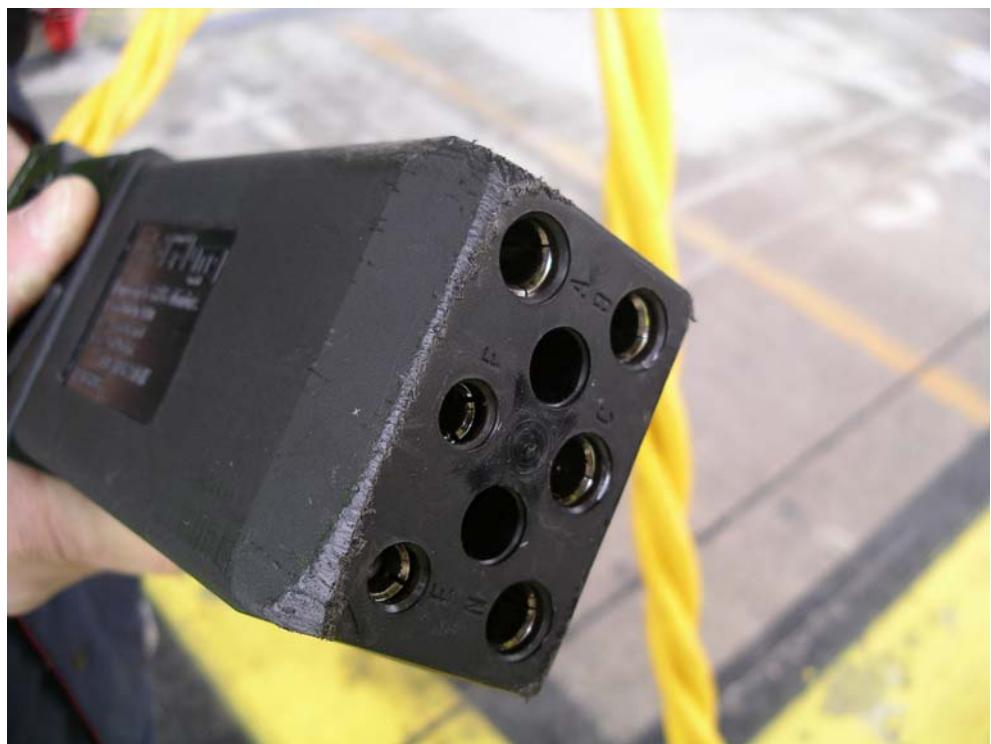
Annex 9: Abrasion marks on the two-day old plug

Two days after the serious incident, the investigation team inspected stand A-57 and observed the cable connection procedure for the external power supply. An aircraft was towed to the stand. The cable was pulled from the dock to the aircraft. In order to open the aircraft-side cover, the worker needed both hands and he therefore placed the cable on the ground. It must be assumed that this procedure was not an isolated case, as the new plug fitted after the incident already exhibited abrasion marks (Annex 9). This allows the conclusion that the cable is not only laid on the ground, but is also dragged around on the ground. If the ground is contaminated, this may cause contamination on the surface of the plug. This creates the conditions which prevailed in the serious incident.
