Statens haverikommission
Swedish Accident Investigation Board

Report RL 2008:06e

**Collision between aircraft B-HIH and a tow
vehicle at Stockholm/Arlanda airport,
AB county, Sweden on 25 June 2007**

Case L-12/07

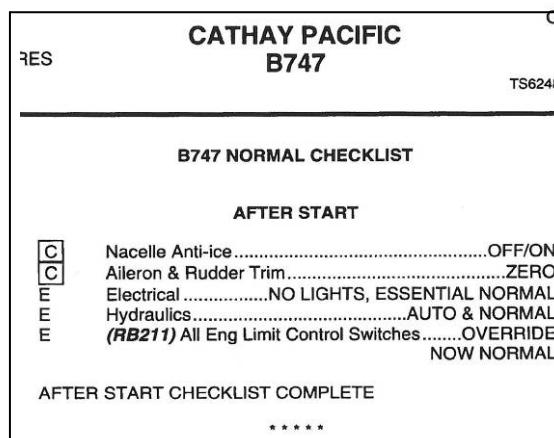
Fig 2. Extract from the normal checklist

The checklist used after engine start (normal checklist), has no item pertaining to the clear signal.

The airline company's normal checklist does not contain any item in respect of checking and verifying that the all clear signal has been received. This must be seen as a deficiency in the operational documentation. The fact that the instructions concerning the all clear signal were only present in the expanded checklist showed that in this particular case there was an inadequate barrier to ensure operational safety in connection with start of taxi.

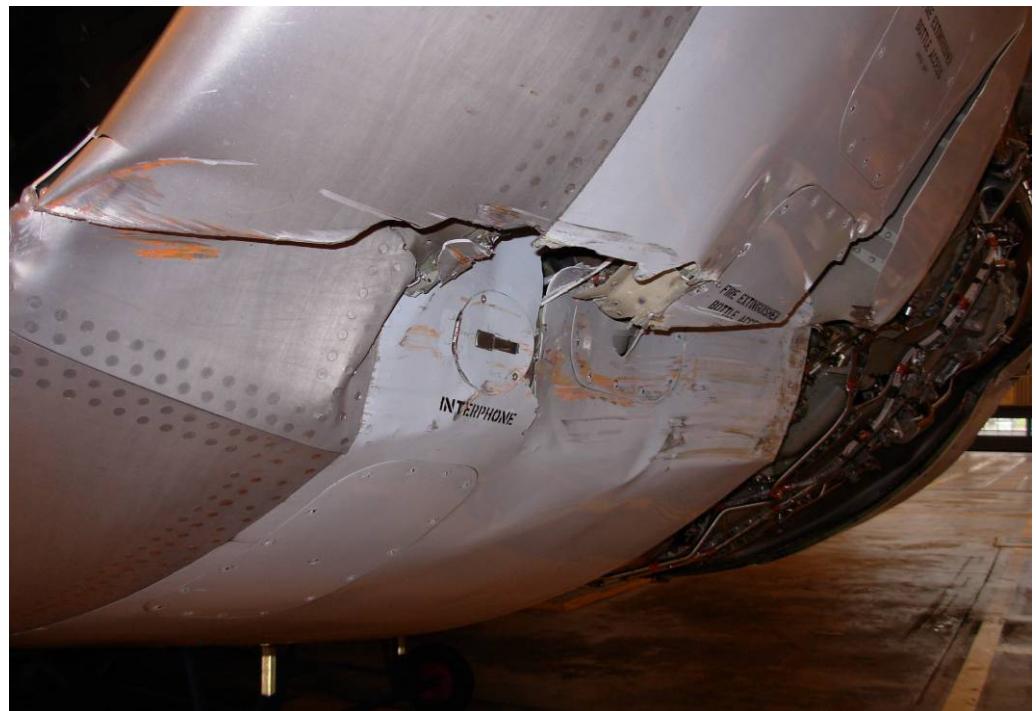
Fig. 9. The damaged engine.

The driver and the technician had to run in order to be safe, and the left inner engine on the aircraft hit the push back vehicle. At the collision the engine was substantially damaged, when the upper corner on the vehicle teared up the cowling and caused damage to engine systems. The aircraft taxied a short distance before the damaged engine stopped. At the time of the accident – which occurred 03:33 in the morning – the pilots had been awake 18-20 hours.

Considerable damage to the left inner engine. The engine cowling and internal systems, including fuel lines, fuel pump and fuel control unit which suffered severe damage.

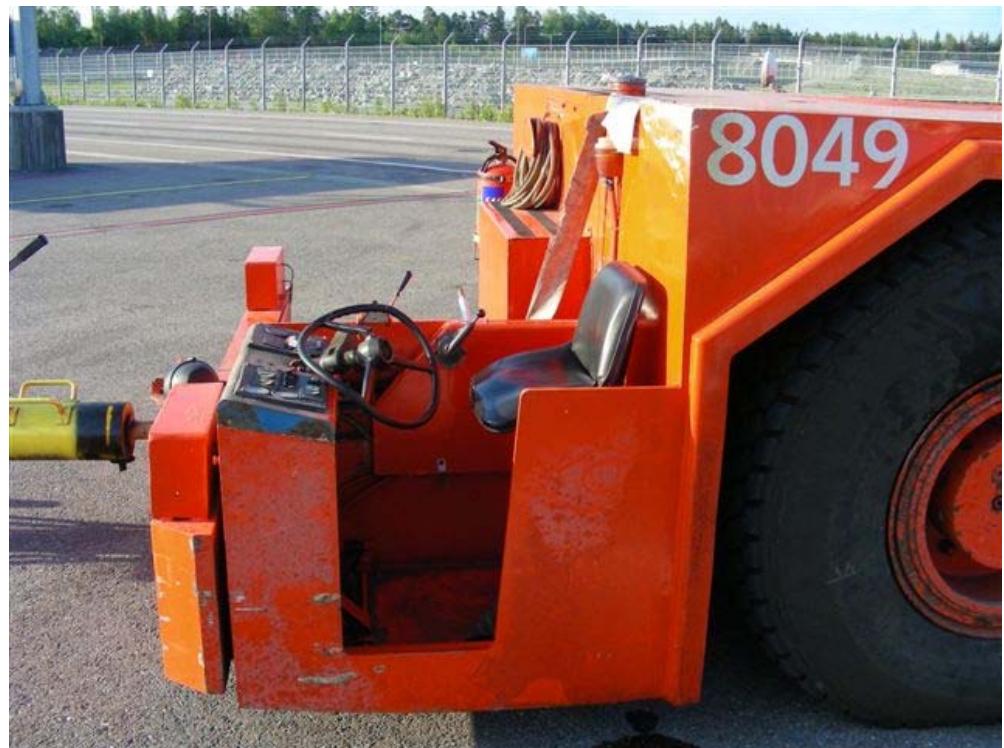
Fig. 10. The damaged tow vehicle

Damage to the pushback tow vehicle. Minor damage to the vehicle's driving position and body.

The vehicle suffered damage at its rear where the outside of the aircraft engine struck it. The steering wheel was deformed and the upper right of the vehicle rear showed traces of the collision in the form of damage to the body, indicating that this corner had penetrated 20-30 centimetres into the aircraft engine nacelle. The lower part of the vehicle mostly showed paint scraping and scratches. The front part of the vehicle showed no visible signs of the collision.

Altogether this means that he had seen the danger and could run to safety. The signs of damage to the tow vehicle show that the aircraft engine struck it at 20-30 cm into the upper front corner and then while turning went away from the vehicle. It is however probable that the still-running engine went past the forward driver's position at a distance of less than one metre, so that there had been an obvious risk of the driver being sucked in if he had not managed to reach safety.

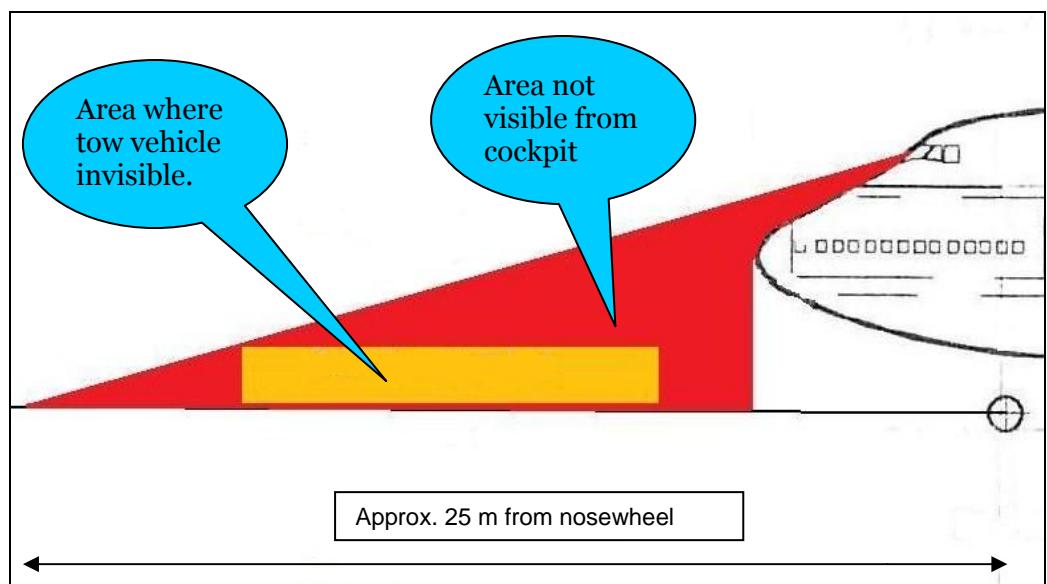
Fig 11. Sketch of the visual field

Figure 11 above shows the area in front of and beneath the nose of the aircraft that was hidden from the pilots. The measured distance on the ground was about 25 metres, using the nose wheel as a datum. With the configuration of the Schopf 356 at the time of the accident, without the driver's cab elevated, the far end of the tow vehicle superstructure would have been visible to the pilots at a distance of about 20 metres from the nose wheel.

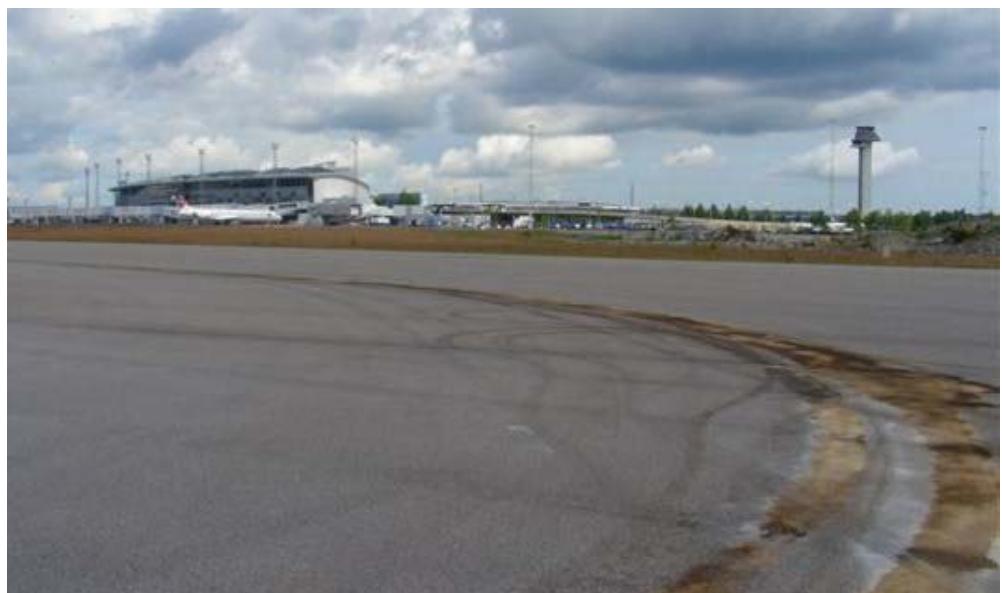
Fig 16. Fuel trail after absorbing agent had been applied.

After the collision a length of about 150 metres of the ramp and the taxiway became contaminated with the jet fuel that leaked out of the damaged engine. It has not been possible to determine the amount of fuel. The total area that was contaminated can, depending on the width of the fuel trail, be estimated as being between 50 m² and 100 m².

The fuel spillage was dealt with by the Swedish Civil Aviation Authority (LFV) field unit. It is not known how much fuel could have soaked into the surface. According to AR-11-2000, item 3.1, cleaning up of aviation fuel, those who caused the spillage must ensure that it is collected and disposed of. In the case of spillage of aviation fuel exceeding 10 m², it must be taken care of by the airport rescue services who must be called to the scene.
