AVIATION INVESTIGATION REPORT
A02O0272

RISK OF COLLISION

NAV CANADA
TORONTO AIRPORT CONTROL TOWER
TORONTO/LESTER B. PEARSON INTERNATIONAL AIRPORT
TORONTO, ONTARIO
25 AUGUST 2002

Report Number A02O0272

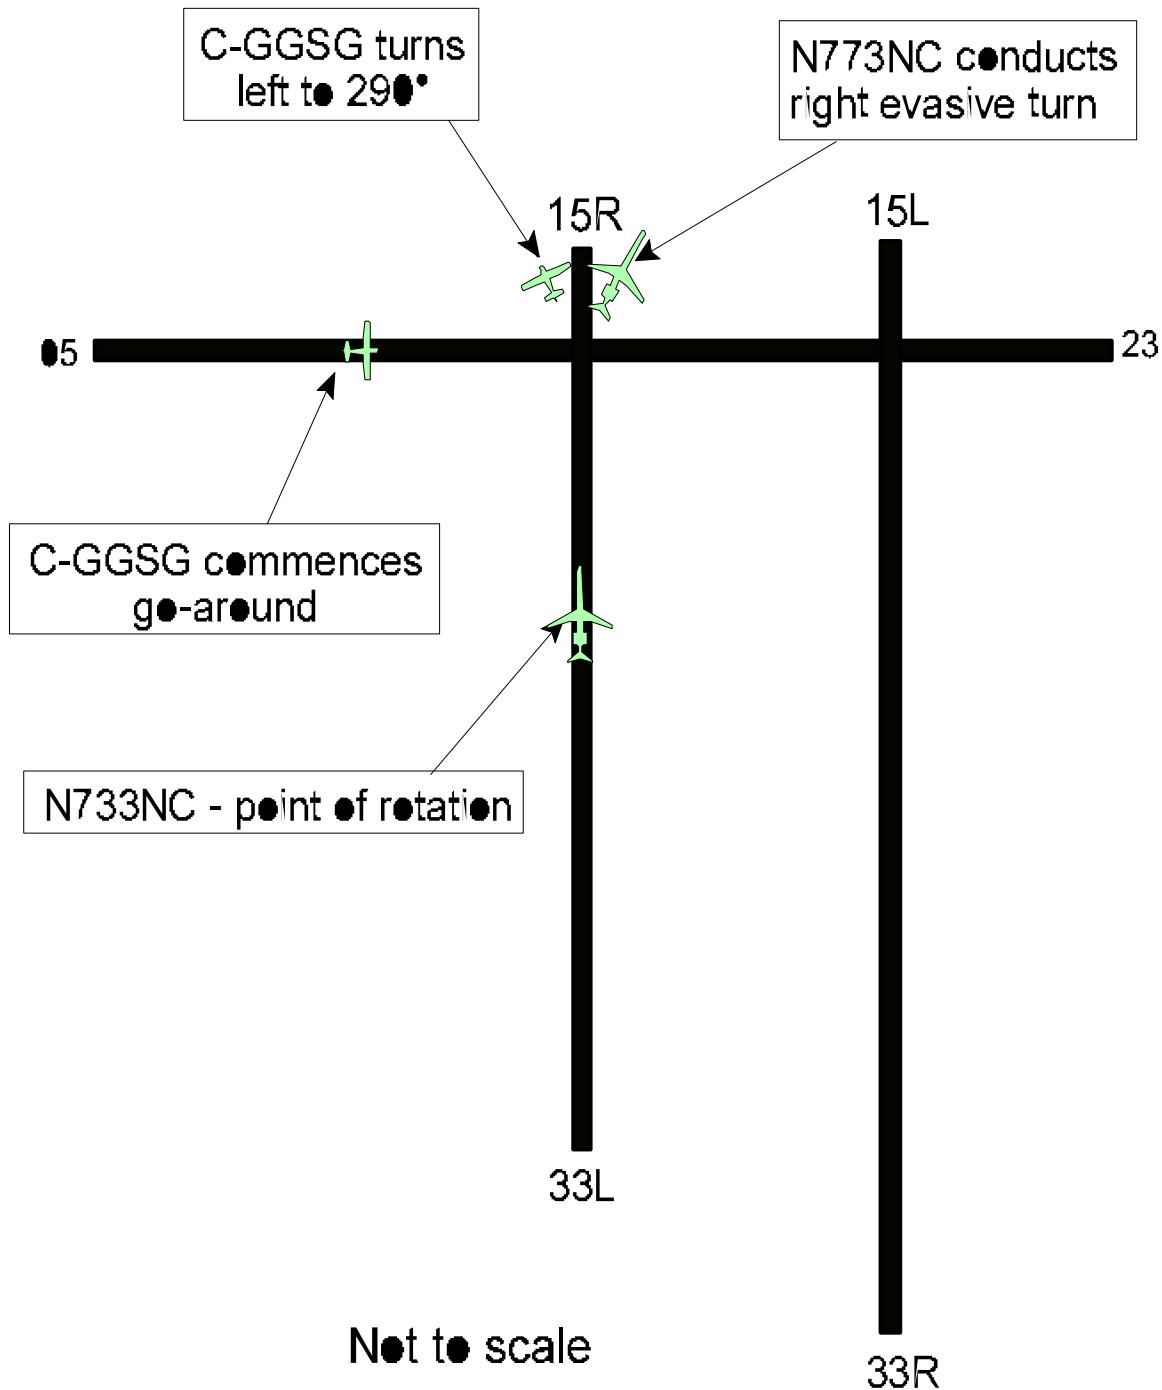
Appendix A - Toronto/LBPIA Site Map and Conflict Depiction

The point of rotation of NWA971 was near taxiway Foxtrot 2, and, as the aircraft commenced its climb, the first officer, the pilot flying, observed the approaching Cessna 206 aircraft. He alerted the captain and took immediate evasive action to the right. A review of the recorded radar data indicated that the spacing between the aircraft was approximately 100 feet laterally and vertically over the threshold of Runway 15R.

1. Because of the backlog of departing traffic and in an effort to expedite departures, the controller chose to use land and hold short operations (LAHSO) instead of sequential runway operations, which ultimately resulted in a near collision.

2. The controller used LAHSO procedures between a departing and arriving aircraft on a runway pair for which this procedure was not authorized.
3. The Cessna pilot had a landing gear problem; however, he did not advise the controller of the problem or of the risk that he may not be able to land on Runway 05 and stop before the intersection of Runway 33L.
