Investigation Report

Type of Occurrence:	Serious incident
Date:	21 August 2008
Location:	Frankfurt/Main
Aircraft:	Transport aircraft
Manufacturer / Model:	Airbus Industry / A340-313
Injuries to Persons:	None
Damage to aircraft:	Minor damage to airplane
Other damage:	Vehicle (passenger bus) damaged
Source of information:	Investigation by BFU
State File Number:	BFU 5X015-08

At 0622¹ hrs, an Airbus A340-313 (A340) collided with a passenger bus on the apron in the area of the crossing of taxiway G and the taxi area road proceeding parallel to taxiway N of Frankfurt/Main Airport (EDDF).

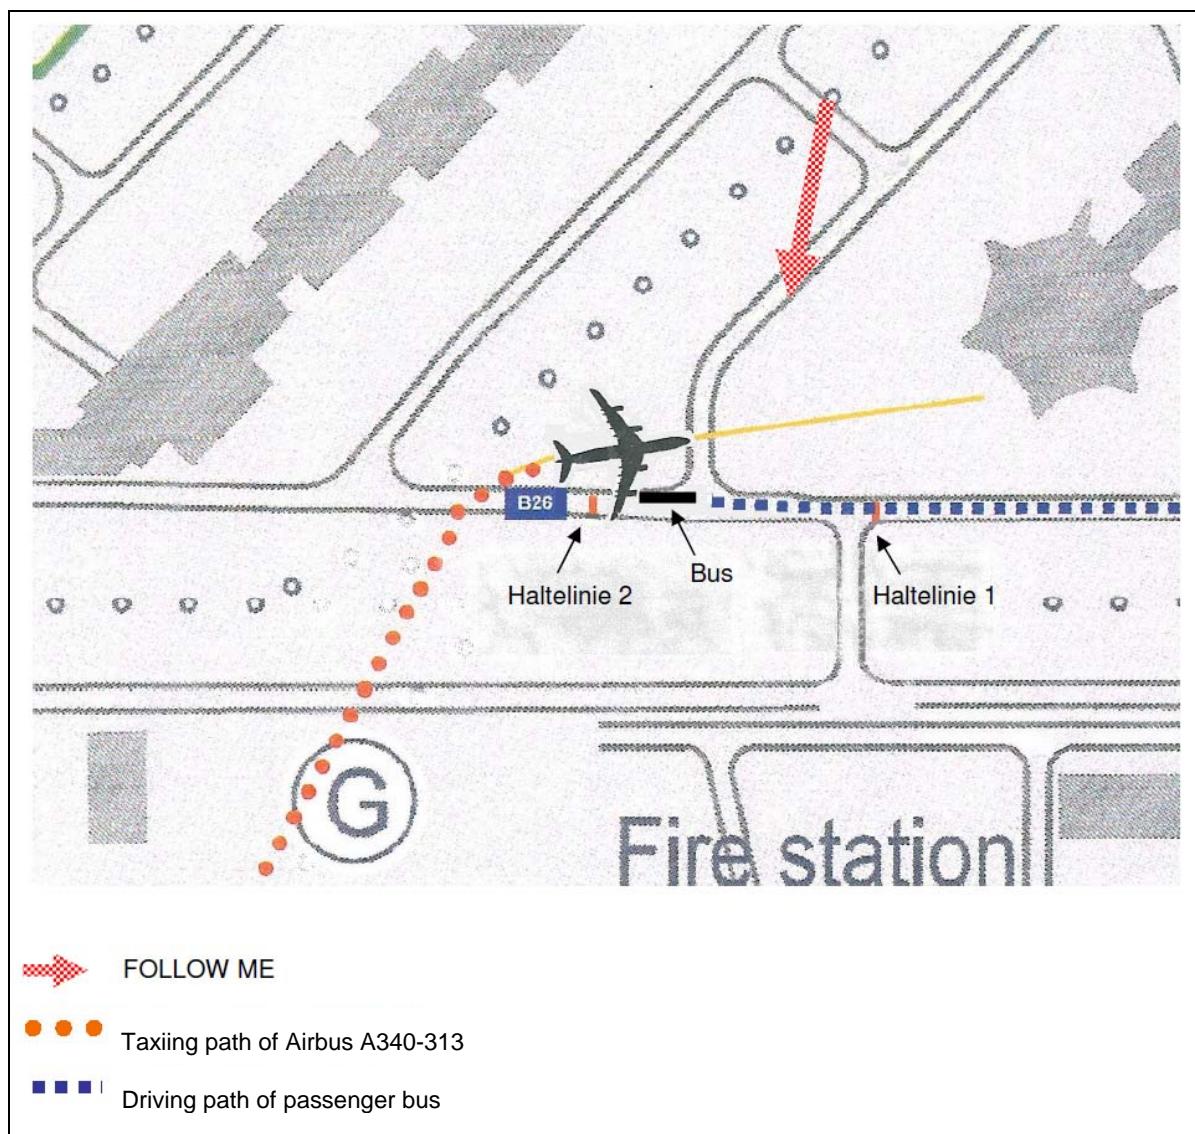
Reconstructed taxiing and driving paths

The investigation revealed that it might be impossible for a vehicle stopped at the first stop line marking on the taxi area road to physically see an aircraft taxiing via taxiway G to parking position B26 due to oncoming traffic. Therefore, the passenger bus driver had no reason, in this case, to stop at the first stop line marking and give the airplane the right of way. After he had noticed the Airbus A340 and brought his vehicle to a stop, the bus already was at a position where the collision was unavoidable.

- The passenger bus coming from the east did not stop at the first stop line on the taxi area road. The passenger bus driver could not see the airplane from this position.

- The passenger bus driver noticed the airplane only after he was already behind the first stop line. After braking, the bus came to a stop approximately 8 m in front of the second stop line.

The operator of the Frankfurt/Main Airport should ensure a spatial separation of the taxiing traffic and the vehicle traffic on the apron in the area of the crossing of taxiway G with the taxi guide line to position B26 by means of infrastructural measures (e. g. change of traffic routing).

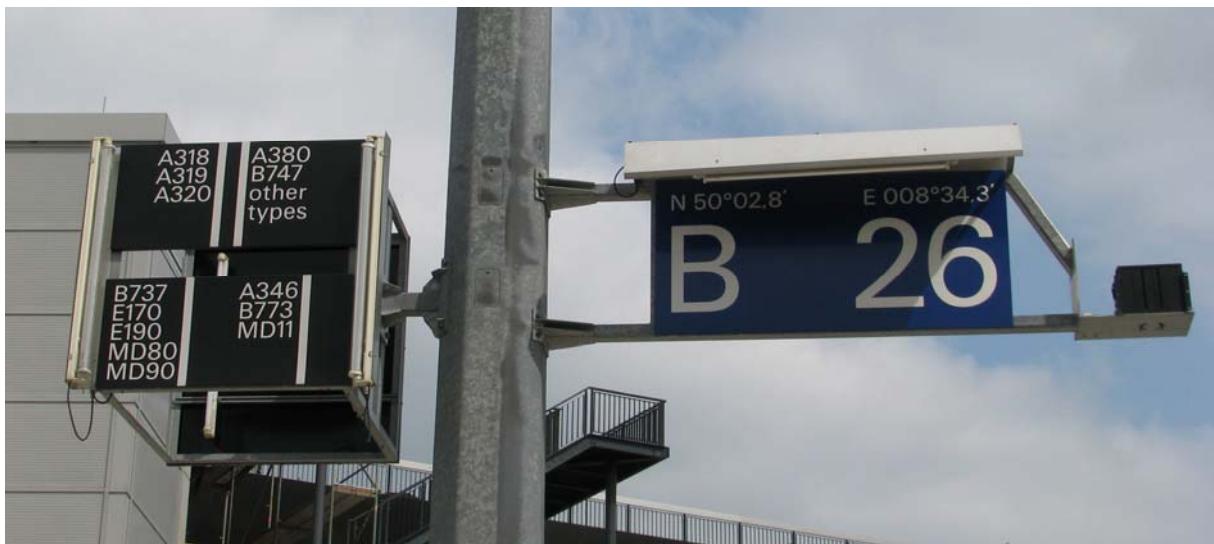
The operating status of the visual guidance system was monitored and documented in the system itself. It showed that the AGNIS/PAPA was not operating at the time of incident.

AGNIS / PAPA at parking position B26

The explanation of the PIC according to which a taxiing clearance towards the parking position was given by apron control as well as by the switched-on AGNIS/PAPA, was incorrect with respect to the system AGNIS/PAPA. It is proven that the system was switched off at that time.

- The visual guidance system AGNIS/PAPA was not activated and did not have any direct influence on the incident.

The operator of the Frankfurt/Main airport should revise the procedure for the assignment of dispatch and parking positions published in the Aeronautical Information Publication (AIP) in chapter AD 2 EDDF 2.20, 3.3. Thereby making it clear that the AGNIS / PAPA system is a visual guidance system for taxiing and parking airplanes, and that its activation does not substitute the taxiing clearance into the parking position.

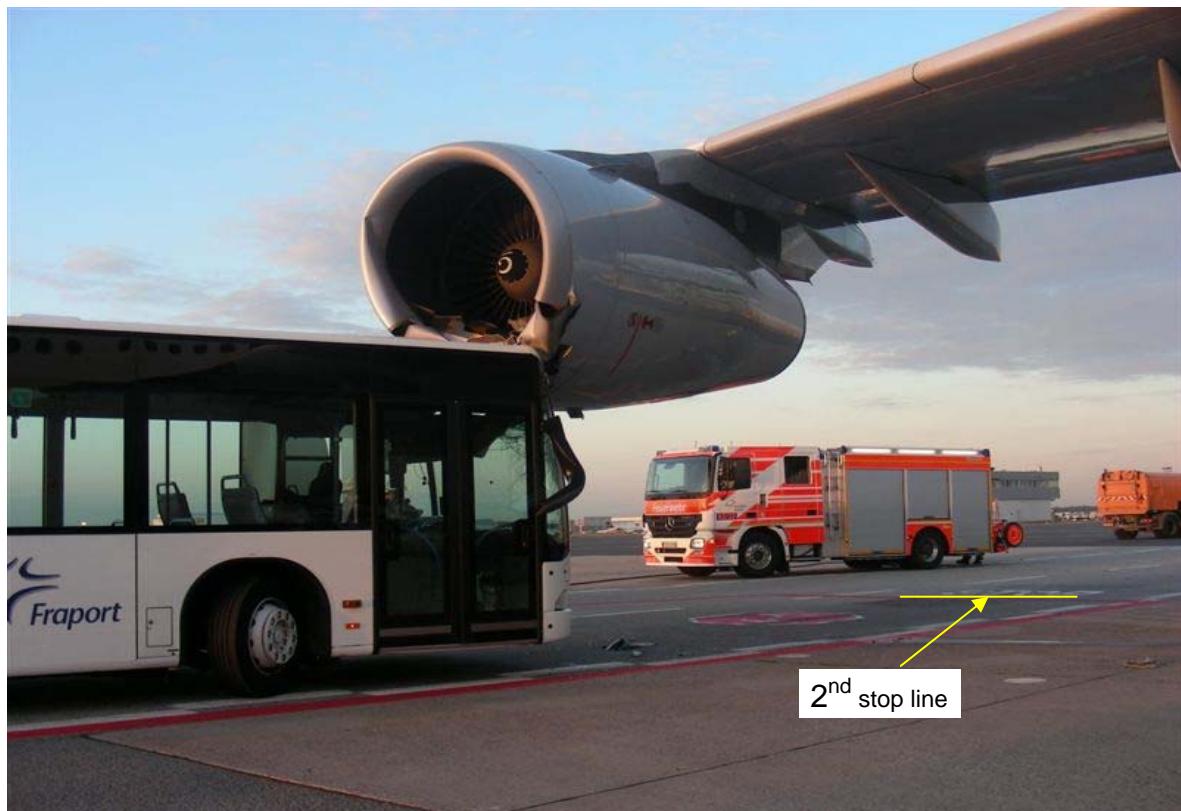
Engine No. 4 of the Airbus A340 rested with the bottom side of the engine cowling on the upper front part of the passenger bus. The airplane was on the yellow guide line for parking position B26, and the passenger bus was on the taxi area road approximately 8 m in front of the second stop line marking for vehicles.

Airplane and passenger bus on the apron

The lower part of the cowling of the airplane's engine No. 4 was compressed; parts of the damaged cowling were found in the engine. The interior of the engine was damaged. It had to be removed for further damage identification and repair.

The passenger bus's upper front carriage was deformed. The rear view mirror and cover panels were torn out of their fixings and damaged.

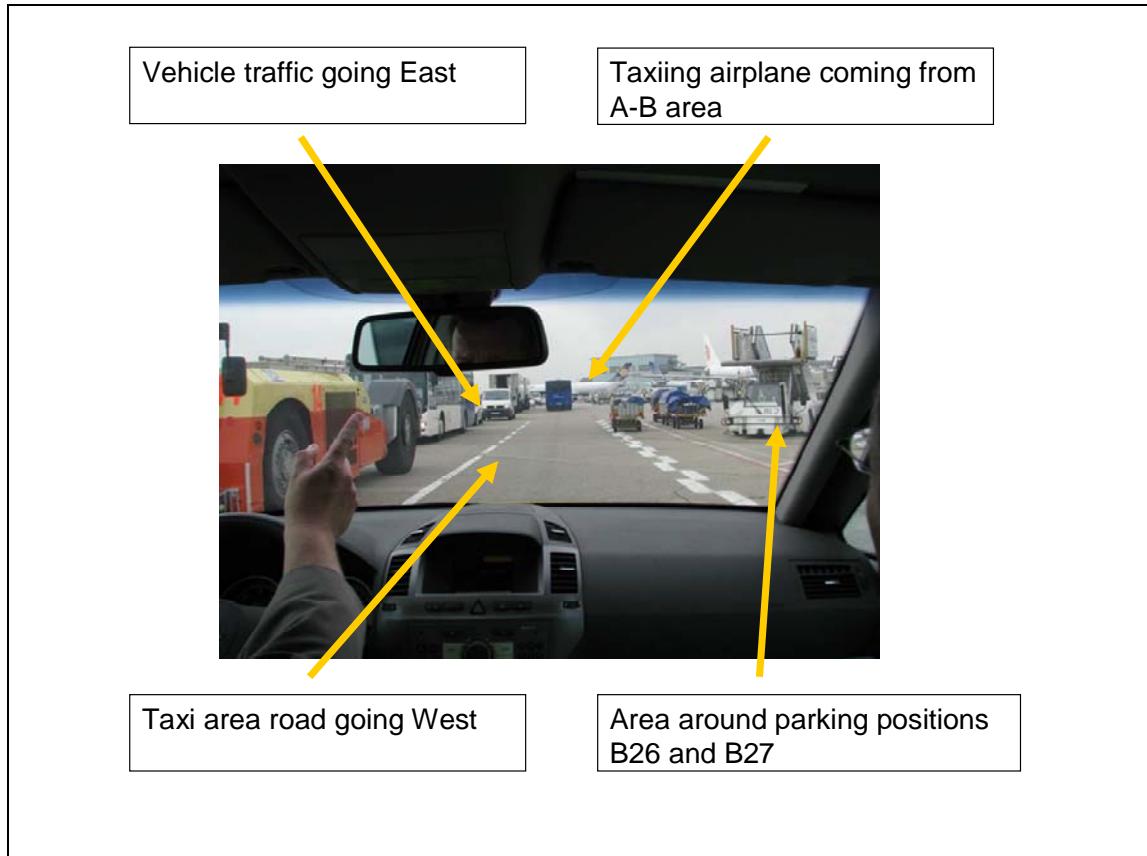
Traffic situation on the taxi area road

The actual traffic density at the time of the incident at the crossing area of taxiway G with the parallel to taxiway N running taxi area road could not be determined by the investigation. From BFU's point of view, the traffic guidance and traffic situation in this apron area was generally complex. The reasons for this were the different traffic flows of vehicles and taxiing airplanes. Almost the entire apron vehicle traffic between the airport's east and west side and vice versa passed through this taxi area road. The taxi area road running from east to west was crossed by taxiing aircraft coming and going to and from Gate B or docking in one of the gates in the A-B area. Ground operations vehicles necessary for the dispatch of aircraft added to the congestion. When considering the traffic density in this area it becomes a general rule that the traffic density increases the more aircraft dock on and the bigger aircraft and gates become.

In the scope of the investigation an on-site inspection revealed that the traffic situation caused by taxiing aircraft and vehicles becomes confusing especially during peak periods.
