Investigation Report

Type of Occurrence:	Serious incident
Date:	4 October 2007
Location:	Kassel
Aircraft:	Civil Air Transport
Manufacturer / Model:	Kyiv State Aviation Plant / Antonov An-26B
Injuries to Persons:	None
Damage:	None
Other damage:	Runway threshold lights
Source of Information:	Investigation by BFU
File Reference Number:	BFU EX011-07

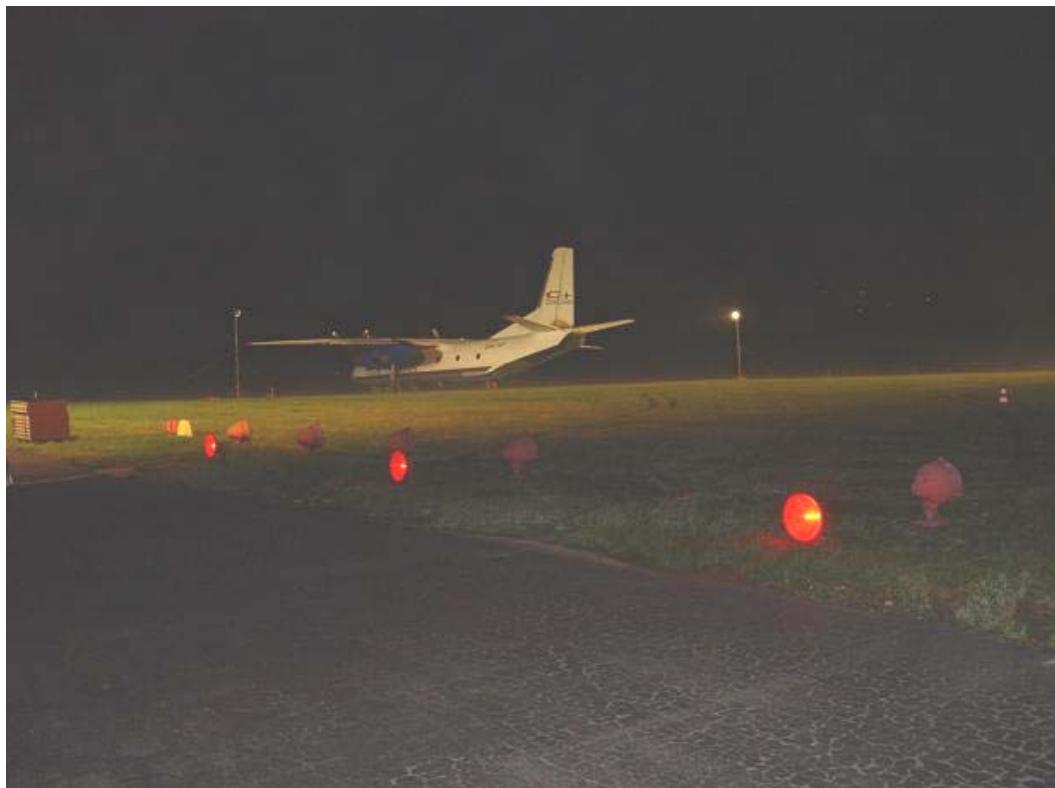
The aircraft overran Runway 22 by about 42 m and came to a halt 47 m south of the runway centreline. The fuselage nose pointed in the direction of about 120°. The air-

craft had sunk up to the wheel rims in soft grass soil. No damage was found to the aircraft.

View of the aircraft in its final position
