Investigation Report

EX005-0/05
July 2010

Type of Occurrence: Serious Incident
Date: 18 July 2005
Location: Nuremberg
Aircraft: Civil Air Transport
Manufacturer / Model: Embraer / EMB 145
Injuries to Persons: None
Damage: Slight Damage to Aircraft
Other Damage: None
Source of Information: Investigation by BFU

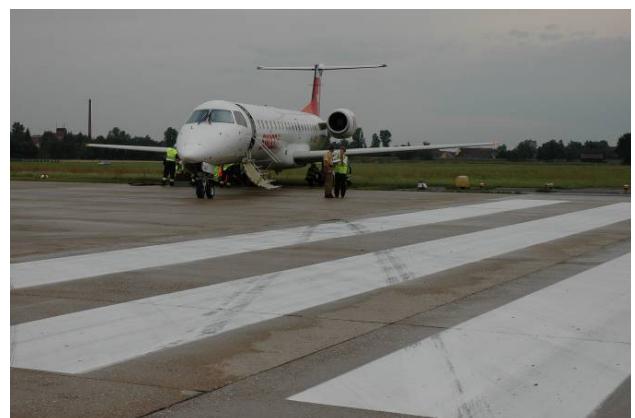
The crew reported that braking action failed to bring the aircraft to a stop before the end of the runway. The pilot-in-command was at the controls and steered the aircraft at high speed left into runway exit F, which is at 90° to runway 28. The aircraft ground looped about 200° to the left, leaving the runway tail first and coming to rest with the main landing gear units on the grass.

Aircraft position after the occurrence

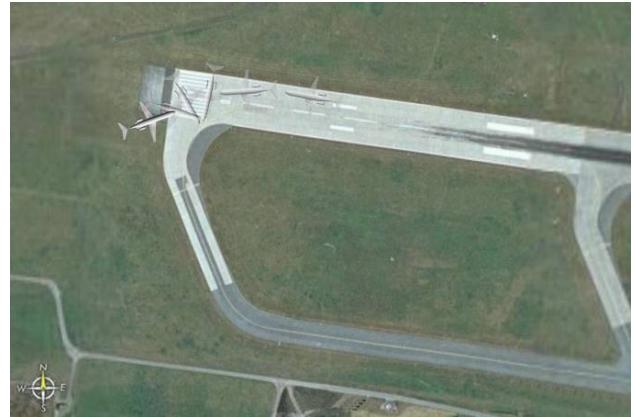
Aircraft position on coming to rest

The aircraft came to rest at the end of the runway about 30 metres south of the runway centreline with the main landing gear on the grass. The aircraft nose was pointed east, opposite to the direction of landing. The landing gear tyres were damaged. Light-coloured brake marks – which looked as if they had been formed by steam cleaning – from the main landing gear were found on the runway. In addition, a large quantity of flaked foam rubber was found on the runway.

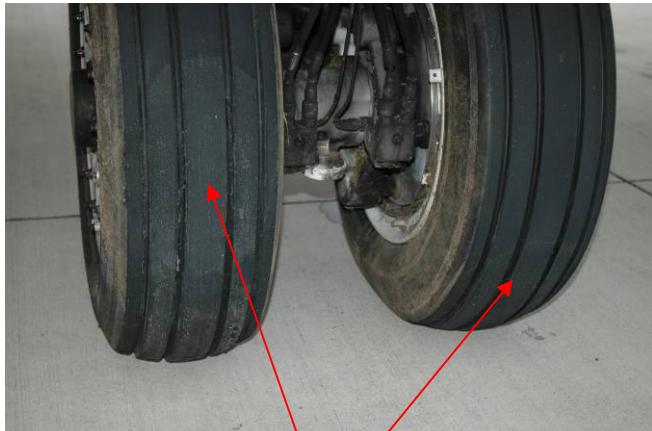
Both, the marks on the runway and the molten tyre rubber on all four wheels of the main landing gear were indicative of a rare type of aquaplaning known as Rubber Reversion Hydroplaning.

Traces of aquaplaning on the tyres

This type of aquaplaning can already happen on moist runways. If the wheel rotation should become blocked, the combination of frictional heat and moisture on the runway result in the formation of a steam cushion between the tyre and the runway surface supporting the aircraft. This can occur at speeds below the otherwise usual aquaplaning speeds.

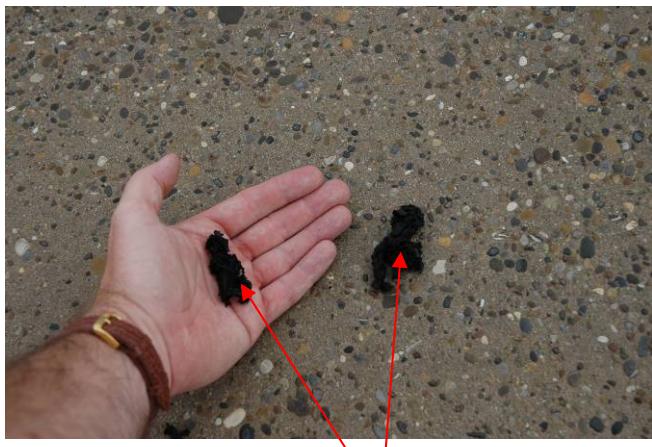
Molten rubber flakes

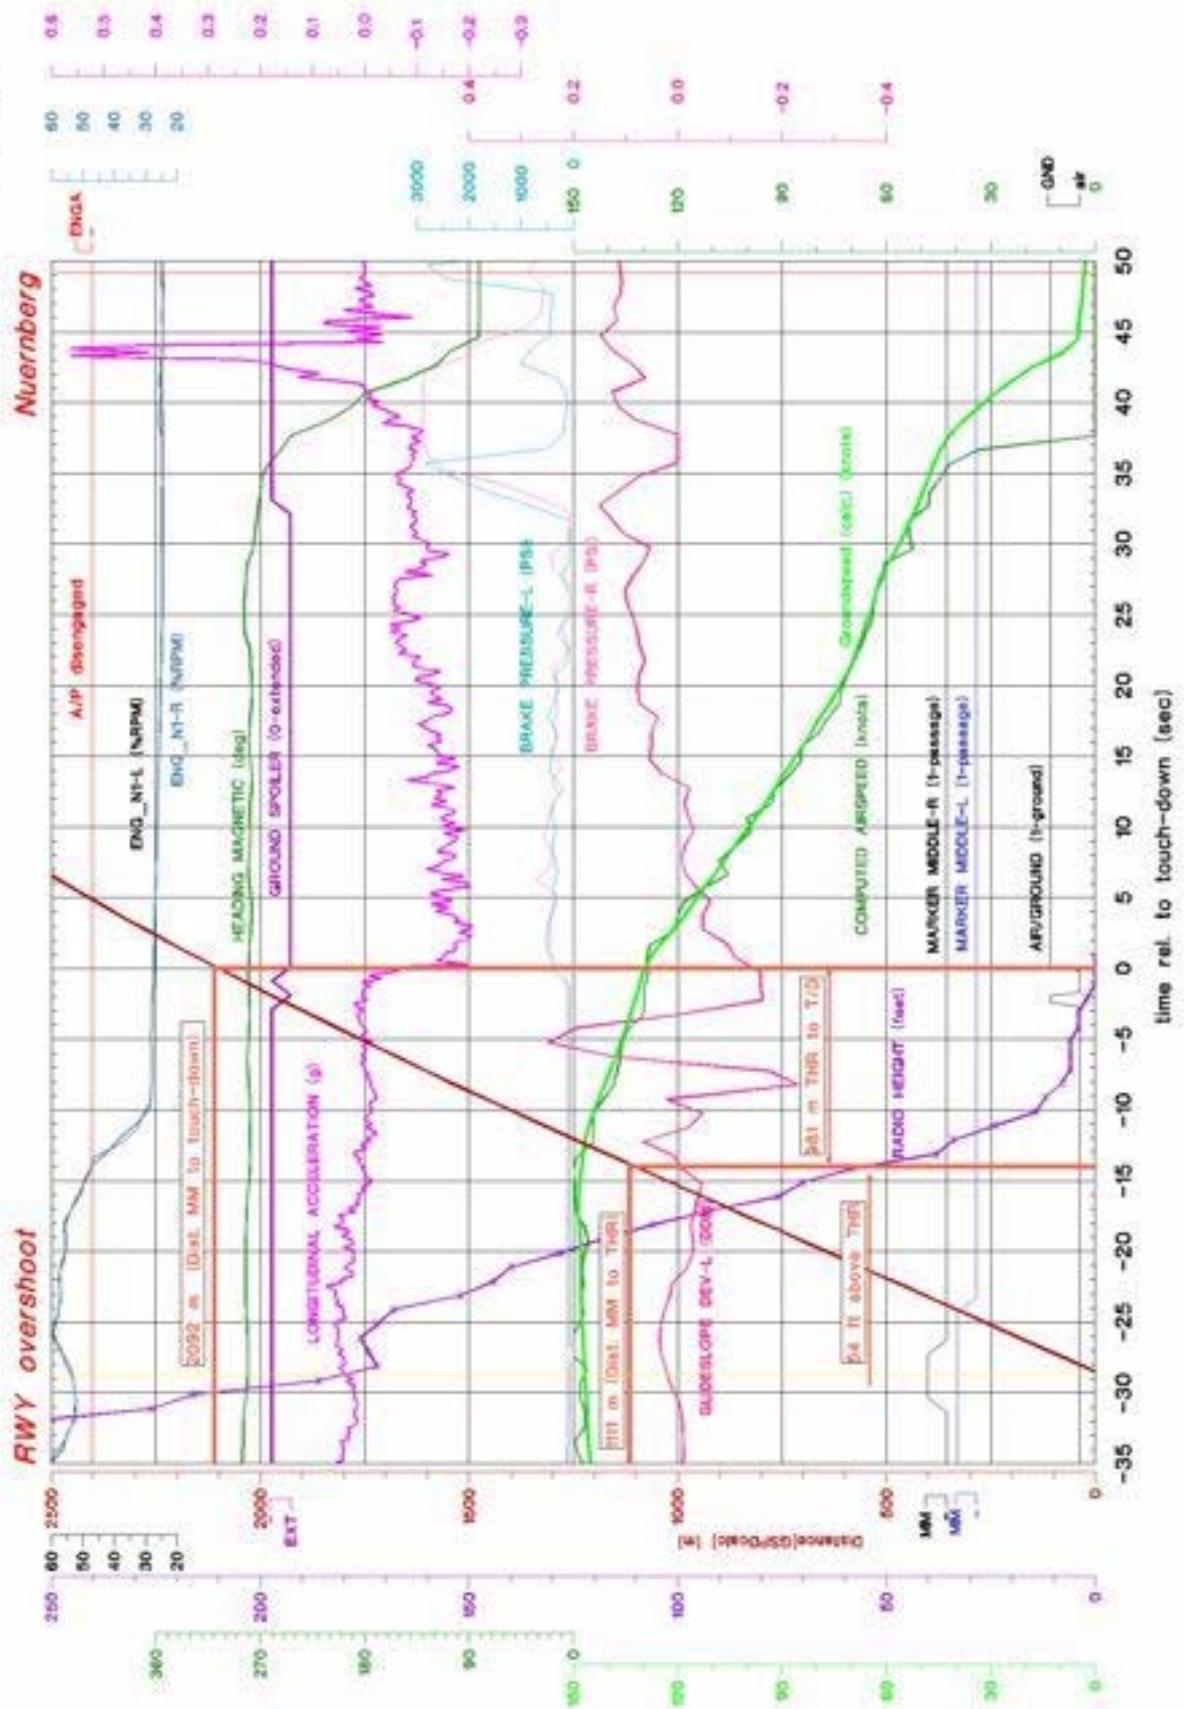
Appendix 2

- During the subsequent 22 seconds, the brake pressure in the left and right main landing gear increased by 400 to 500 PSI; the braking action was about -0.14 g (1.37 m/s^2), after which reducing to -0.07 g (0.67 m/s^2); the brake pressure fluctuated between zero and 250 PSI.

- 35 seconds after touchdown the brake pressure in the left landing gear increased briefly to 3,000 PSI, while the pressure in the right landing gear remained constant at 3,000 PSI for 7 seconds. The braking action remained at -0.07 g .

- 32 seconds after touchdown and at a speed of 52 kt, the aircraft commenced a 200° ground loop to the left, starting on a heading of 280° and finishing at 080° . At the same time, the ground spoilers retracted.

22 seconds after the landing, braking action was halved to -0.07 g; in all probability, this was the moment at which aquaplaning set in.

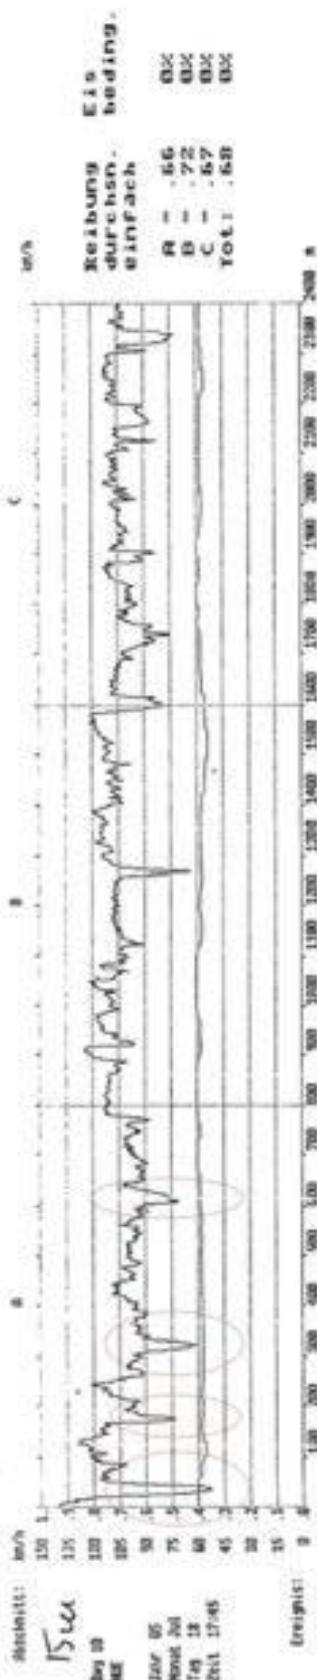
Braking Action Graph

Section A of the trace – the last one third of the runway – reveals several sudden drops in friction values. These might be the result of smooth areas on the runway. (Appendix 4).

Reduced Braking Action in Sector "A"
