## FINAL REPORT

**AAIU Synoptic Report No: 2010-012**

<b>Aircraft Type and Registration:</b>	Gulfstream IV (GIV) SP, VT-MST	
<b>No. and Type of Engines:</b>	2 x Rolls Royce Tay 611-8	
<b>Aircraft Serial Number:</b>	1379	
<b>Year of Manufacture:</b>	1999	
<b>Date and Time (UTC<sup>1</sup>):</b>	13 July 2009 @ 08.13 hrs	
<b>Location:</b>	Near Killarney, Co. Kerry, Ireland	
<b>Type of Flight:</b>	Private	
<b>Persons on Board:</b>	Crew - 2	Passengers - 1
<b>Injuries:</b>	Crew - Nil	Passengers - Nil
<b>Nature of Damage:</b>	Substantial damage to No. 1 engine Windshield fractured	
<b>Commander's Licence:</b>	Airline Transport Pilot Licence issued by the U.S. Federal Aviation Administration (FAA)	
<b>Commander's Details:</b>	Male, aged 45 years	
<b>Commander's Flying Experience:</b>	12,500 hours, of which 1,027 were on type	
<b>Notification Source:</b>	Shannon Air Traffic Services (ATS) and Kerry Airport ATS	
<b>Information Source:</b>	AAIU Field Investigation

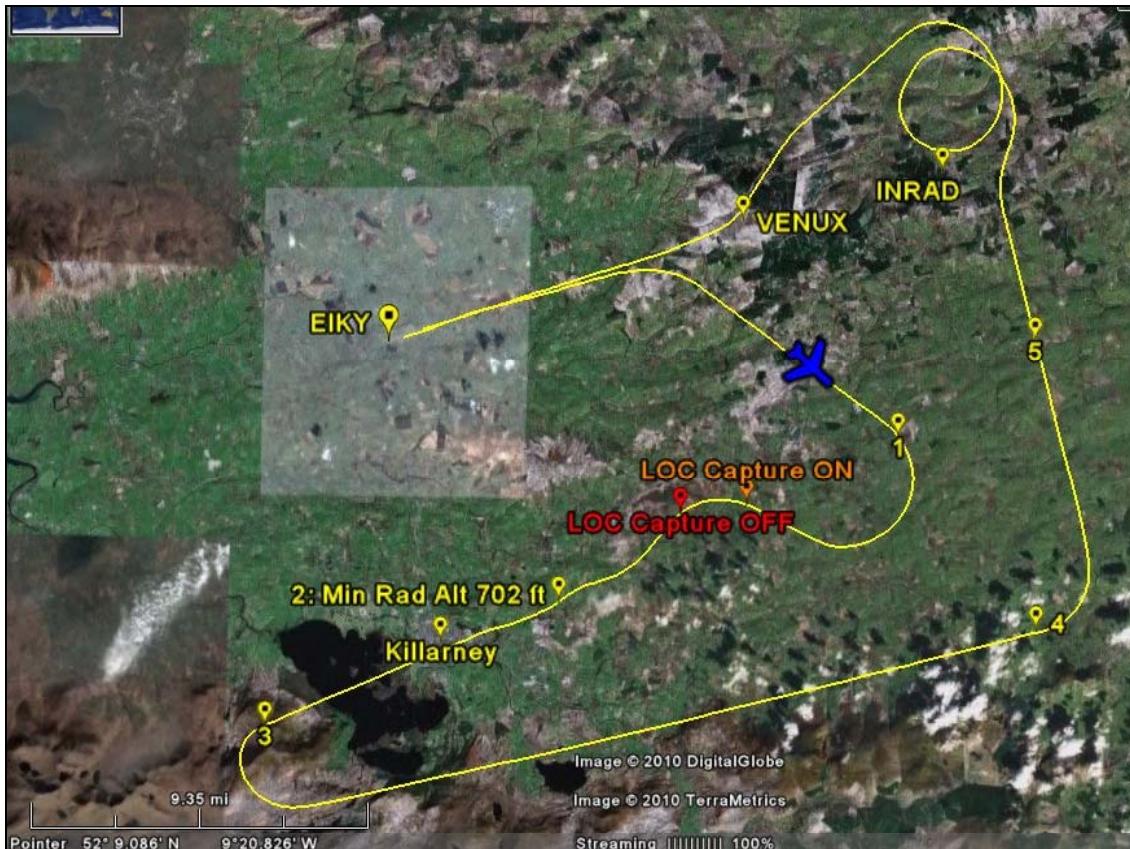
**Figure No. 1:** Flight Path of VT-MST

The aircraft, which had initially been following the CRK 1C departure procedure, levelled off at 3,000 ft and then commenced a 180° turn to the right at 08.09:20 hrs, (Point 1 on **Figure No. 1**). It rolled out onto an inbound heading towards EIKY.

Subsequently, at 08.15:45 hrs, (Point 3 on **Figure No. 1**) Shannon ATC vectored the aircraft initially on a heading of 090°M and at 08.21:34 hrs, (Point 4 on **Figure No. 1**) onto a heading of 350°M towards the localiser for RWY 26 at EIKY. At 08.23:42 hrs, (Point 5 on **Figure No. 1**), VT-MST confirmed that the aircraft was 4.7 nm from reporting point VENUX<sup>8</sup>. Shannon cleared VT-MST to turn left and route direct to VENUX to establish on the localiser RWY 26 at EIKY and, when ready, to descend to 3,300 ft. VT-MST acknowledged this instruction and stated that they would report when established on the localiser.

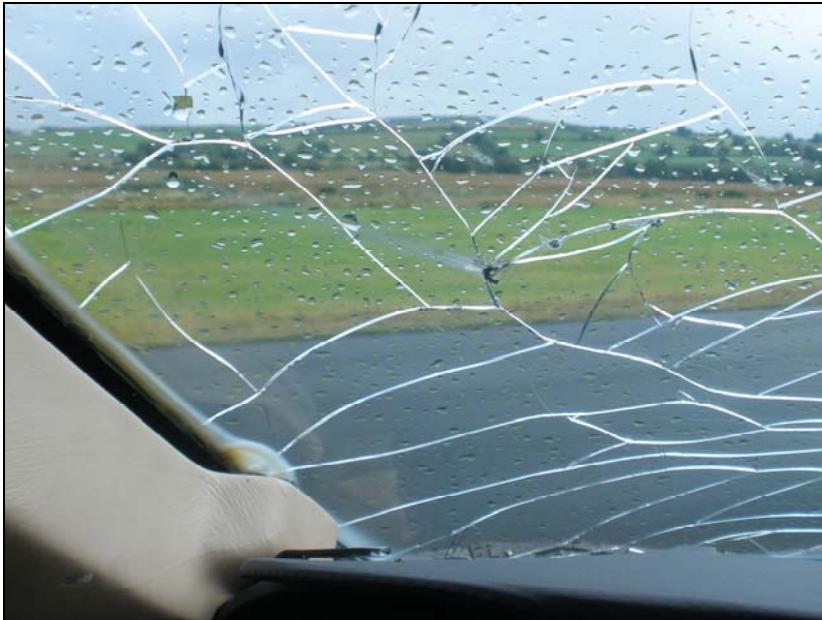
Initial inspection of the damaged windshield at EIKY suggested that the fractures were initiated by an electrical fault, (**Photo No. 1**). Since the Captain was of the opinion that an object had struck the aircraft shortly after rotation, the Investigation decided to return the windshield to its manufacturers in the United States for failure analysis under the supervision of the U.S. National Transportation Safety Board (NTSB).

**Photo No. 1:** Damage to Windshield  
(Note: The lines are cracks and the dots are raindrops)

The windshield manufacturers confirmed that the outboard glass ply failed due to electrical arcing at the interface between the inner edge of the bottom bus-bar and the conductive anti-ice heating film. The electrical arcing resulted when moisture ingress was absorbed by the interlayer and caused degradation of the bus-bar at the bottom forward corner of the windshield. The degradation of the bottom bus-bar created a potential for electrical arcing. The electrical arcing generated an excessive amount of heat that caused damage to the inner laminated surface of the outboard glass ply. The damage penetrated the surface compression and entered the centre tension layer of the chemically strengthened glass, causing spontaneous fracture.

There was evidence of degradation of the outer moisture seal due to wind and rain erosion. Cracking of the seal was observed indicating cyclic wear. There was no evidence of repair or attempted repair of the seal. There was evidence of moisture ingress and interlayer degradation around the periphery of the windshield, particularly at wire routing locations.

18. The windshield failure after take-off was caused by electrical arcing. The arcing resulted when moisture ingress was absorbed by an interlayer and caused degradation of the bus-bar at the bottom forward corner of the windshield.

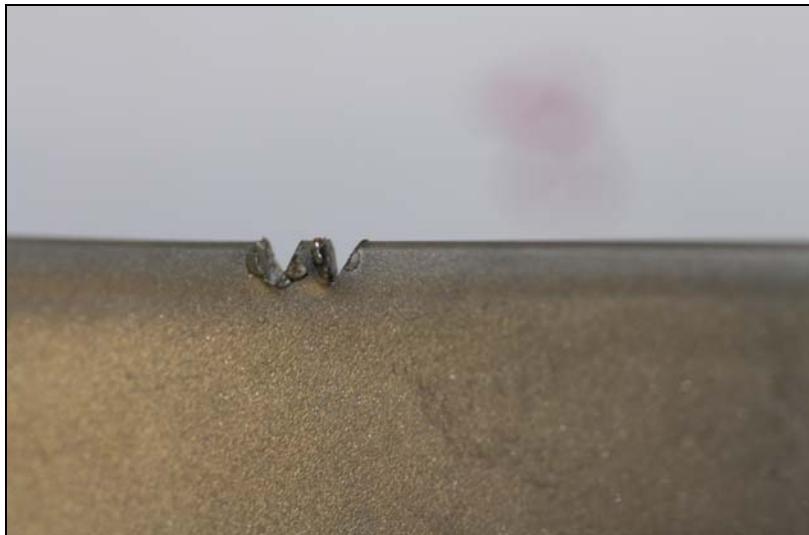
the fan blades had sustained V-shaped notch-like damage, between 1 and 4 mm wide on their leading edges. See **Photo No. 2**.

**Photo No. 2:** Typical Fan Blade Damage (VT-MST)

It was clear from inspection that the engine had sustained significant damage and that the aircraft required an engine change at EIKY. This was carried out over the period following the occurrence. The Operator decided to return the damaged engine to the engine manufacturer for repair and it was duly shipped to a facility in Scotland. The Investigation requested assistance from the engine manufacturer's incident investigation section and this was readily provided.

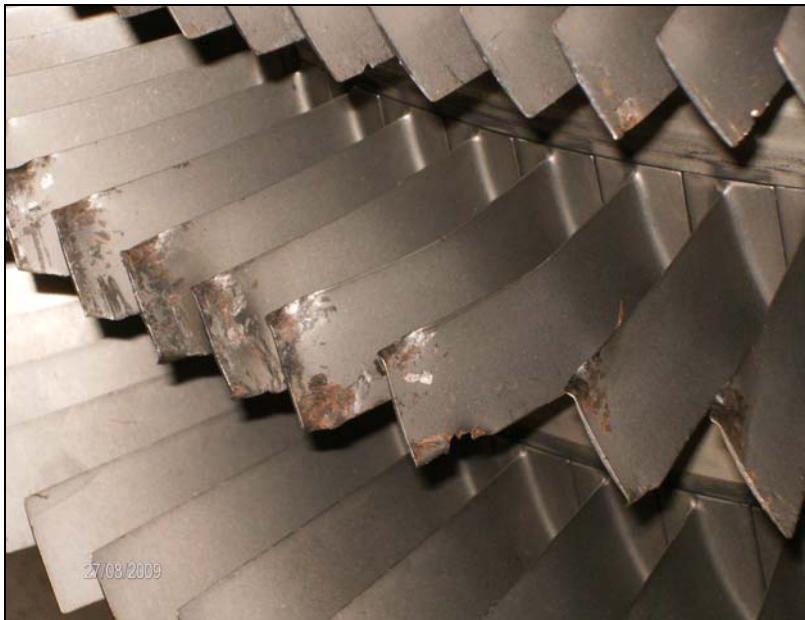
Significant hard body impact damage was sustained by the 1<sup>st</sup>, 2<sup>nd</sup> and 3<sup>rd</sup> stage rotor blades of the LP compressor, **Photo No. 3**. There was an arc of approximately six 2<sup>nd</sup> stage blades that had been significantly bent in a direction opposite to rotation, indicating that the engine spool speed was relatively high and that the impacting body was of significant mass. The 1<sup>st</sup> and 2<sup>nd</sup> stage stator vanes had also sustained significant damage. Three adjacent 1<sup>st</sup> stage stator vanes had sustained rounded impact damage.

**Photo No. 3:** Damage to LP Compressor

There was evidence of clashing between the 2<sup>nd</sup> stage rotor blade leading edges and the trailing edges of two 1<sup>st</sup> stage stator vanes, this being indicative of a surge event.

Considering the damage which was found on the No. 1 engine fan blades, the LP compressor and the HP compressor, there can be no doubt that the engine ingested a hard-bodied object. Laboratory analysis of the impact sites revealed consistent traces of debris similar to low carbon steel (typical of mild steel). Impact marks suggest that the object may have been of round shape with a diameter of 25 mm.

In summary, it is likely that the No. 1 engine of VT-MST ingested a foreign object constituted of mild steel at some point, possibly after the aircraft landed from the flight. The FOD caused significant damage to the engine compressor, which was exacerbated by extensive and inappropriate post-flight engine runs.

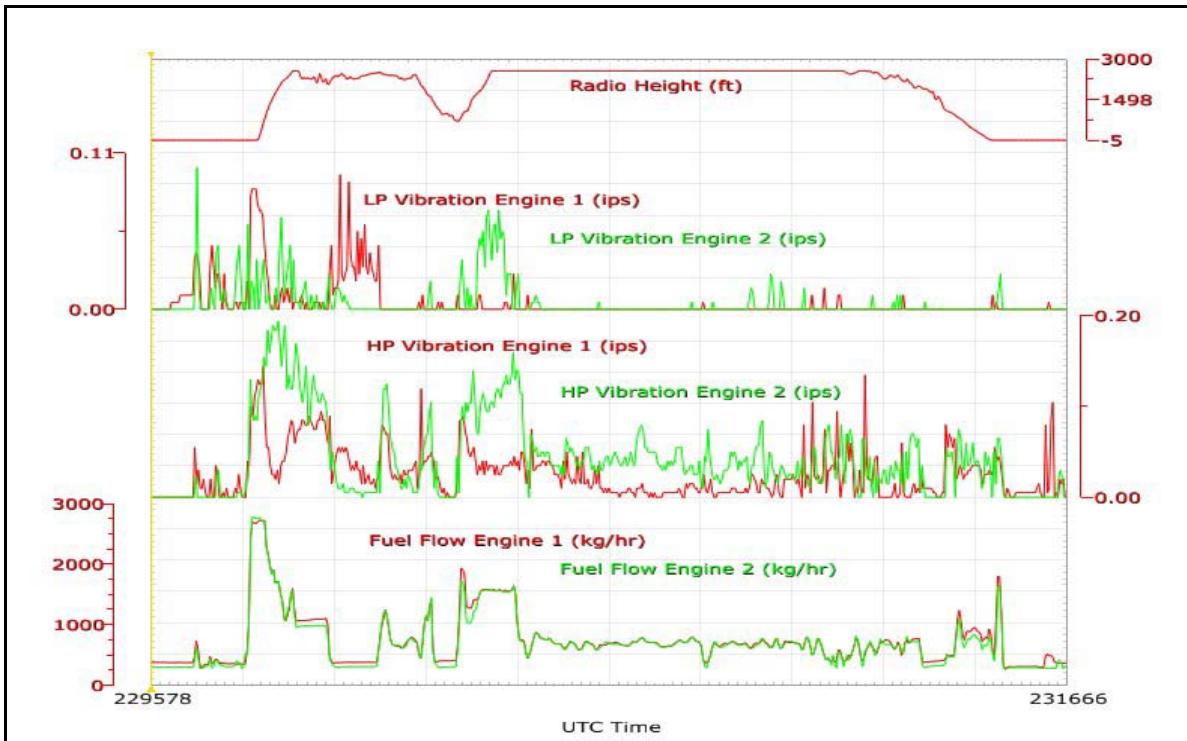
**Figure No. 2:** DFDR Selected Data During Flight

The DFDR data contains no evidence that there was a significant high vibration event on either the LP or HP turbine of the damaged No. 1 engine during the initial climb-out or during the occurrence flight. Also, the DFDR data does not show any evidence of retardation

In **Figure No. 2**, the upper trace shows the radio height profile of VT-MST during the flight. The initial climb of the aircraft is shown on the left hand side of the upper trace, while the V-shaped notch is the unscheduled descent. The final descent to land is shown on the right hand side of the trace. This trace may be used as a timeframe for the engine parameters shown in the lower traces.

DFDR data indicates that the engine operated in a normal manner throughout the flight. There is no evidence of a significant event that might indicate that engine damage occurred during the flight.

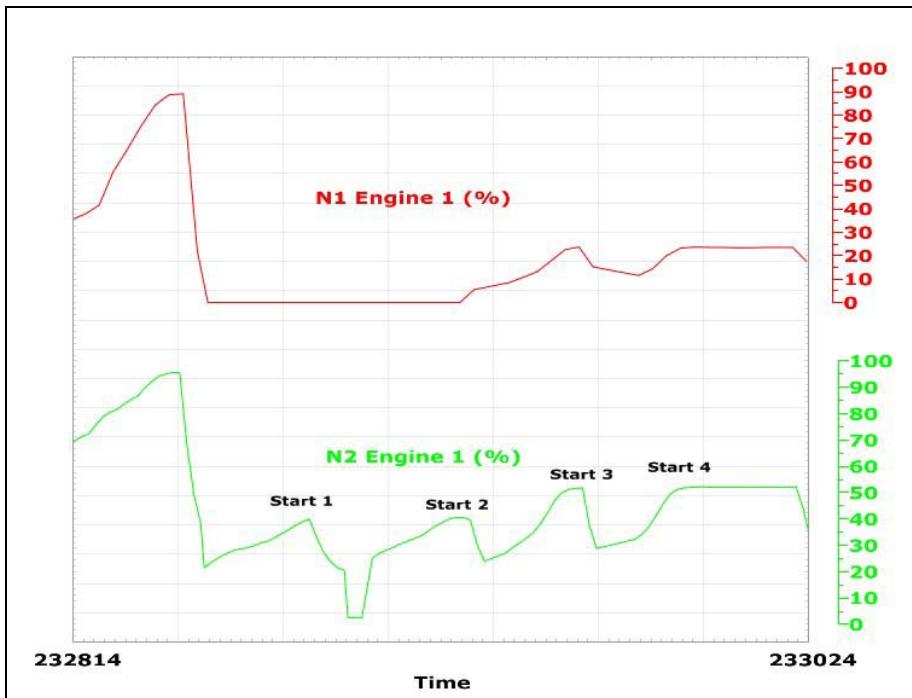
**Figure No. 3:** Final Engine Starts

Recorded parameters from this final sequence are shown in **Figure No. 3**. The top trace (red) is the rotational speed of the LP assembly (N1) and the lower trace (green) is that of the HP assembly (N2). The rapid engine deceleration, where the values of both N1 and N2 fall steeply during the final engine run on the 13 July, is seen on the left side of the Figure. This was co-incident with the loud engine stall sound heard on the CVR recording. The data then continues onto the attempted starts on the following morning. The period of 72 seconds when N1 remains at zero while N2 varies between a low of 2.6% and a high of 40.6% is also clearly visible. The DFDR data indicates that there were four distinct cycles where the engine stalled and tried to recover but at this stage the engine speeds were sub-idle. Following the fourth cycle, the engine tried to recover for a short period when the data came to an end.
