AIRCRAFT ACCIDENT REPORT 1/93

Air Accidents Investigation Branch

Report on the accident to Piper PA-28-161 Cadet, G-BPJT at Oxford Airport, Kidlington on 12 July 1992

Aircraft Accident Report No: 1/93

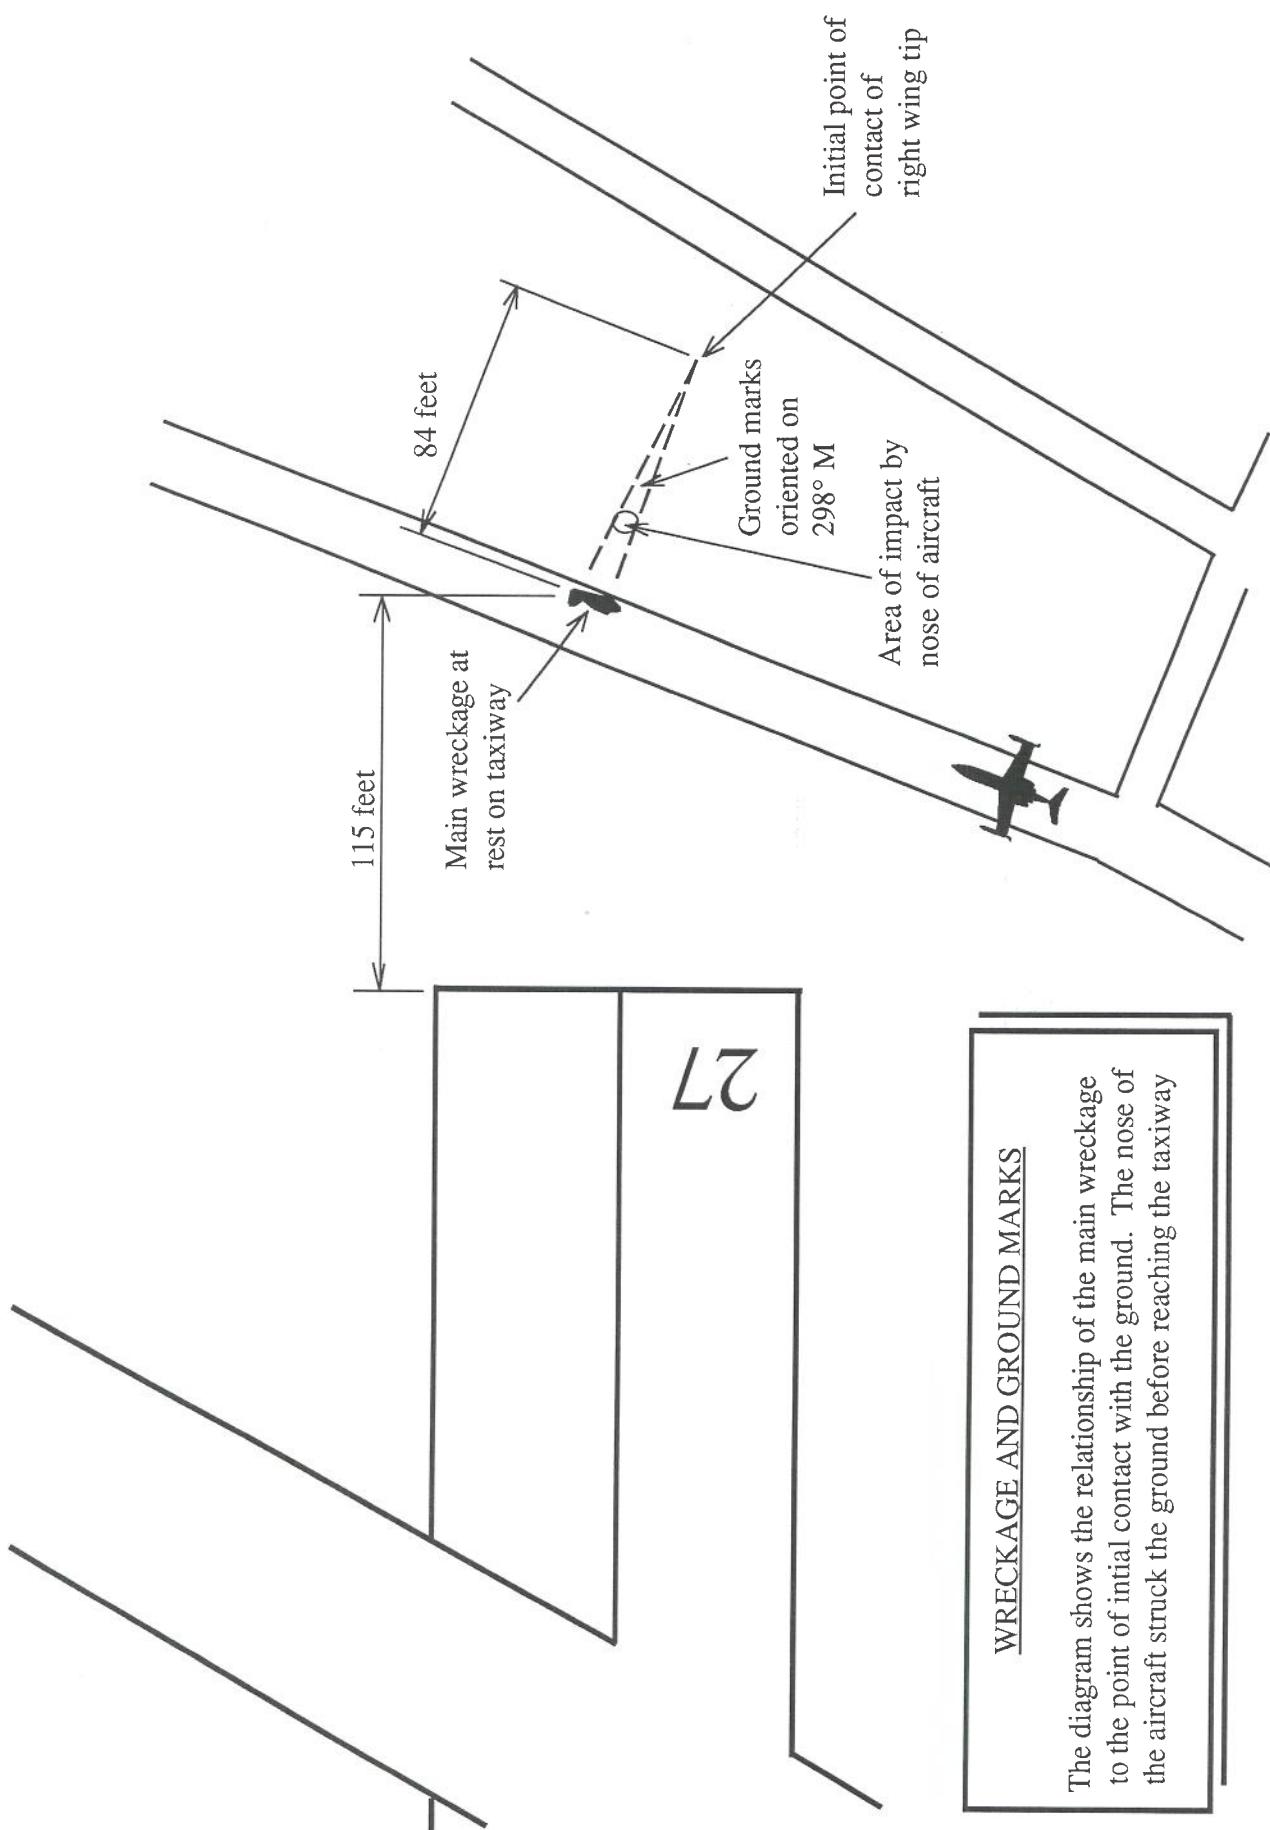
The ground impact marks and distribution of the wreckage on the ground showed that the aircraft had impacted on a heading of about 298°M while banked steeply to the right. Following the initial ground contact the aircraft had yawed to the right and the wing had collapsed allowing the nose of the aircraft to strike the ground about 40 feet from the first ground mark. Following this the aircraft had inverted, striking the ground with the left hand wing before coming to rest on the taxiway, with the fuselage on a heading of about 210°M (see Appendices A & B).

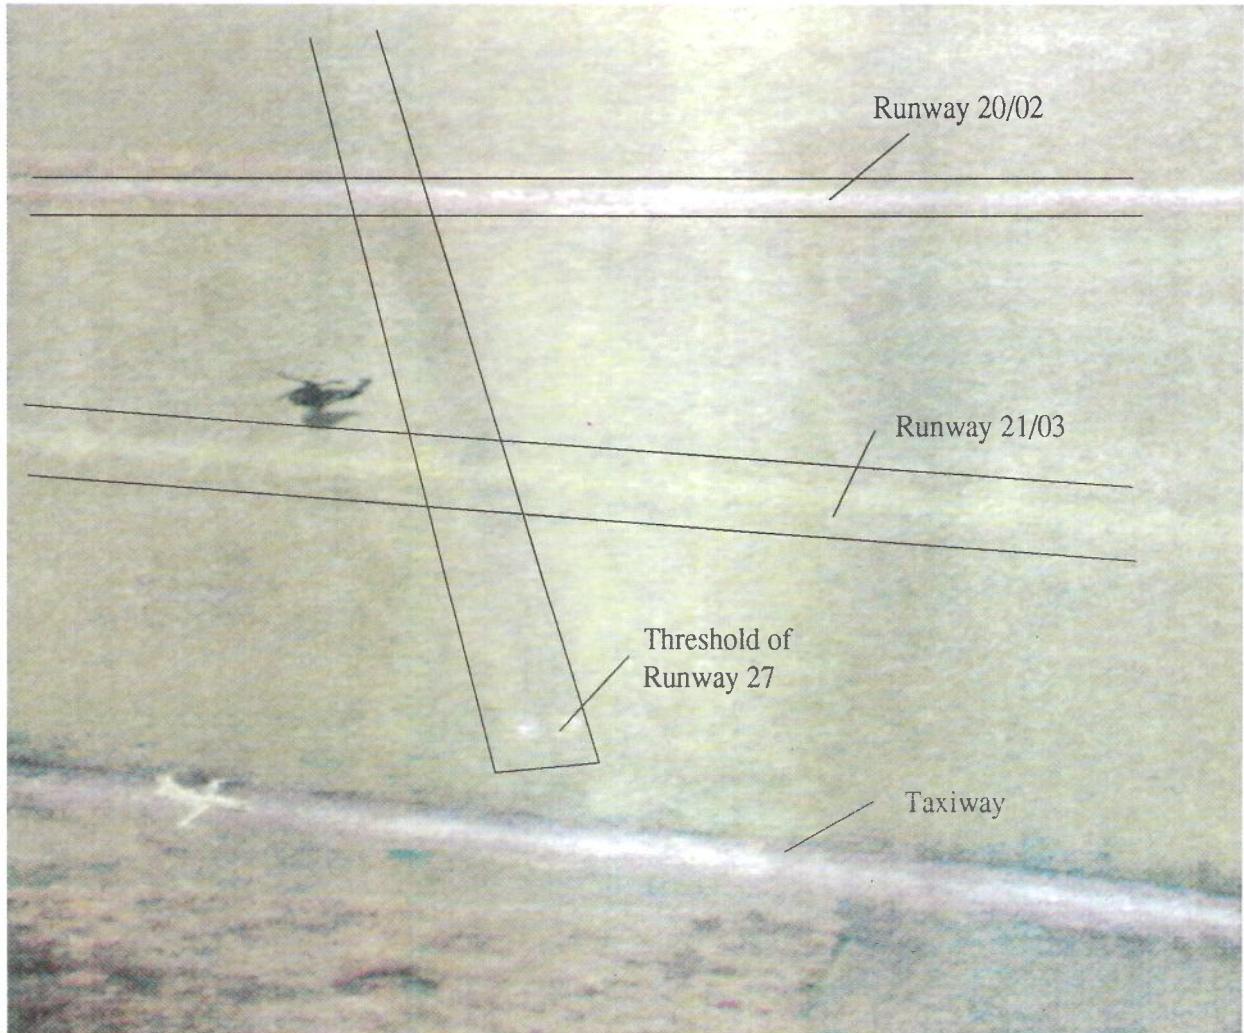
COMPUTER GENERATED RECONSTRUCTION OF THE VIEW FROM THE APPROACH
TO RUNWAY 27 AT KIDLINGTON

The accident occurred in fine weather with no restrictions to in flight visibility. Surface winds were light to moderate westerlies with no previous pilot reports of wind shear or turbulence on the final approach. Post mortem examination of both pilots revealed no medical condition that may have contributed to their loss of control. The engineering examination of the aircraft wreckage revealed no evidence of any pre-impact failure of the aircraft's flight controls. Therefore it may be concluded that, in a late stage in the approach, the aircraft encountered severe turbulence and that this turbulence was generated by the Sikorsky S-61N. It is impossible to establish whether this was residual turbulence which was generated when the helicopter decelerated as it crossed the runway threshold, or active turbulence generated whilst it was hovering and clearing the runway. If, as seems more likely, it was the downwash and turbulence generated during the hovering phase, the surface wind of 270° at approximately 10 knots would have caused it to drift downwind and directly into the approach path of runway 27 (see Appendix G).

in the prevailing weather conditions, the pilots should have had no difficulty in seeing both the Learjet, which was at the holding point and the S-61N which either had just cleared or was in the process of clearing the runway to the left. A computer generated simulation of the view that the pilots of 'JT' may have been presented with is included at Appendix G.
