ATSB TRANSPORT SAFETY REPORT
Aviation Occurrence Investigation – AO-2008-003
Final

Electrical system event
25 km NNW of Bangkok International
Airport, Thailand
7 January 2008
VH-OJM
Boeing 747-438

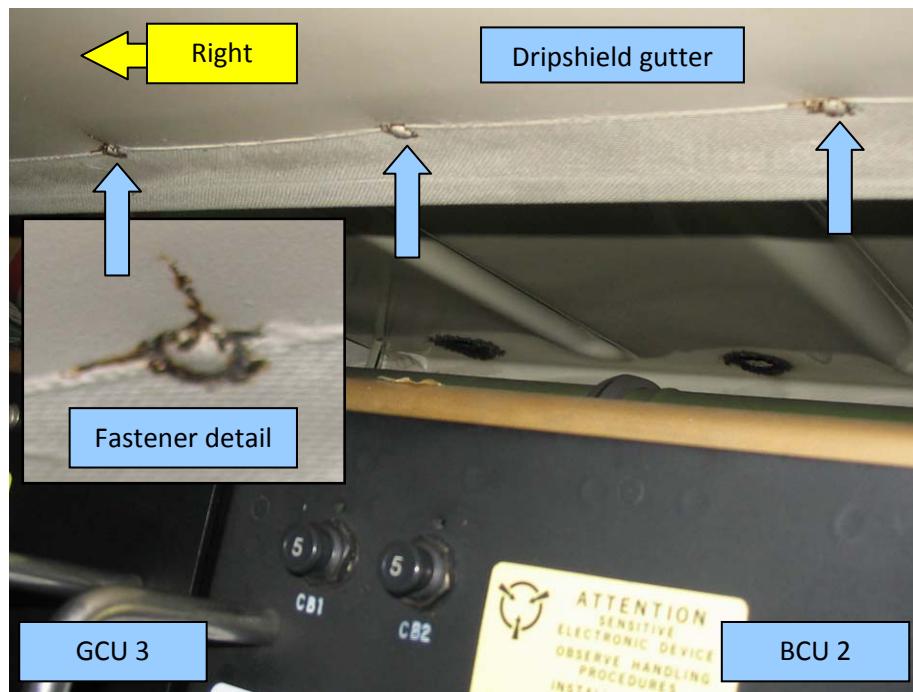
Figure 3: Dripshield fasteners, viewed from below

Inspections of the aircraft's main equipment centre (MEC) found cracks around a number of fasteners in a polycarbonate dripshield above the E1/E2 equipment racks⁹ (Figure 2 and Figure 3). Water was observed on and around the No 3 generator control unit (GCU).¹⁰

- No 2 and No 3 GCUs and both BCUs were replaced
- a temporary repair of the dripshield was carried out
- the batteries were recharged
- the electrical power system was tested
- an inspection and temporary rectification of potential water leak sources was carried out
- various systems were inspected for liquid ingress and/or tested for correct operation.

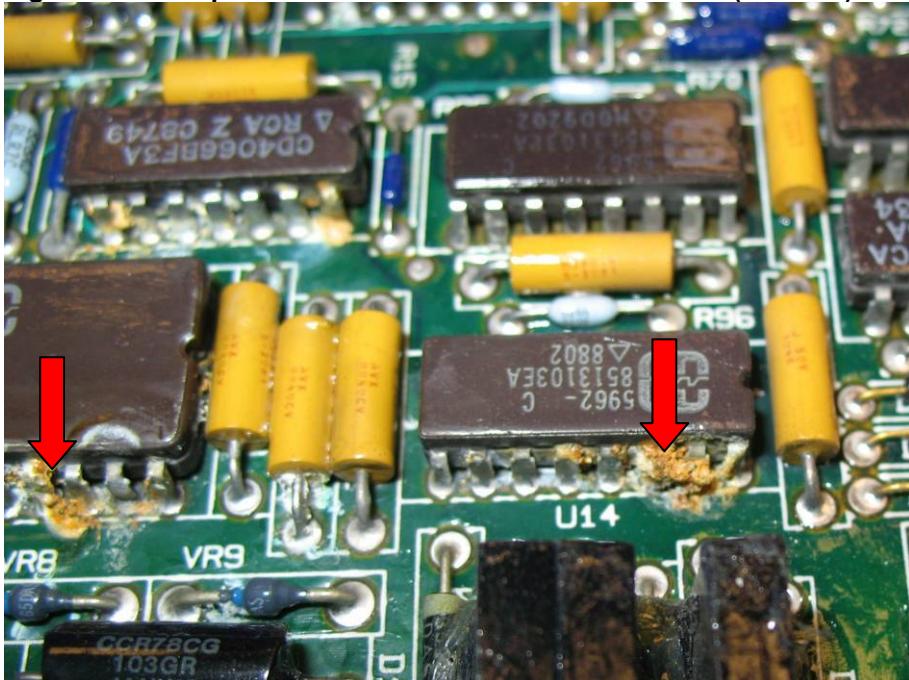
Figure 17: Example corrosion on the GCU 3 circuit board (arrowed)

The A08 circuit board was located directly underneath the rear edge of an equipment rack brace when the units were installed on the aircraft.

The test report stated that many of the units exhibited dust on the circuit boards, and that any moisture present could cause the dust to be slightly conductive. The report also recorded that some boards had areas that did not have conformal coating.

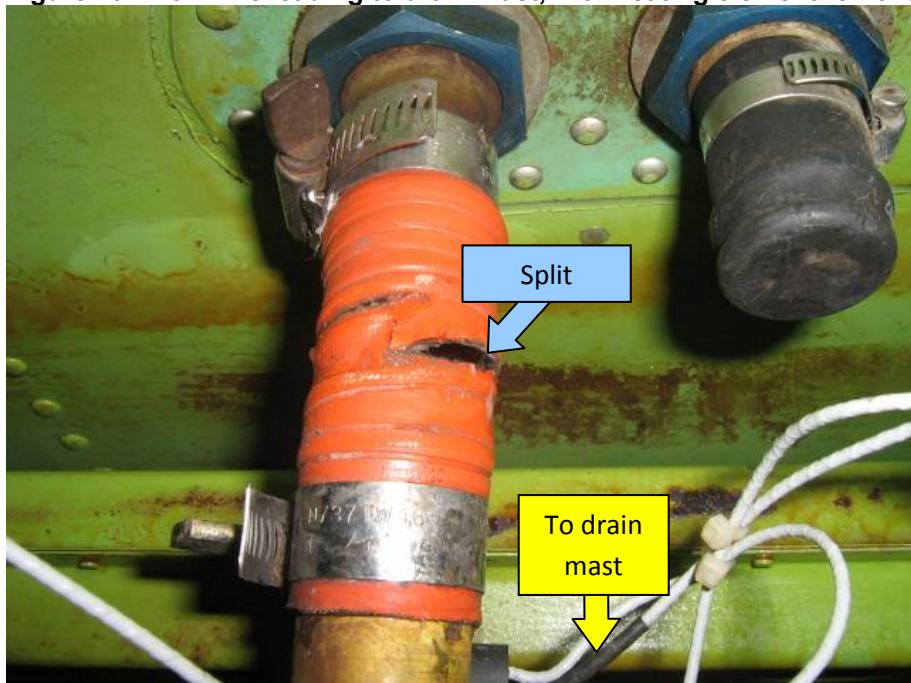
Figure 19: Drain line leading to drain mast, with heating element removed

Subsequent inspections found that a drain line ribbon heater around a drain line to the forward grey water drain mast was inoperative, and that a length of drain line at that location was split (Figure 19). The heater and hose were removed for examination and testing. The drain line heater element was found to be broken at two locations and was inoperable. The examination could not determine the cause of the damage. Tape that had been wrapped around the heater element showed marks consistent with excessive heat damage, although the investigation could not determine whether those marks were collocated with the heater element damage.

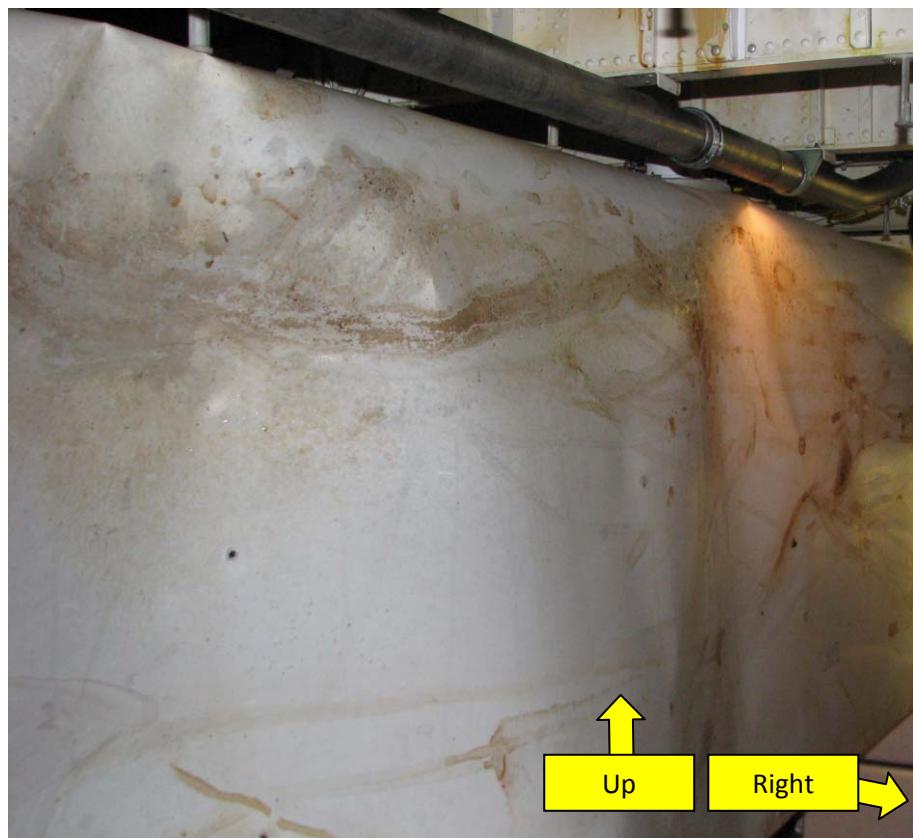
Figure 20: Forward cargo lining upper surface

Water accumulation had occurred around the forward galley area prior to the maintenance activity. The carpets immediately aft of the forward galley on both sides of the cabin were saturated. Inspection of the under floor area around the galley revealed several litres of water that had collected in the ceiling lining of the forward cargo bay. That lining had extensive brown liquid staining on its upper surface (Figure 20), although it was not determined whether that staining was due to fluids spilt during maintenance or during the operation of the aircraft. There was no evidence of water spillage from the lining onto the electrical panels at the forward end of the cargo bay, or into the MEC.

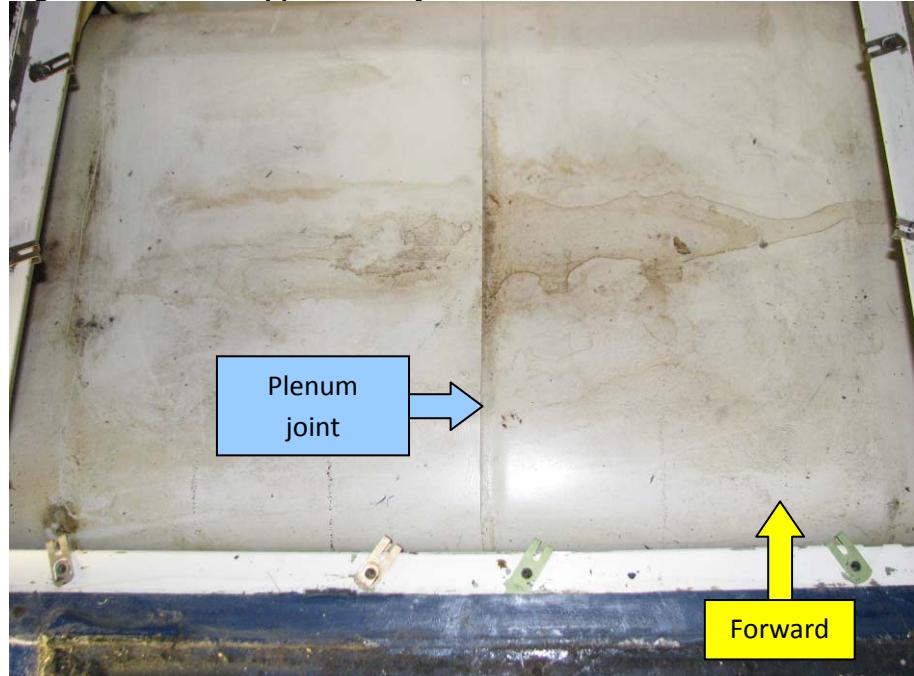
Figure 21: Plenum upper centre joint and stain

The side of the aircraft structure showed the same evidence of condensation and water flow as seen during the inspections on 8 January (section 1.8), with a clear area on the structure under the right side of the galley bulkhead.

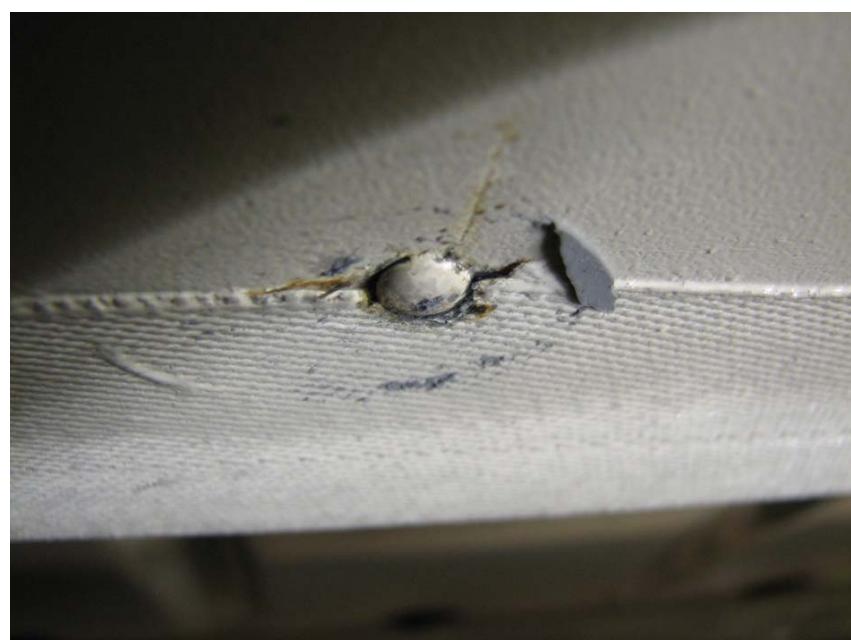
Figure 22: Dripshield fastener detail, sealant removed

The dripshield gutter joints and some of the fasteners had been sealed at the time of inspection (Figure 22). Testing of a section of dripshield gutter resulted in a very slow leak (less than one drop every 15 minutes) through the unsealed dripshield fasteners, and a fast leak (several millilitres per second) through one of the unsealed dripshield gutter joints. However, the investigation was unable to test the gutter joint in the state that existed at the time of the occurrence.

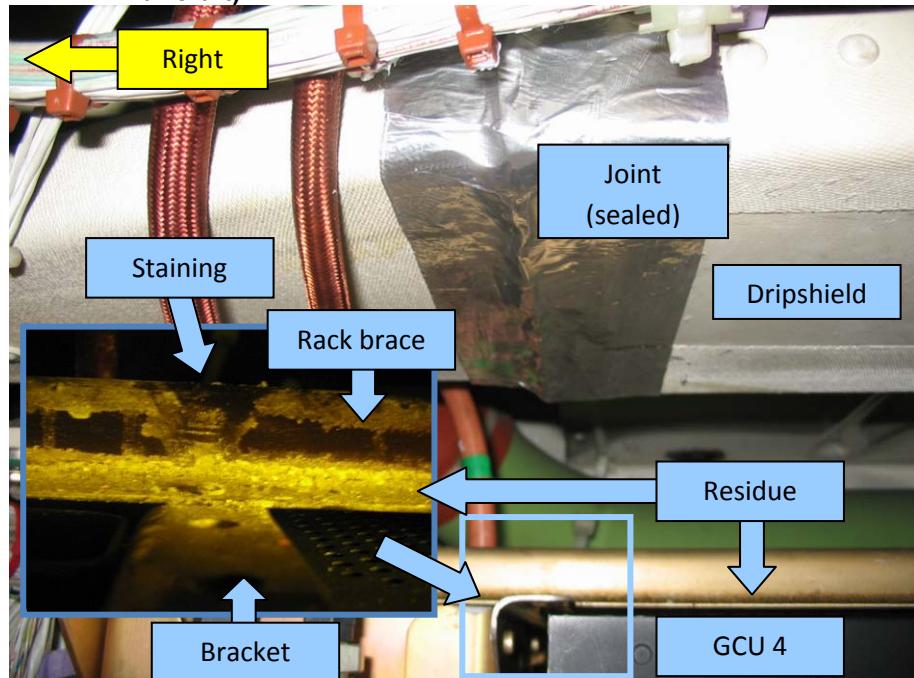
Figure 23: Dripshield joint and drip marks (looking towards the rear of the aircraft)

Forensic light inspection of the E1/E2 equipment rack showed staining beneath the right side dripshield joint consistent with liquid flowing from the joint onto the rack brace (Figure 23). The rack brace under the left side dripshield joint did not show any evidence of liquid staining.

The rack brace also showed significant residue on both sides of the E1/E2 equipment rack brace consistent with liquid contact and evaporation. The residue was most concentrated nearest the edges of the rack under the dripshield gutter joint and extended inward to about the area of each BCU. The presence of residue was also evident in photographs of the rack that were taken on 8 and 10 January.

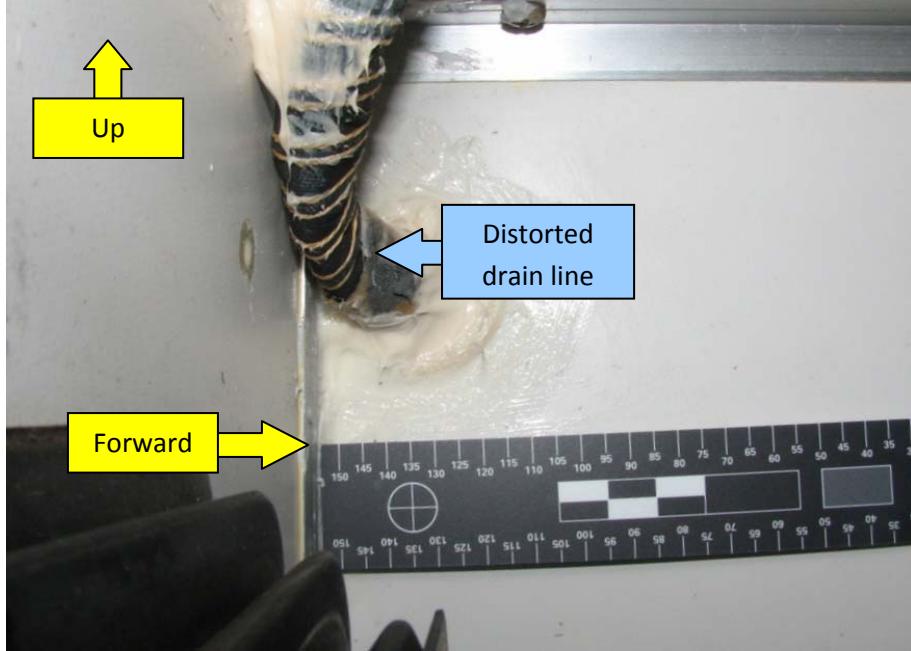
Figure 26: Distorted forward galley ice tray drain line, inside cart bay

The ice tray drain line in one of the forward galley cart bays was crushed, consistent with contact by the rear of a service cart (Figure 26).

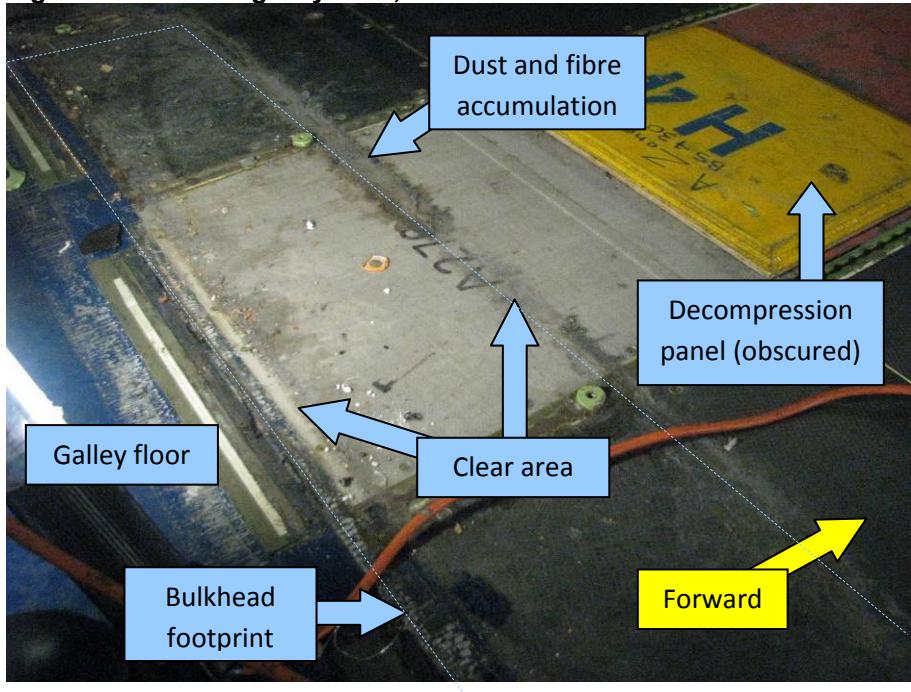
Figure 27: Forward galley floor, bulkhead removed

The lower edge of the forward galley bulkhead was not sealed. Inspection of the galley floor after removal of the bulkhead showed a large amount of loose dust and fibre accumulation around the edges of the bulkhead (Figure 27). A decompression panel was installed forward of the bulkhead. An area between the galley floor and that panel was clear of the dust and fibre accumulation, consistent with water flow through that area. The decompression panel door and the area around the panel exhibited liquid stain marks.

The galley floor sealing had partially deteriorated in some areas at the rear of the galley. Corrosion was identified on the floor beams and seat racks behind the galley.

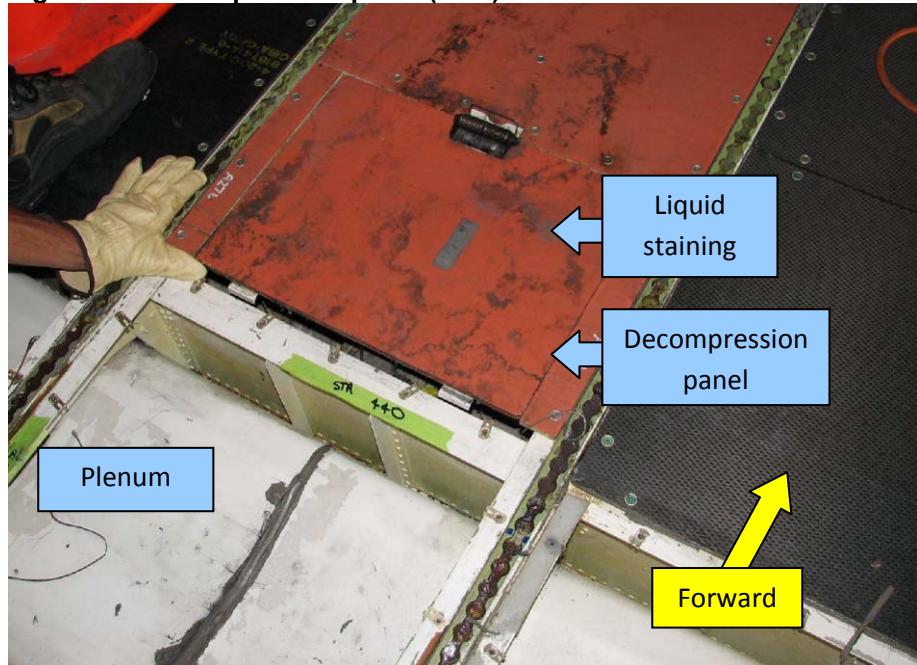
Figure 29: Decompression panel (OJK)

Examination of the galley floor revealed liquid staining on the floor panels, including the decompression panel (Figure 29).

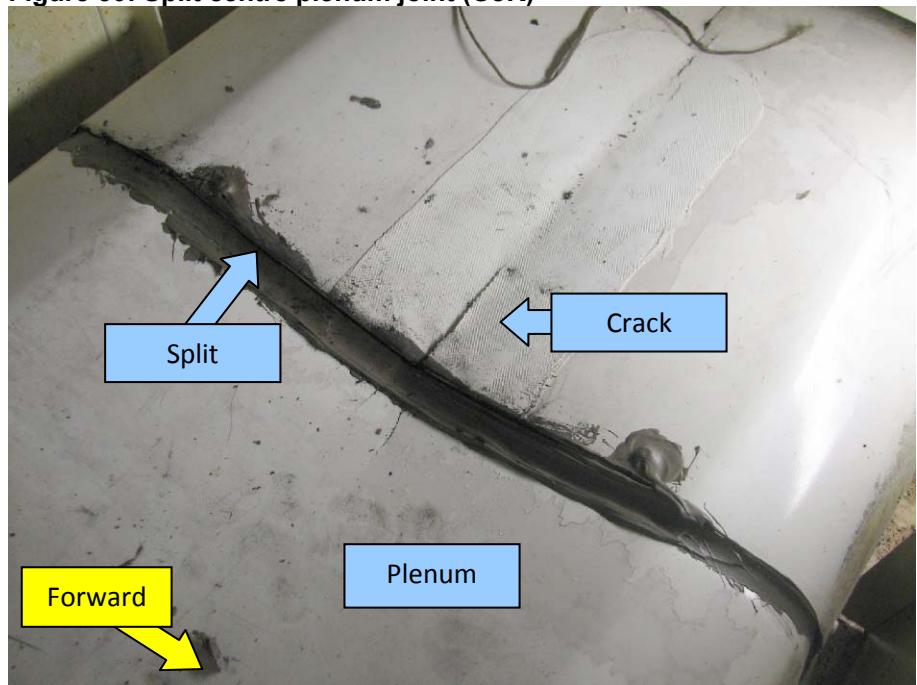
Figure 30: Split centre plenum joint (OJK)

The upper plenum joints on OJK were split and did not appear watertight (Figure 30). There was also a longitudinal crack in the central section of the plenum where a repair had been performed. Damage and distortion in that section of the plenum was consistent with excessive weight being placed on the plenum from above.

The substance used to seal the joints was of a different appearance to that on OJM. An application of light pressure on one side of the left plenum joint indicated that the seal had split.

During the inspection of OJK on 6 February 2008, it was observed that the upper surface of the plenum was split and cracked, and would probably not have prevented water from entering the plenum. Cracks and splits similar to those seen on OJK have been observed in plenums on other 747-400 aircraft. Although that ingress path did not contribute to the water ingress in OJM, the MEC dripshield and plenum was not sufficiently protective of equipment on other aircraft.

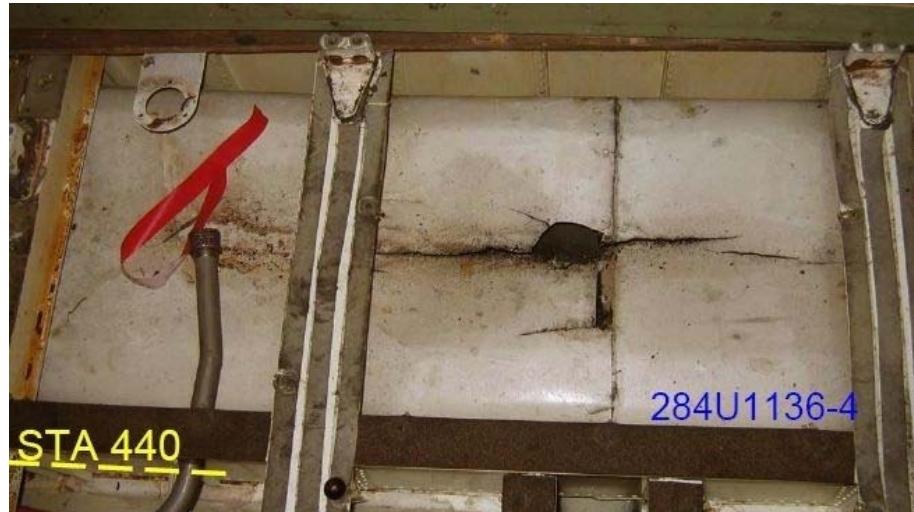
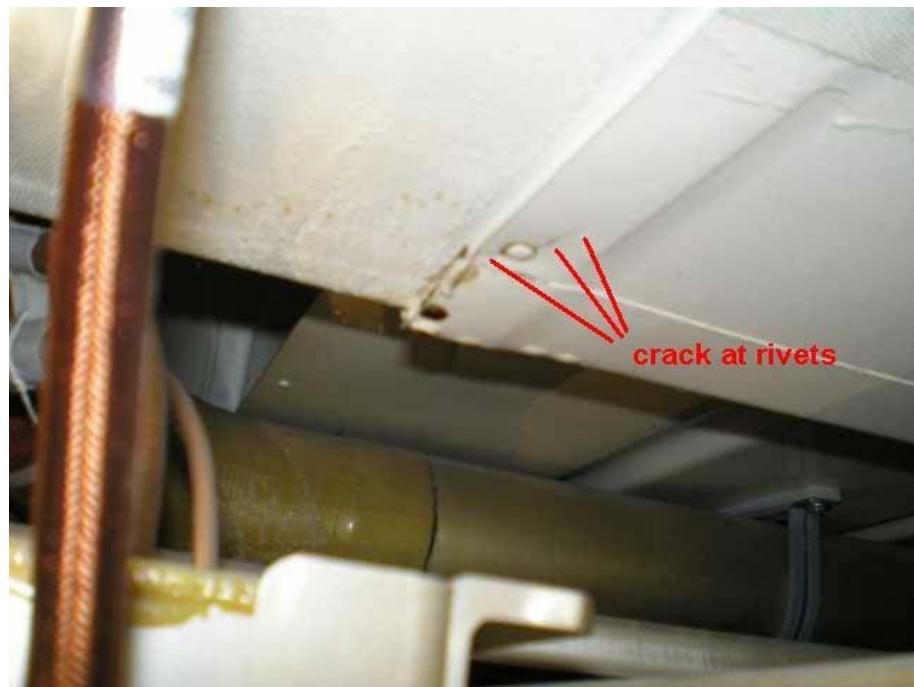
The aircraft manufacturer has received a number of reports of damaged dripshields in other 747-400 aircraft (examples shown in Figure 31 and Figure 32). At the time of the drafting of this report, the aircraft manufacturer had received 69 reports, 52 of which indicated damage to the dripshield or gutter.

The high proportion (52 out of 69) of damaged dripshields or gutters in the worldwide 747-400 fleet indicates that the issue was widespread, even though that particular problem could have been readily identified by a visual inspection during regular maintenance activities. It could be expected that as the aircraft continues to age, the incidence of damage to the dripshields could increase.

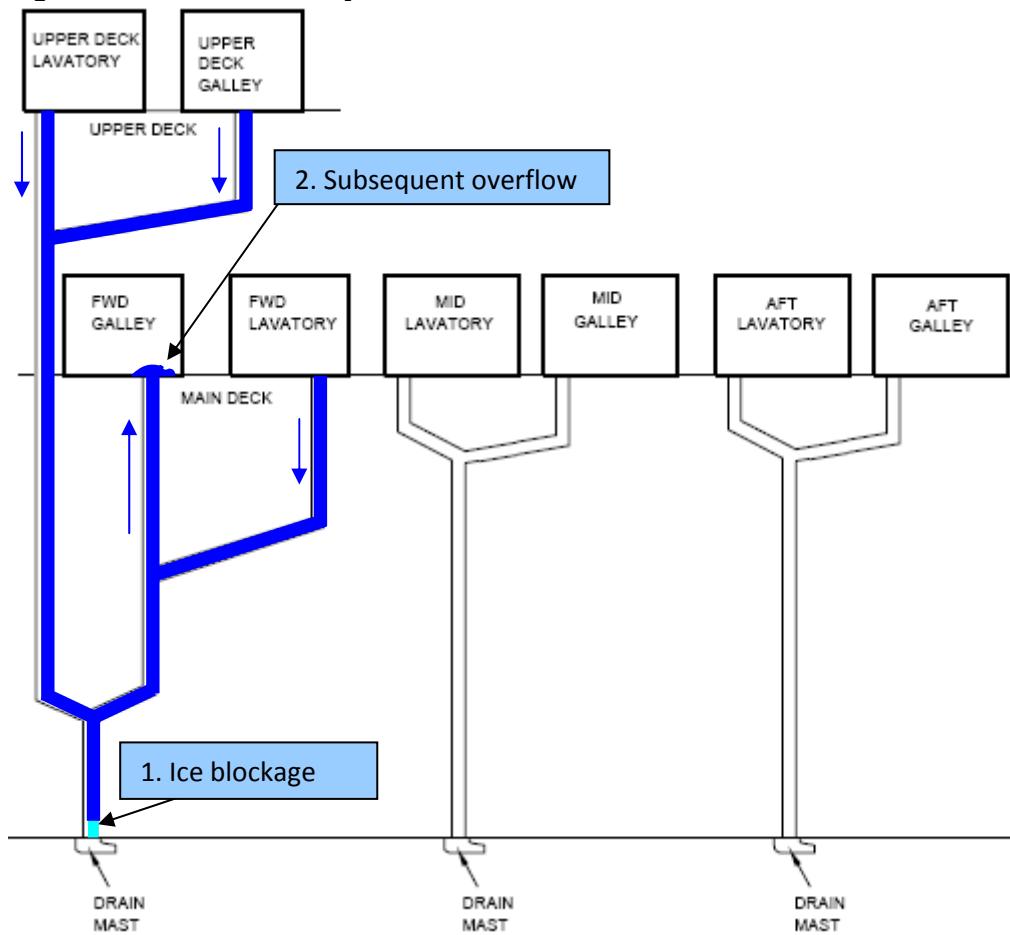
Figure 34: Forward drain system overflow

The replacement of a two-port drain mast with a single-port drain mast combined the upper and lower deck drains into a single system, decreasing the effectiveness of both systems. Due to the increased volume of waste passing through the drain mast, it was more likely to become blocked. In addition, a blockage occurring below the Y connector would affect both drain systems and potentially cause waste liquid from the upper deck to overflow onto the main deck.

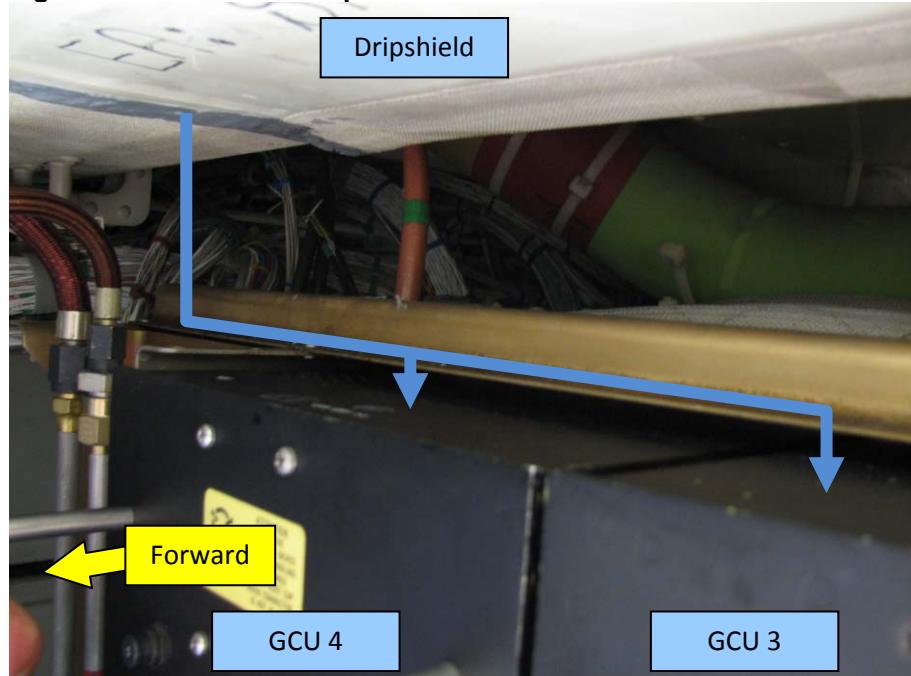
Figure 36: Probable water path

The absence of BCU faults may be explained by the more distant location of the BCUs from the edge of the racks relative to the GCUs, which would make water ingress less likely.
