# Report

Incident on **2 June 2010**

**Bordeaux FIR, OLRAK Point**

between the **A318** registered **F-GUGJ** operated by **Air France**  
and the **PC 12** registered **EC-ISH**

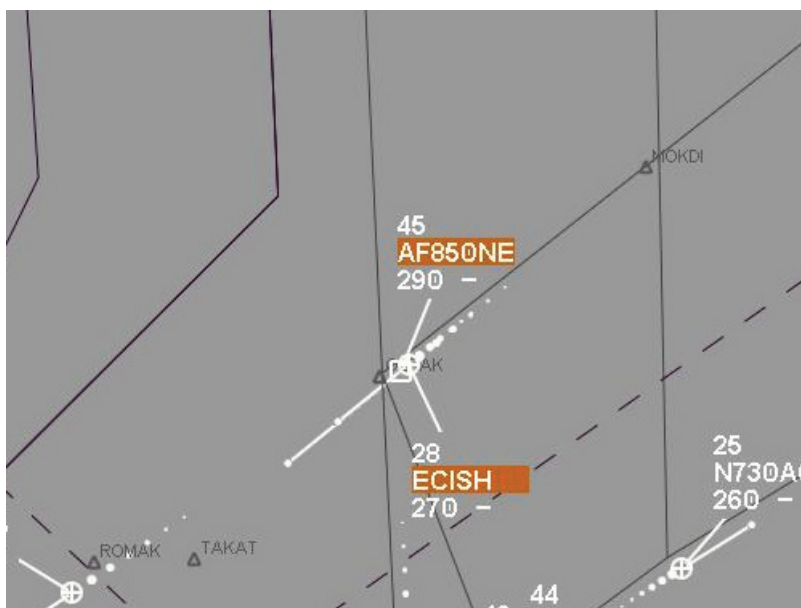
The minimum separation between the 2 airplanes could not be measured on the recording, the 2 radar plots being mixed together. The crews estimated that the separation was between 15 and 30 metres horizontally and about 100 feet vertically.

Figure 1: Radar image taken at the moment of the conflict

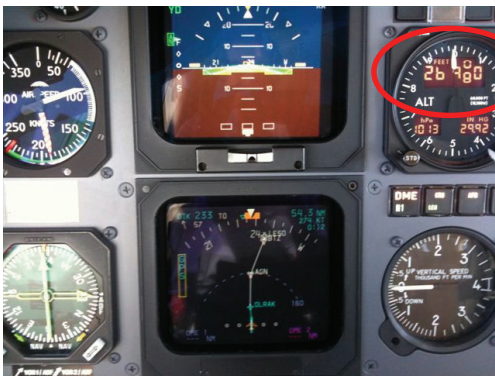
Figure 2:

During the climb towards FL 270, they noticed that the differences in altitude and speed between the 2 barometric and speed units were increasing. Stable at FL 270, they saw on the first unit, on the pilot's side, FL 270 and an indicated speed of 90 kts and on unit 2, on the right side, FL 290 and an indicated speed of 160 kts. The crew tried to dispel this doubt with the GPS but the GPS altitude was between 27,000 feet and 29,000 feet and did not allow them to dispel the doubt (see note below).

Left side barometric and speed unit

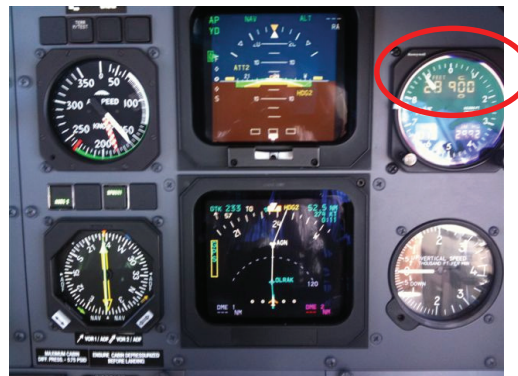
Figure 3:

Right side barometric and speed unit

Thus the speed displayed on the right side unit was consistent with the flight conditions at that moment.

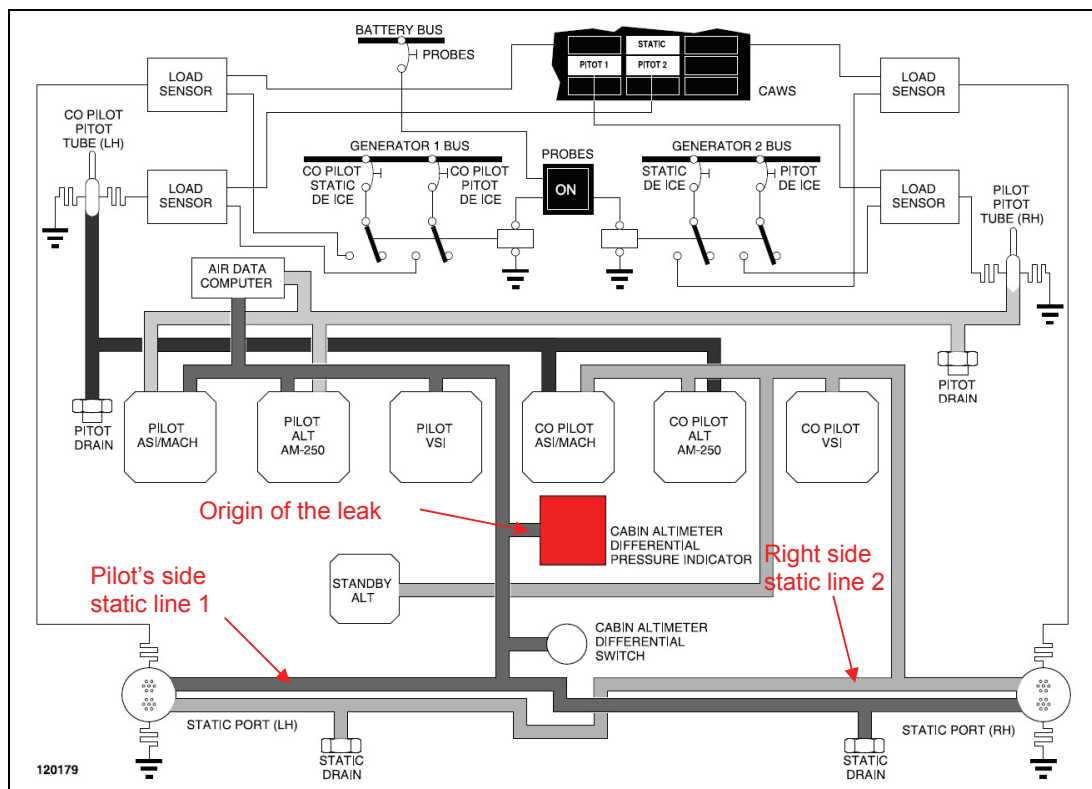
Figure 4: Synoptic of the speed installation on the PC-12

The airplane being pressurised, it possesses a cabin differential pressure indicator that uses the static pressure pneumatic line on the pilot's side to develop its indication (in red in figure 4).

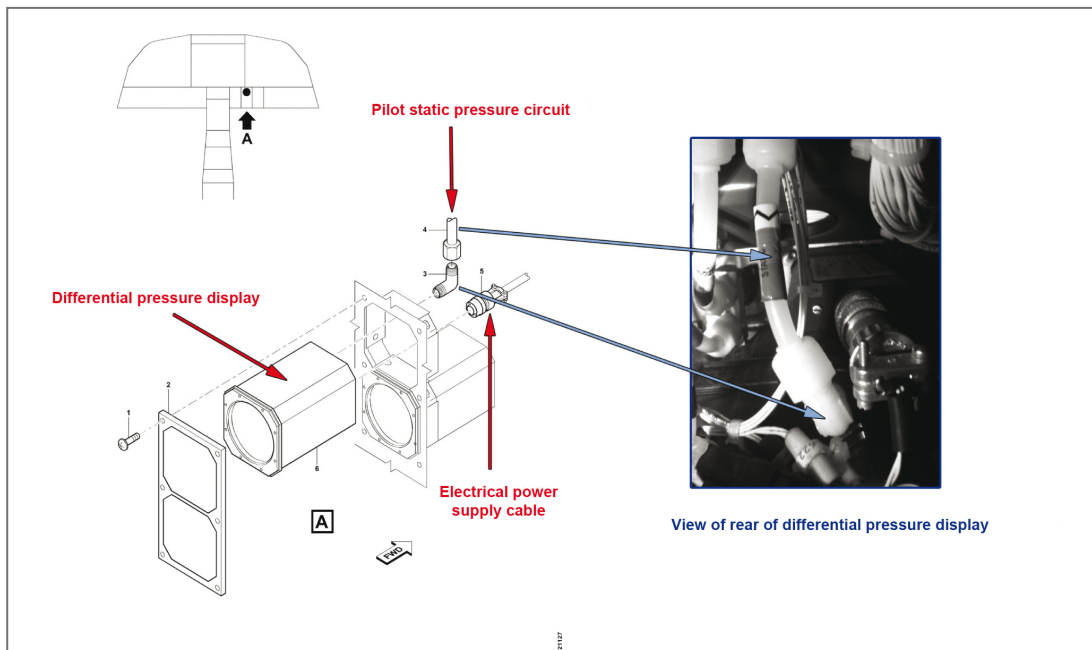
The search for the failure on the airplane the day after the incident showed that the pilot's side static line (see figure 4) had a leak on a connector that joined this line and the cabin differential pressure indicator (parts referenced 3 and 4 on figure 5).

Thus, a part of the pressurised air in the cabin was able to penetrate the static pressure line and increase the value of this pressure. This increase in pressure was, at FL 290, equivalent to a value of 2,000 feet.

Due to this, as soon as the cabin was pressurised, the instruments on the pilot's side indicated an altitude and a speed that were lower than they were in reality.

Figure 5: Schema and photo of installation

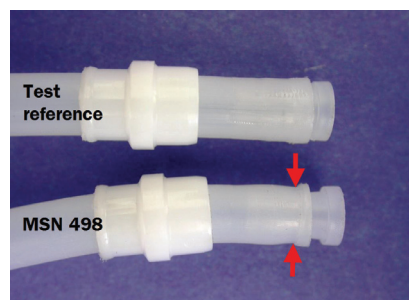
The connector that was the cause of the leak was analysed. There was shrinkage of a circumferential groove at the level of the joint with the cabin differential pressure indicator (see figure 7 below).

Figure 7: Shrinkage of the cross-section of the connector

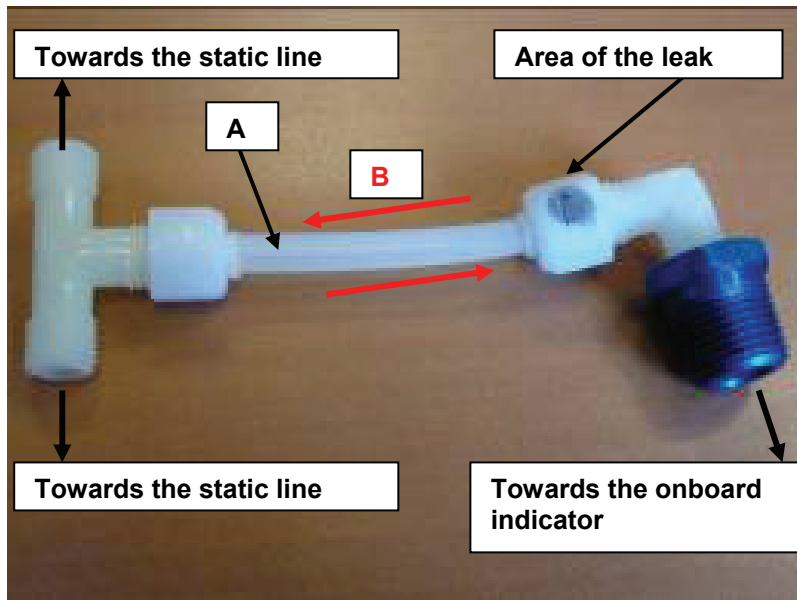
It was possible to establish, during these tests, that the deformation observed on the connector made a perfectly impermeable joint impossible between the pipe and the cabin differential pressure indicator. Due to this, the tube (see "A" figure 8) could be moved in the longitudinal direction though it is, normally, immobilised by the tightening. Without manipulating this tube, no notable leak occurred. As soon as it was displaced in a longitudinal direction (see "B" figure 8), a leak appeared.

Thus, during the impermeability tests performed by Pilatus, on the airplane on the ground, no leak was detected. During departure of the PC 12, the vibrations in flight, as well as the stresses created by the climb with pressurisation of the cabin, very likely led the tube to move, thus causing the leak at the level of the connector.

Figure 8: Photo of the pipes
