AVIATION INVESTIGATION REPORT
A09O0117

**ERRONEOUS INSTRUMENT INDICATIONS RESULTING IN
AIRSPEED AND ALTITUDE DEVIATIONS**

BOEING 767-300 SP-LPA

19 JUNE 2009

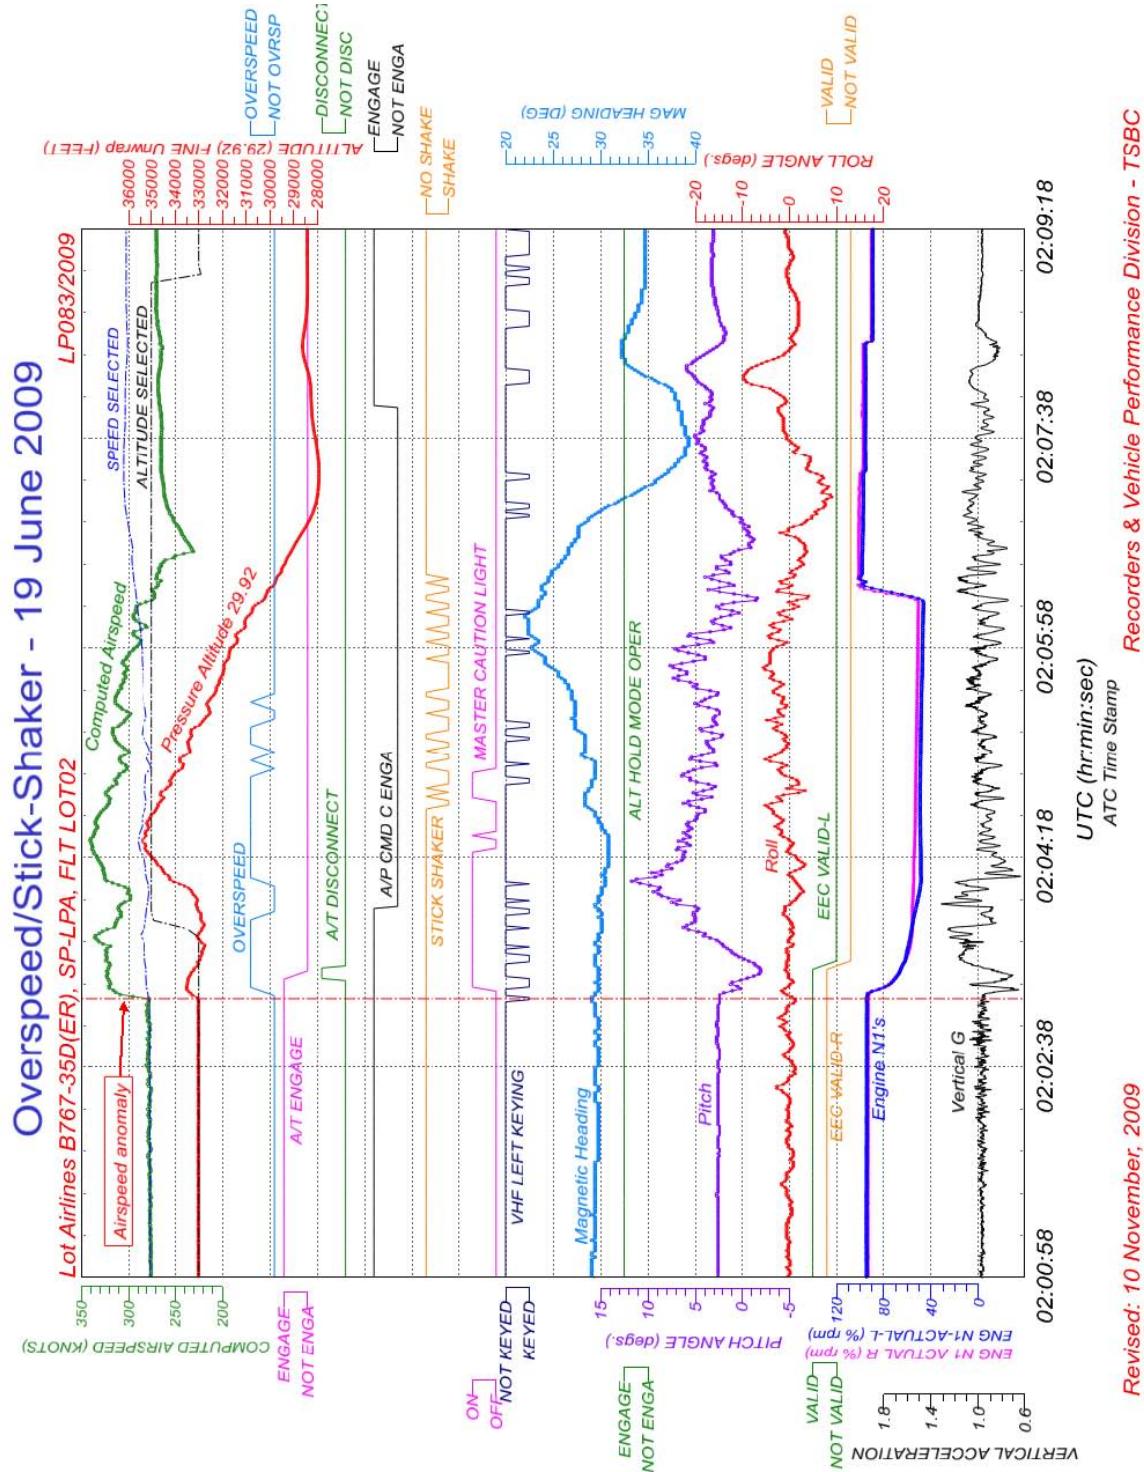
Appendix A - FDR PLOTS

The flight data recorder (FDR) installed on the aircraft was manufactured by Honeywell. The FDR contained approximately 52.5 hours of data which included the occurrence and 5 previous flights. The overspeed event and the subsequent stick shaker activations are plotted in Appendix A.

Stick shaker trip angles were also calculated for the occurrence conditions to determine which vane angles of attack would be expected to activate the stick shaker. The results showed that for the recorded stick shaker activations, the trip angles had been reached or exceeded and that the system worked as designed.
