REPORT QUITO-1/2007

Date and time	Friday, 31 August 2007; 21:05 h UTC
Site	Mariscal Sucre International Airport in Quito (Ecuador)

Registration	EC-JFX
Type and model	AIRBUS A-340-600
Operator	Iberia, L.A.E.

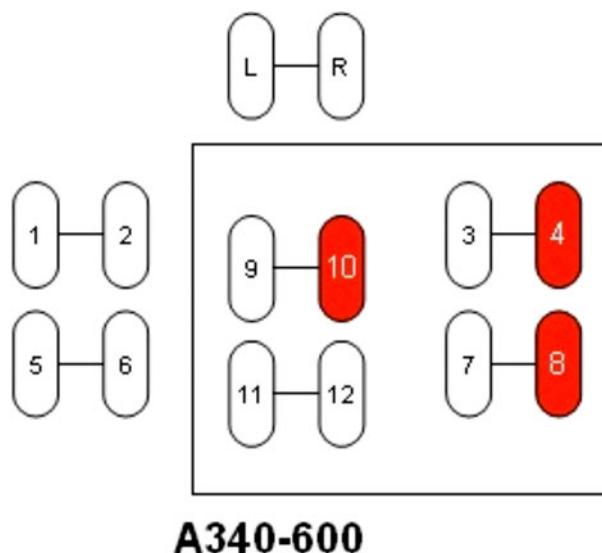
Figure 2. Wheel numbers according to diagram published by the tire manufacturer (Michelin)

Tires 10, 4 and 8 had burst. Tire 12 had deflated, while tires 3 and 7 had endured a high brake temperature.

Tires 3, 4, 7, 8, 9, 10, 11 and 12 from the aircraft (see Figure 2) were sent to Michelin's facilities in France for a detailed inspection. The most relevant results from that inspection (Michelin RG report number 307-122) were as follows:

- No abnormalities were found in the tires' manufacturing records.
- Tires 4, 8 and 10 had withstood high landing loads due to the considerable stresses, deformation and drift.

- Severe impact on landing to the outer edge of the crown (serial number side).
- Flexion of the sidewall, contact with the ground, friction and total abrasion of the sidewall causing a rapid deflation and burst.
- Dislocation of the tire during the realignment of the aircraft with the runway centerline while running flat, breaking of the casing plies on the rim flanges and shoulders; friction, scuffing and perforation of the crown and total breaking of the crown block.

The loads and stresses withstood by those three tires during the crab landing led to the rapid burst after touchdown and dislocation of the components during the subsequent run, once they had completely deflated.

No anomalies were detected on the 5 other tires except for transversal scratches on the shoulders and longitudinal scratches at a 10° angle to the tread, confirming the existence of a landing with drift.

Once the burst and deflated tires were replaced, the aircraft was taken to the stand. Tires 3, 7, 9 and 11 were later replaced as well due to an overload condition.

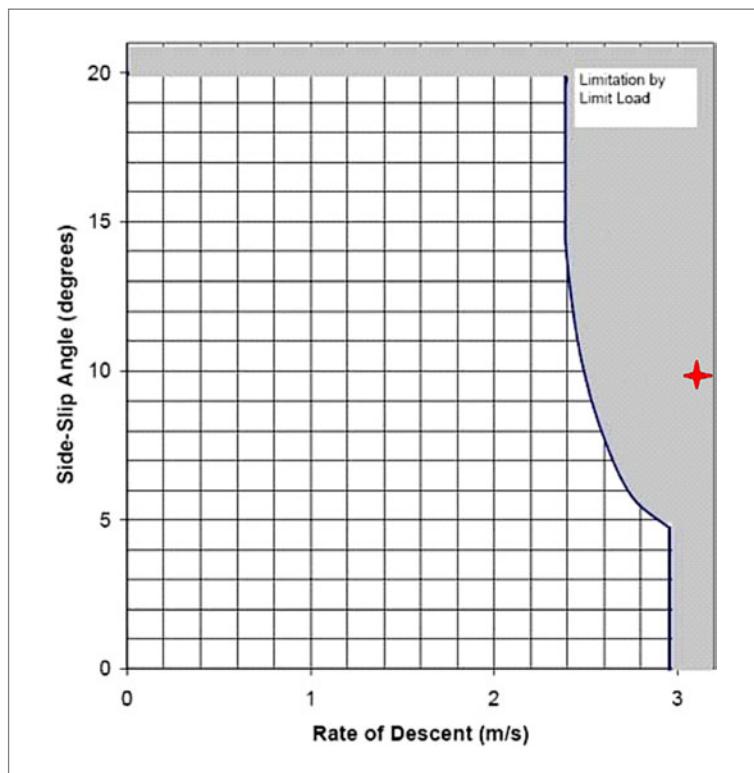
Figure 3. Operational envelope for the A-340-600 tires, indicating the landing conditions for the EC-JFX landing in this incident, with approximately 3.3 m/s y 10° of side slip

Airbus reported that its tire specifications included an explicit requirement to cover landings with side slip, which called for the tire to withstand a landing with a combined descent rate and drift angle as shown in Figure 3 below.

Airbus reported that its calculations indicated that each tire on EC-JFX had been subjected to at least 36,000 daN during the incident landing (conservatively assuming a uniform load distribution among the 12 wheels), thus exceeding the maximum value of 24,000 daN tested for during the tire certification.

Information was requested from the aircraft manufacturer concerning tire strength under a combination of lateral and vertical loads. The reply was that the landing conditions at Quito exceeded the specifications tested during the tire certification process (see Figure 3).

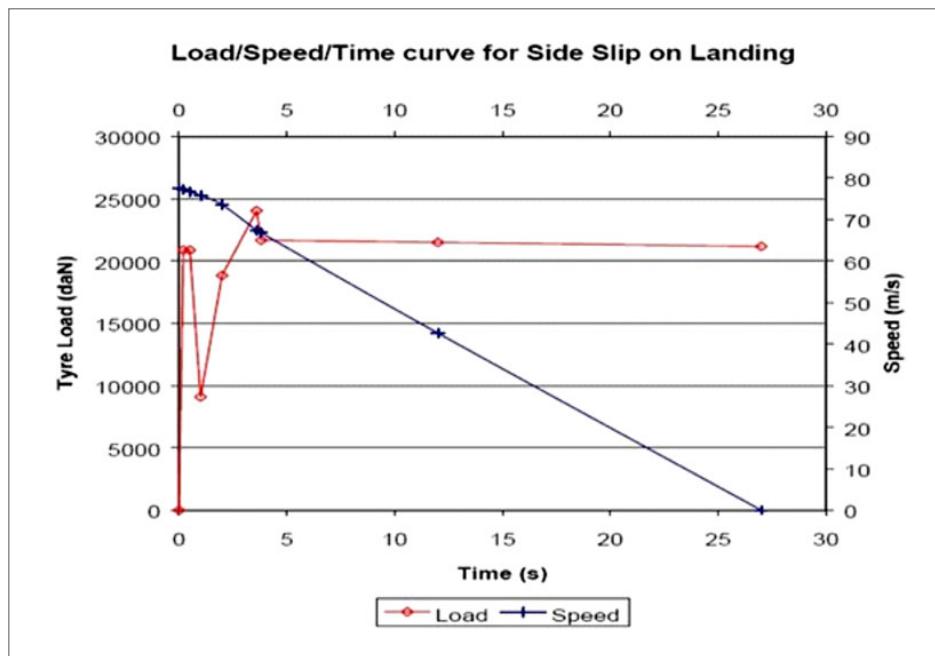
Figure 4. Combination of speed and vertical load used to certify the tires used on the EC-JFX for a landing with side slip

The Airbus specification also detailed the applicable speed/time curve for demonstrating the tire's strength using a test which consisted in simulating a landing with drift on a dynamometer, in which the speed is constantly decreased as the vertical load changes. In the test, a vertical load peak of some 24,000 daN (see Figure 4) was reached.

For the type of tires in the incident, Airbus stated that Michelin had shown compliance with this requirement by performing a dynamometer test which simulated a landing with over 20° side slip angle and a descent rate of 2.4 m/s (7.9 ft/s) without any tire damage.

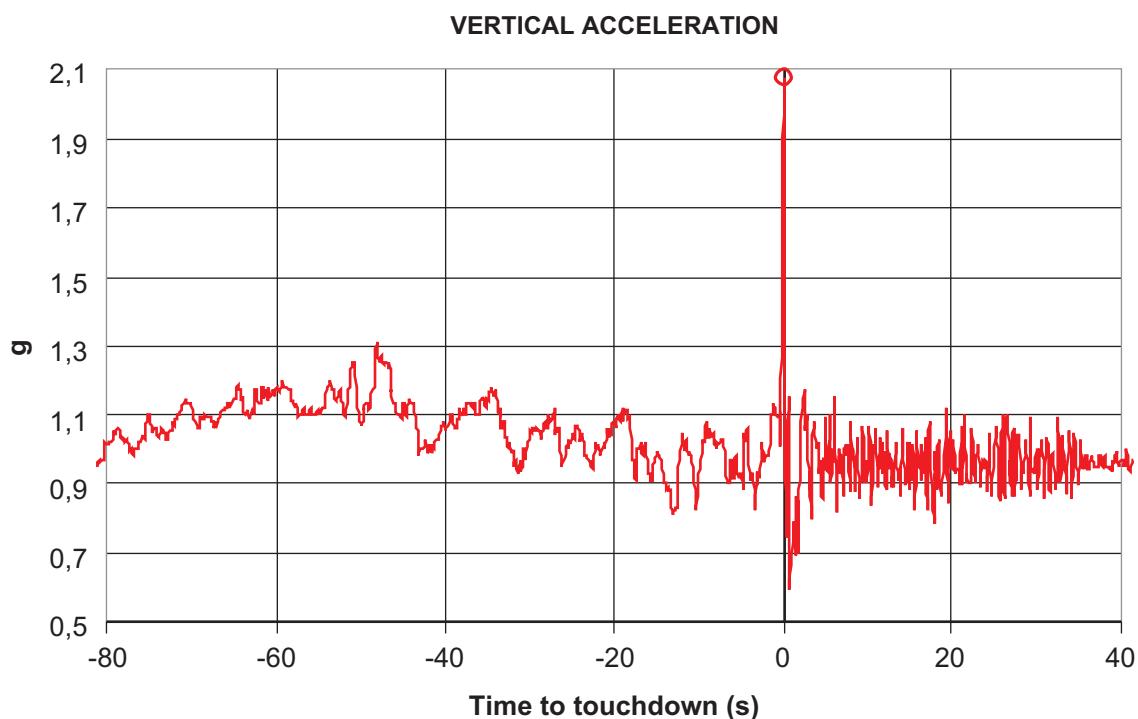
Figure 12. Vertical acceleration (maximum during touchdown: 2.08 g)

The first contact indication on the microswitches of the main landing gear legs was recorded at 21:05:06. Calibrated airspeed was about 146 kt. The weight of the aircraft upon landing was 240.3 tons (the maximum landing weight is 259 tons). Since certain vertical acceleration and descent speed values were exceeded, a "load report 15" was generated, according to which the following limit values were recorded for various parameters from one second before to one second after touchdown:

Maximum	Minimum
Vertical acceleration	2.080 g	1.018 g
Lateral acceleration	-0.050 g	-0.561 g
Roll angle	2.5°	-0.4°
Pitch angle	5.7°	3.7°
Descent rate according to radio altimeter	-16,0 ft/sec	6.7 ft/sec

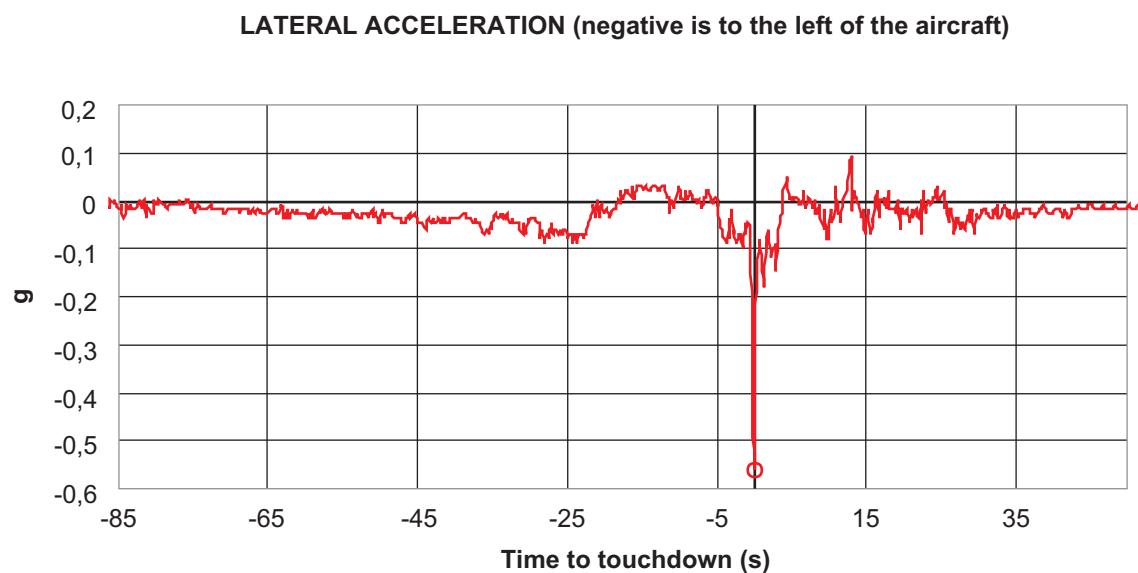
Figure 13. Lateral acceleration (maximum during touchdown: -0.561 to the left)

Large left roll angles are present until second -25, as the turn from base to final is completed. After the turn, the aircraft's heading varied from 160-165°. The graph of lateral acceleration shows the aircraft deviating right (producing acceleration to the left).

Had the aircraft not touched down with a certain crab angle, the resulting lateral acceleration of $-0.561g$ may not have been generated (thus avoiding the burst), though the lateral force may then have been insufficient to change its trajectory.

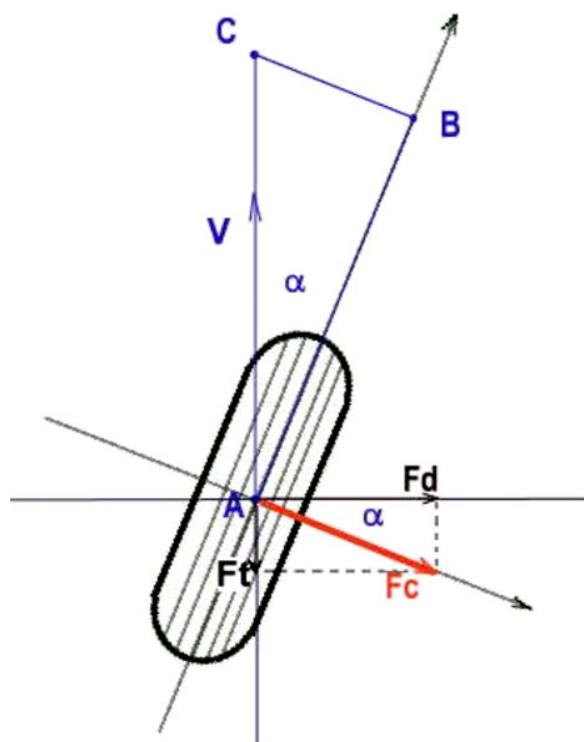
Figure 17. Force diagram

During a touchdown with crab angle α , the motion of the wheel from A to C (see Figure 17) can be separated into rotation from A to B and displacement or slip from B to C perpendicular to the wheel's plane of rotation.

To maximize the driving force, $F_d = F_c \cdot \cos(\alpha)$, of the cornering effect, the angle of the wheel that maximizes the product $F_c \cdot \cos(\alpha)$ must be found using trial and error. For increasing values from 0° to 30° , F_c also increases, while the cosine decreases with increasing α . The maximum value of F_d is obtained experimentally by considering the characteristics specific to each case.
