**Rejected takeoff after the takeoff
decision speed ' V_1 ', Boeing B737-800,
at Eindhoven Airport**

4 June 2010

The Hague (project number 2010040)

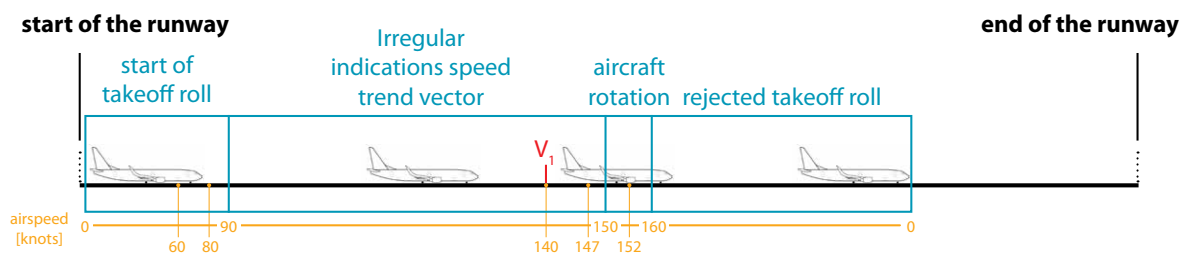
Figure 5: Timeline of takeoff with the four events which will be analyzed in this paragraph in more detail.

This paragraph is divided into four subparagraphs. The first subparagraph deals with the takeoff roll where it was difficult to keep the aircraft on the centreline. The second subparagraph details the timeframe where irregular speed trend vector indications were observed. The third subparagraph deals with a perceived controllability problem at the time of rotation of the aircraft. The fourth subparagraph will describe the time frame of the rejected takeoff.

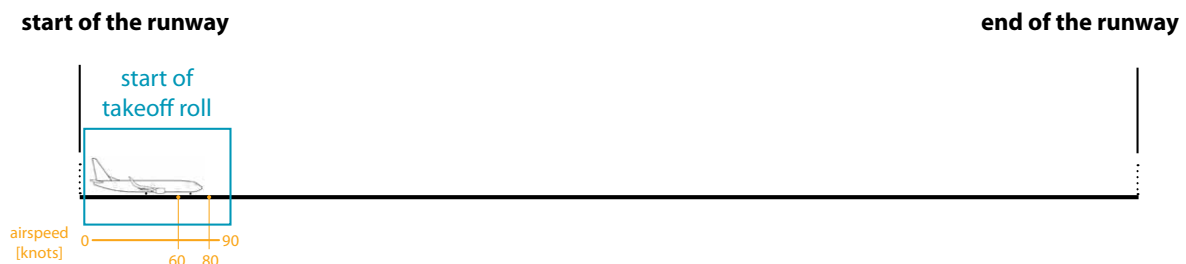
Figure 6: Timeframe start of takeoff roll, from standstill to 90 knots computer airspeed.

After the event the first officer stated he had trouble in keeping the aircraft on the centreline at low speed. According to the first officer the heading deviation was interpreted as an engine power asymmetry. The captain, who was the pilot monitoring the instruments, also noted the deviations in aircraft heading. The captain also interpreted the feeling as engine asymmetry. Therefore the captain performed an additional engine cross check during the takeoff roll. However, no difference in engine indications was observed. Nor was the cross-check communicated to the first officer who was flying, this was however not mandated either.

The flight data shows a deviation in aircraft heading at low airspeed. The analysis of engine parameters flight data during this timeframe does not show engine asymmetry or large differences in engine performance which could explain the observed heading changes.

The data from the flight data recorder shows that the aircraft reacted to the given rudder pedal inputs and it was possible to get the aircraft lined up with the runway. The tiller which controls the nose steering of the aircraft is not recorded, heading changes as a result could not be analyzed. The changes in aircraft heading could possibly be related to over controlling the aircraft or an outside disturbance.

Another possible cause of atmospheric disturbance is gusty winds or turbulence created by buildings or structures near the runway. The reported weather conditions from air traffic control at the time of the event indicated a wind speed up to 10 knots. Prior to and after the event the meteorological information does not show the presence of gusting conditions. At the airport structures and buildings are present which could create turbulence. However given the distance between the buildings and the runway with the reported wind conditions it is unlikely that turbulence was generated by buildings. No information to substantiate either possibility or any other explanation which may have caused heading changes could be determined.

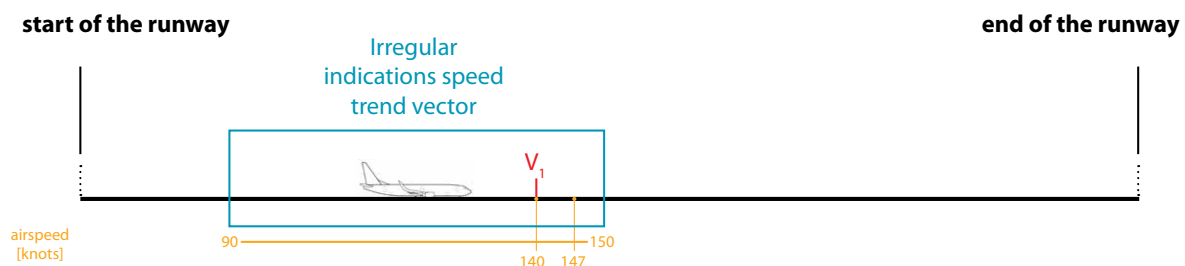
Figure 7: Timeframe airspeed from 90 to 150 knots where irregular speed trend vector was observed.

After the event each crew members reported an irregular speed trend vector indication. According to the first officer the speed trend vector was negative between 90 and 140 knots, which would indicate the aircraft was expected to slow down in the next 10 seconds. The captain stated that around 140 knots airspeed, a large speed trend vector in positive direction was observed on his display.

The captain as the pilot monitoring should be observing and verifying conditions of aircraft systems during the takeoff roll. The captain had noticed a large positive speed trend vector but deemed this not an issue for takeoff. The first officer also observed an irregular speed trend vector during the takeoff roll. This implies that the instruments in cockpit were showing large deviations which were noticed by both crewmembers.

Although the recorded airspeed was only available from the captain's side it is likely that similar deviations occurred on the first officer's side. However, since the available airspeed data was from the captain's side only, an definitive conclusion could not be reached. It is possible that some sort of atmospheric disturbance occurred which explains the sharp deviation in computed airspeed. A explanation or cause for a atmospheric disturbance could not be determined. However in the previous timeframe, start of takeoff roll, an atmospheric disturbance was deemed to be the likely cause.

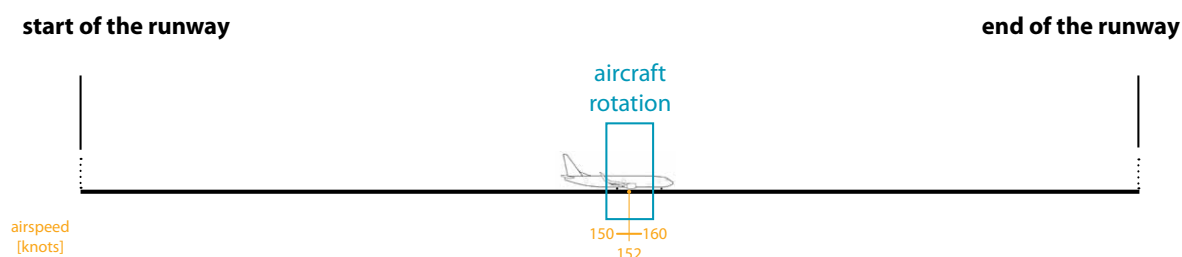
Figure 8: Timeframe between 150 and 160 knots where the aircraft rotated.

The first officer stated that the control column was moving towards him at a speed around V_1 . Both the control column positions and the control column forces were recorded on the flight data recorder. The data showed that around V_1 no movement or force was applied on the control column. The data from the flight data recorder showed that the first officer performed a flight control check during taxiing, at that time no anomalies were detected. Analysis and comparison of the control column positions and forces with previous flights did not reveal any difference. A possibility exist whereby the aircraft could rotate on its own due to improper weight and balance or large trim setting. However the weight and balance of the aircraft was within prescribed limits. Also the trim setting according to the flight recorder was as to be expected.

Data on the flight data recorder shows that around the time of rotation of the aircraft, large lateral accelerations (left and right movement) were recorded. The heading of the aircraft subsequently changed and the rudder pedals were used to align the aircraft back to the runway heading. These large lateral accelerations occurred around the same time the control column was moved aft in order to rotate the aircraft. The lateral accelerations were quite large and could have induced a feeling (tactile input) to the first officer which gave him the impression the aircraft was unsafe to fly. This input may have led the first officer to deem the aircraft to be unsafe to fly and reject the takeoff.

The reason for the large lateral accelerations was probably caused by an external, possibly atmospheric, phenomena. This would be a third time an anomaly could be related to an outside atmospheric phenomena. Up to this moment in time no warnings or failures were recorded on the flight data recorder.

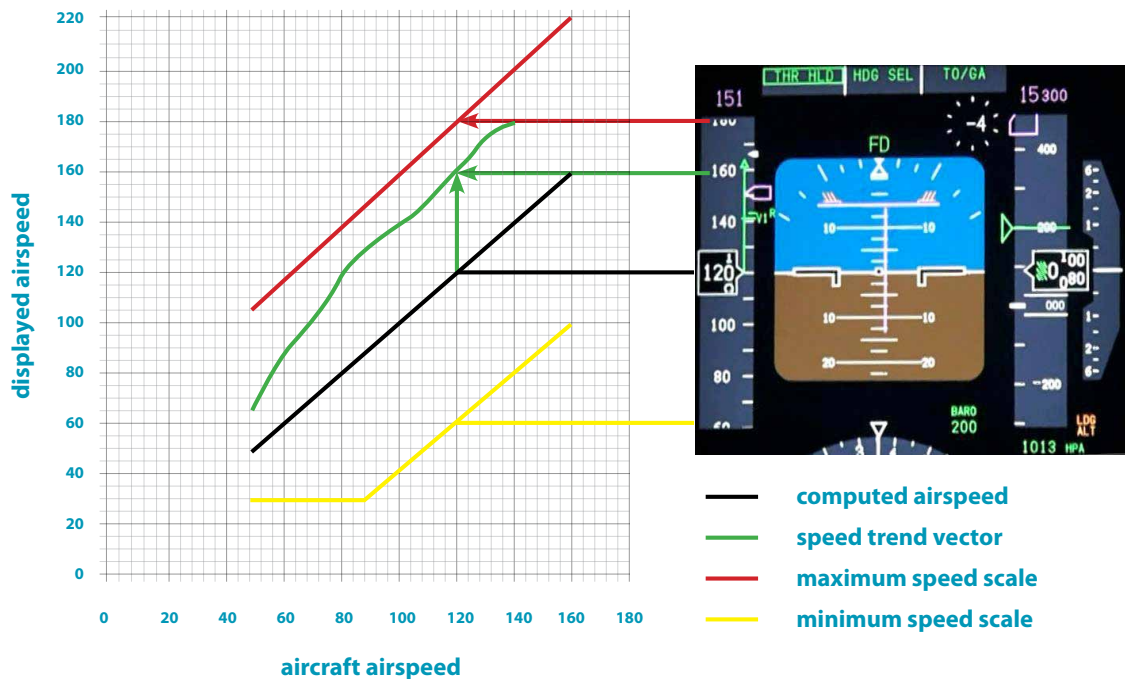
Figure 15: Graphical representation of the recorded airspeed and speed trend vector length.

Apart from the operational investigation, the B737-800 simulator tests were also conducted to determine the length of the speed trend vector during the takeoff roll. Using video equipment the length of the arrow was recorded and analysed later. These tests and video analysis showed that on average the speed trend vector length was approximately 40-45 knots. The maximum the tip of the speed trend vector arrow can point to is 60 knots. During the takeoff roll the length of the speed trend arrow was about 2/3 of the maximum length.

In Figure 15, the yellow and red line depicts the minimum and maximum displayed airspeed on the moving scale tape. In black the displayed airspeed is shown and in green the airspeed which the tip of the speed trend vector. The length of the speed trend vector on the display is the vertical difference between the displayed airspeed (black) and the tip of the speed trend vector (green).
