Investigation Report

AX002-0/05
November 2010

Type of occurrence: Serious Incident
Date: 23 April 2005
Location: Stuttgart
Aircraft: Commercial Aircraft
Manufacturer / Type: Boeing / B737-800
Injuries to persons: One person slightly injured
Damage: Major damage to aircraft
Other damage: None
Information source: Investigation by BFU

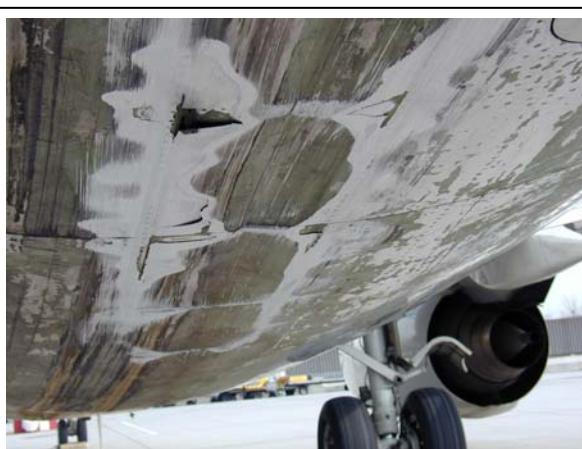
Damage on the lower side of the fuselage

The tail strike caused severe structural damage in the aft fuselage area.

The cause of the tail strike was the extreme tail-heavy aircraft balance, caused by the remaining passengers and their luggage in the aft part of the aircraft.
