ATSB TRANSPORT SAFETY REPORT
Aviation Occurrence Investigation – AO-2006-154
(previously 200601076)
Final

**Warning device event
232 km south of Paraburdoo, WA
28 February 2006**

**VH-NXH
Boeing Co 717-200**

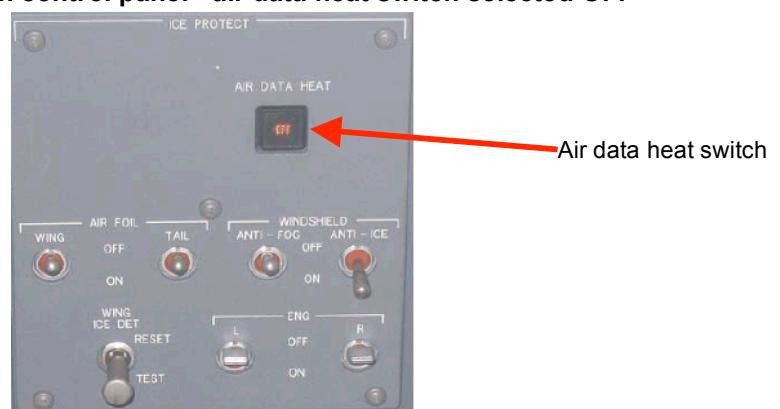
Figure 4: Ice protection control panel - air data heat switch selected OFF

The air data heat switch was part of the aircraft's ice protection control panel (Figure 4). That switch was the only push-button switch on the ice protection control panel, and the only push-button switch in that vicinity. The aircraft's electrical systems were configured so that, when the switch was latched (OFF), the heaters for the aircraft's flight environment data sensors were off, and the switch was illuminated with an OFF annunciation. In that position, the switch protruded about 5.5 mm from the surface of the control panel.

When the switch was unlatched (ON), the flight environment data sensor heaters were on and the switch was not illuminated. In that position, the switch protruded about 7.6 mm from the overhead panel.

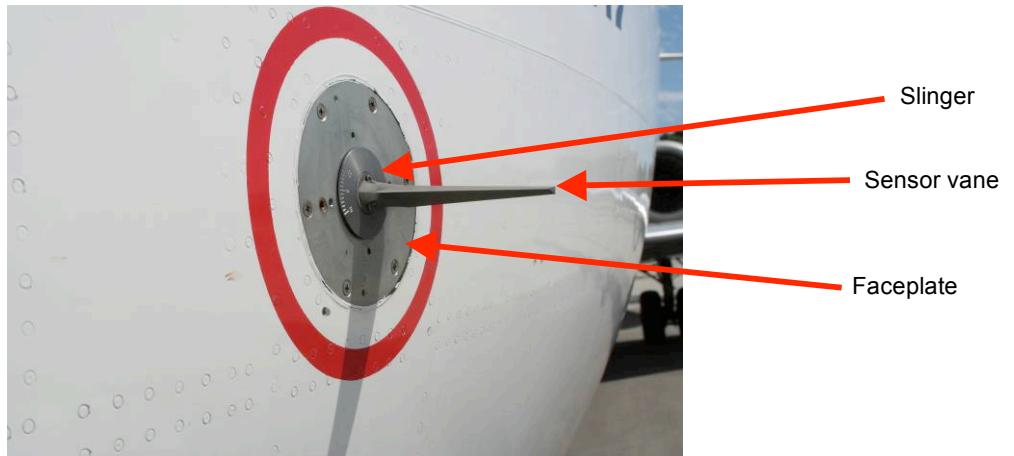
Figure 6: Angle-of-attack sensor

The aircraft was equipped with two angle-of-attack sensors that were mounted on each side of the aircraft’s forward fuselage. Each included an aerodynamically-shaped swept sensor vane that was designed to align with the local airflow (Figure 6).

Each angle-of-attack sensor vane was mounted on a ‘slinger’ and a central shaft assembly. The main structural component was the sensor mounting section, which included a sealed bearing to support the vane-slinger-shaft assembly. The component manufacturer reported that a labyrinth path between the slinger and the mounting section was resistant to water ingestion, while still allowing the sensor to ‘breathe’.
