Air Accident Investigation Unit Ireland

SERIOUS INCIDENT REPORT
Boeing 737-8F2, TC-JGG
Airbus 319, D-AGWJ
Dublin Airport, Co. Dublin
16 October 2010

AAIU Report No: 2011-019

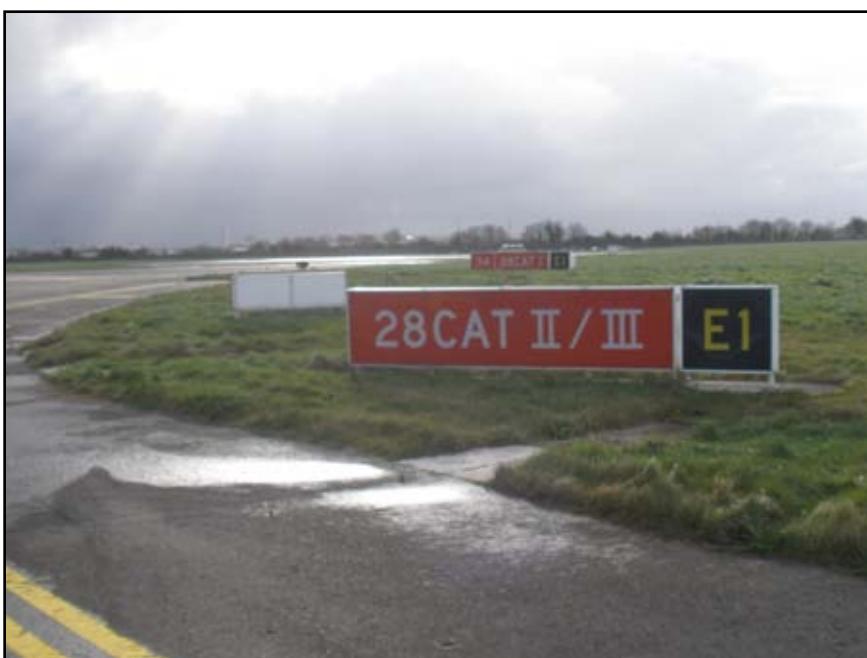
Photo No. 1: TWY E1 Cat II/III Holding Position for RWY 28

As an aircraft taxied along TWY E1 from TWY F1 towards the thresholds of RWY 28 and RWY 34, it first encountered the ILS Cat II/ III holding position for RWY 28. This was marked by runway designation/Cat II/III holding position signage in accordance with the requirements of ICAO Annex 14 - Aerodromes. These signs were located in the grass verges on both sides of TWY E1, and displayed "28 CAT II/III" in white against a red background, **Photo No. 1**. At the same point, there were two large rectangular signs painted on the taxiway surface, one on either side of the centreline, with "34 28" in white against a red background. These were immediately followed, in the direction of taxi, by double yellow lines painted across the taxiway, as per runway-holding position marking "Pattern B", as defined in ICAO Annex 14, see **Appendix C**.

This point was marked by ICAO standard signage on both sides of the taxiway and by painted signage on the taxiway surface. As this holding position was normally only active during low-visibility conditions, it was not in use at the time of the incident. Nevertheless the signage should have alerted the crew to the fact that they were approaching the active RWY 28.

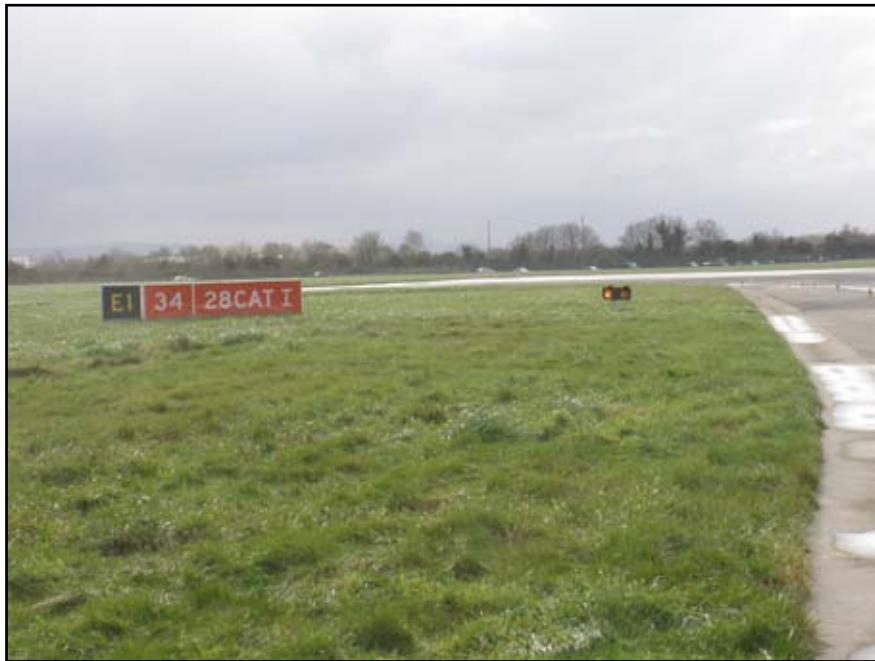
Photo No. 2: TWY E1 Cat I Holding Position RWY 28, Holding Position RWY 34

Approximately 60 m further along TWY E1, a taxiing aircraft encountered the combined holding position signage for RWY 28 ILS Cat I and for RWY 34. These were red and white signs marked "34 28CAT I" accompanied by yellow flashing runway guard lights, mounted in the grass verges on both sides of the taxiway, **Photo No. 2**. At the same point, there were two large rectangular signs painted on the taxiway surface, one on either side of the centreline, with "34 28" in white against a red background. There were also double yellow solid lines and double yellow broken lines painted across the taxiway, as per runway holding position marking "Pattern A", as defined in ICAO Annex 14, see **Appendix C**.

In these circumstances, the Investigation considers that the provision of a stopbar facility at the combined holding position of RWY 34 and RWY 28 Cat I on TWY E1 would provide an additional degree of protection against runway incursions at this location. This is in accordance with the guidance provided in ICAO Annex 14. A Safety Recommendation is issued to the DAA, in conjunction with the IAA (as the ATC service provider), in this regard.

The Investigation notes that stopbar lights were introduced into service at the combined holding position of RWY 34 and RWY 28 Cat I on TWY E1, and also at TWY B7 protecting RWY 10, on 25 October 2011. Further information is provided in Section 4 Safety Recommendations.

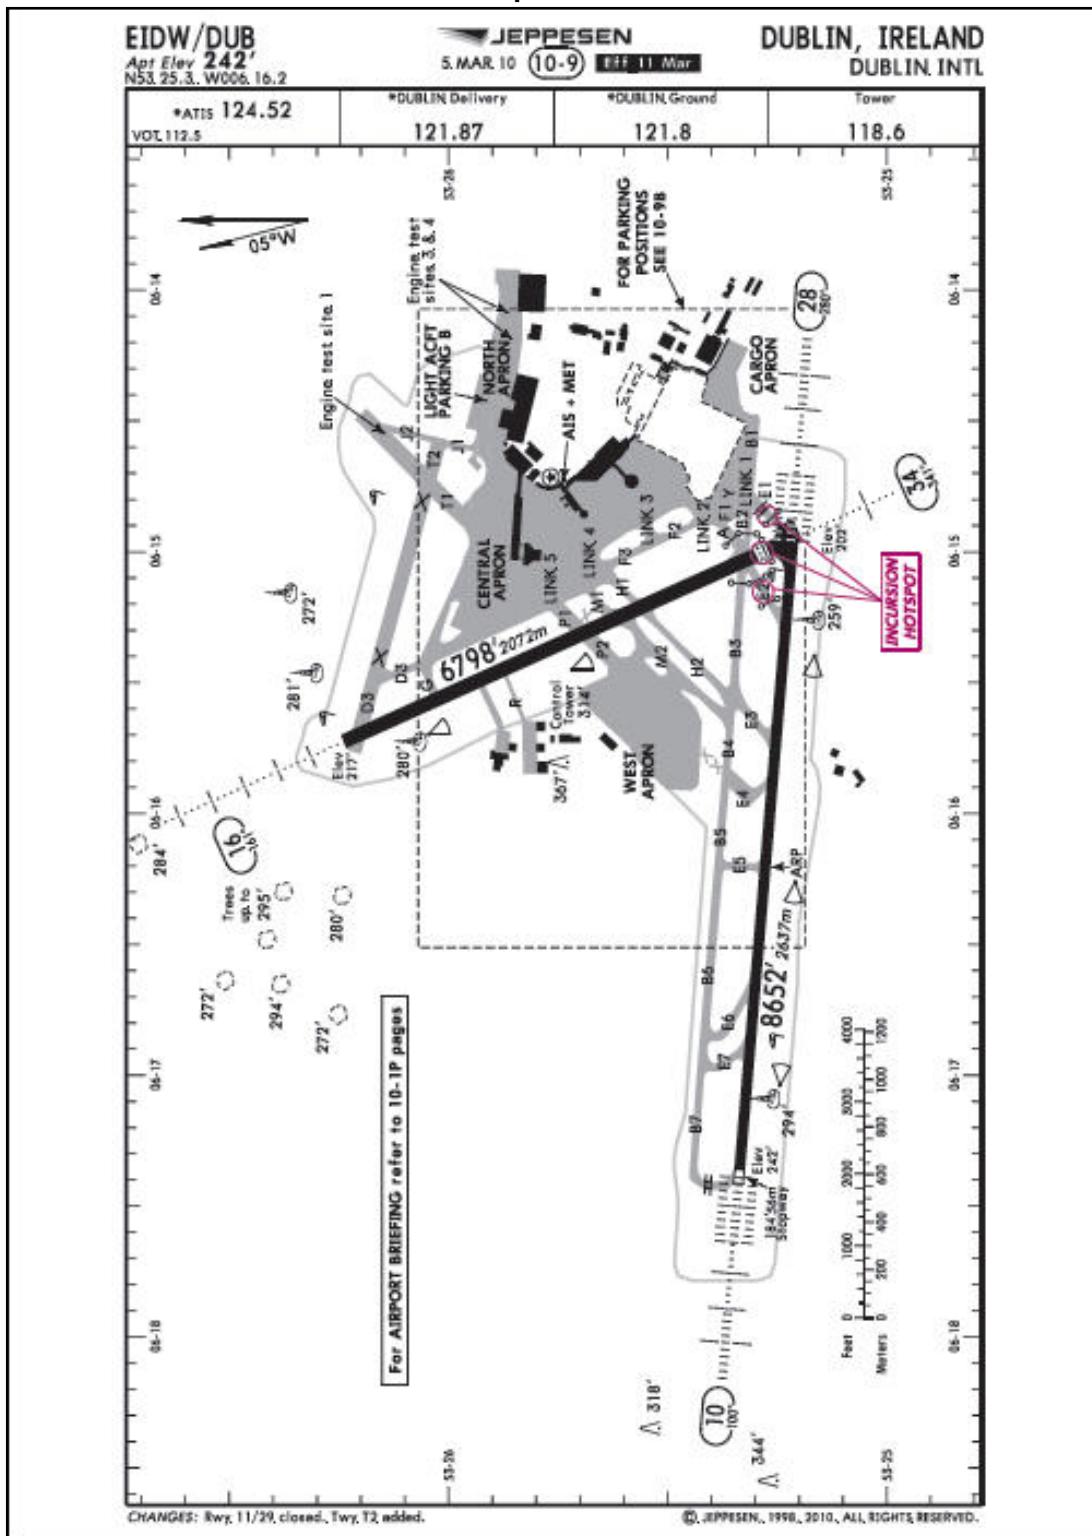
On EIDW Airport Chart 10-9 (**Appendix A**), the holding position for RWY 28 on TWY E1 was designated as an "Incursion Hotspot". ICAO defines a hot spot as "*a location on an aerodrome movement area with a history or potential risk of collision or runway incursion, and where heightened attention by pilots and drivers is necessary.*"
