# Report

Serious Incident on **11 January 2010**  
At **Lagos Aerodrome (Nigeria)**  
To the **Boeing 777-300ER**  
Registered **F-GSQI**  
Operated by **Air France**

**BEA**

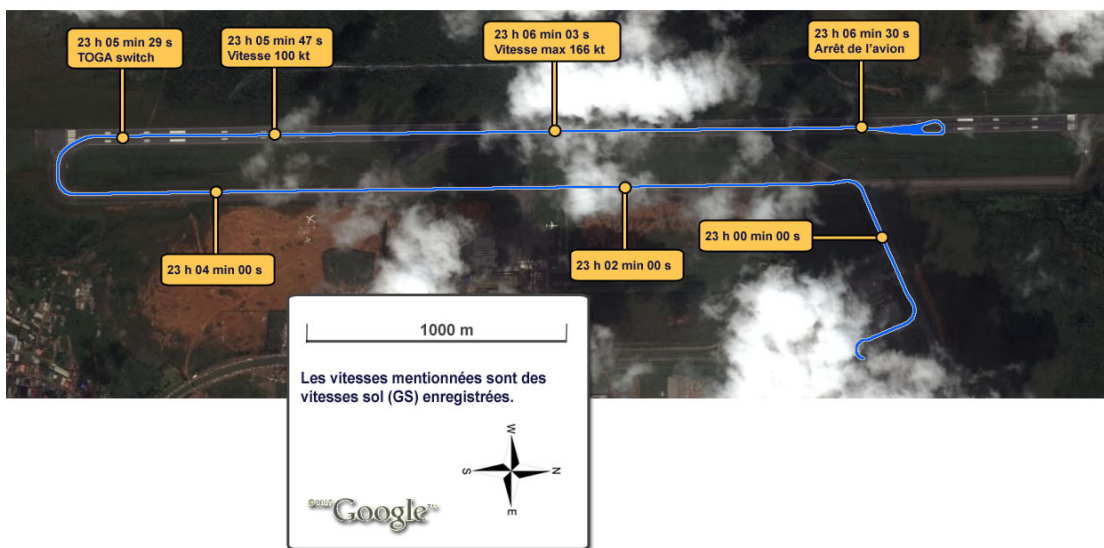
At 23 h 05 min 58, the copilot announced "*rotation*". The aircraft by then had travelled about 1,500 meters. Two seconds later the Captain announced "*abort takeoff*". The CAS recorded on the FDR was then 155 kt. The maximum airspeed of 164 kt was recorded 3 seconds later.

The automatic braking system of the aircraft was activated<sup>(3)</sup> and the aircraft stopped about 900 meters from the end of the runway at 23 h 06 min 30.

Partial flight path of F-GSQI calculated from the parameters recorded on the FDR

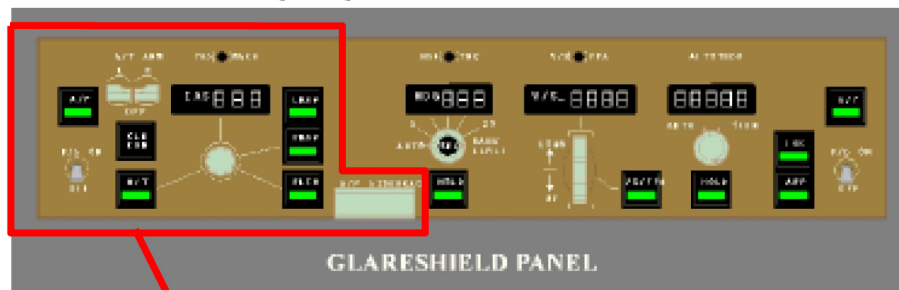
Representation of the Boeing 777-300ER MCP

The auto-throttle is armed by the 2 A/T ARM switches on the MCP beside the Captain (see the illustration above).

The autopilot is engaged by pressing one of the A/P pushbuttons (see reference 1 in the figure above). Engaging the AP results in the display of A/P on the PFD and the switching on of the green light on the corresponding pushbutton.

- ❑ The Captain noticed the auto-throttle did not engage when he pressed the TO/GA switches.
- ❑ The Captain removed his hand from the thrust levers to arm the auto-throttle on the MCP. Without noticing it, he engaged the autopilot while doing so.

On 22 January 2010 Boeing issued a service bulletin advising of the release of a new software version of the autopilot calculators preventing its involuntary engagement on the ground during the takeoff roll. Air France has applied the service bulletin on its entire Boeing 777 fleet.
