Tail strike on runway during night landing

Airplane	McDonnell Douglas MD-81 registered OY-KHP
Date and time	6 February 2010 at 18h25 ⁽¹⁾
Operator	Scandinavian Airlines System (SAS)
Site of accident	AD Grenoble-Isère (38)
Type of flight	Public transport of passengers Unscheduled international flight
Persons on board	Captain (PNF); Co-pilot (PF); 4 PNC; 127 passengers
Consequences and damage	Rear part of fuselage seriously damaged

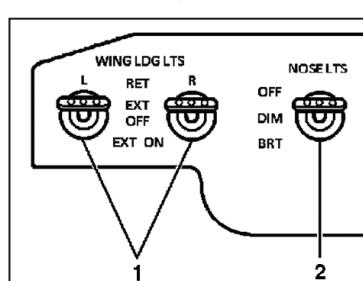
- OFF position: lights off
- DIM position: lights on, dimmed
- BRT position: lights on, bright

According to the pilots' interview, SAS crews are encouraged to favour the "DIM" position for the lights, as the lights in "BRT" position undergo considerable wear and tear. Most night landings are carried out with lights in "DIM" position. However, the operating manual allows the crew to judge the level of lighting best adapted to external conditions.

The landing lights were set at the dimmest level ("DIM" position). The fact of being used to setting the lights in this position probably contributed to the crew deciding not to increase the brightness of their lights, even though they could. Maximum lighting would probably have allowed for an improved perception of distance and height in relation to the runway on short final.

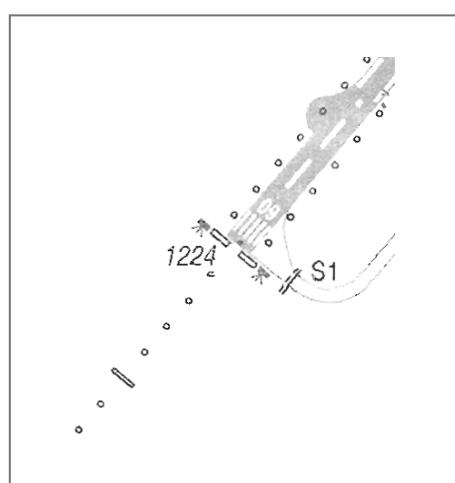
Symbol presented on the SIA aerodrome chart

Grenoble airport's lighting is simplified approach lighting. It covers a distance of 420 metres and has a crossbar located 300 metres from the runway threshold, as indicated on the aerodrome chart published by the SIA (French Aeronautical Information Service).

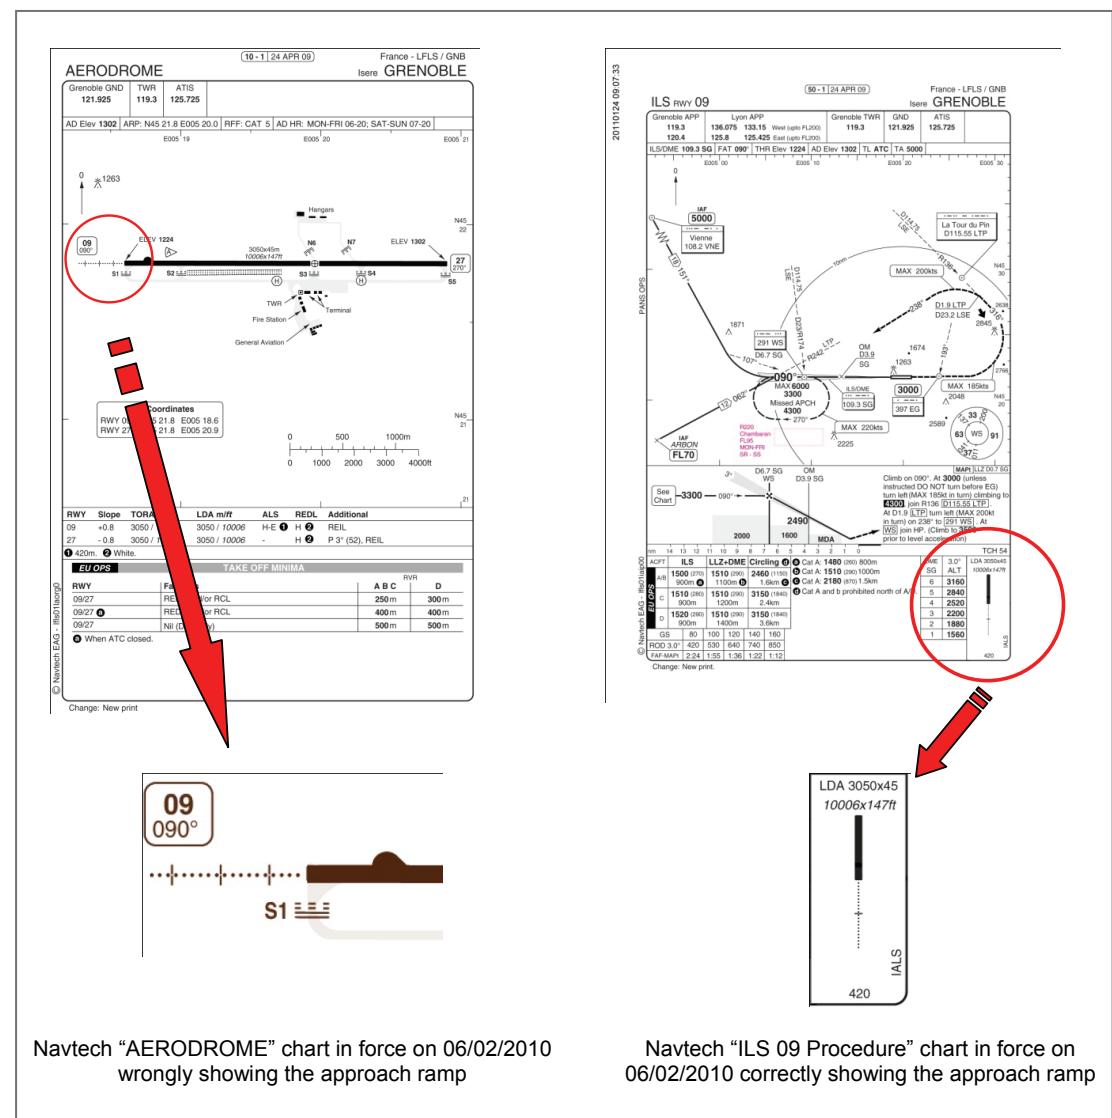
On the day of the accident, the "AERODROME" Navtech EAG chart indicated that the approach lighting system was at least 900 m long and had 3 crossbars, whereas in reality it was only 420 m and had only one crossbar.

The "ILS 09 Procedure" chart however showed the approach lighting system correctly.

Since the accident, this inconsistency has been corrected by Navtech.

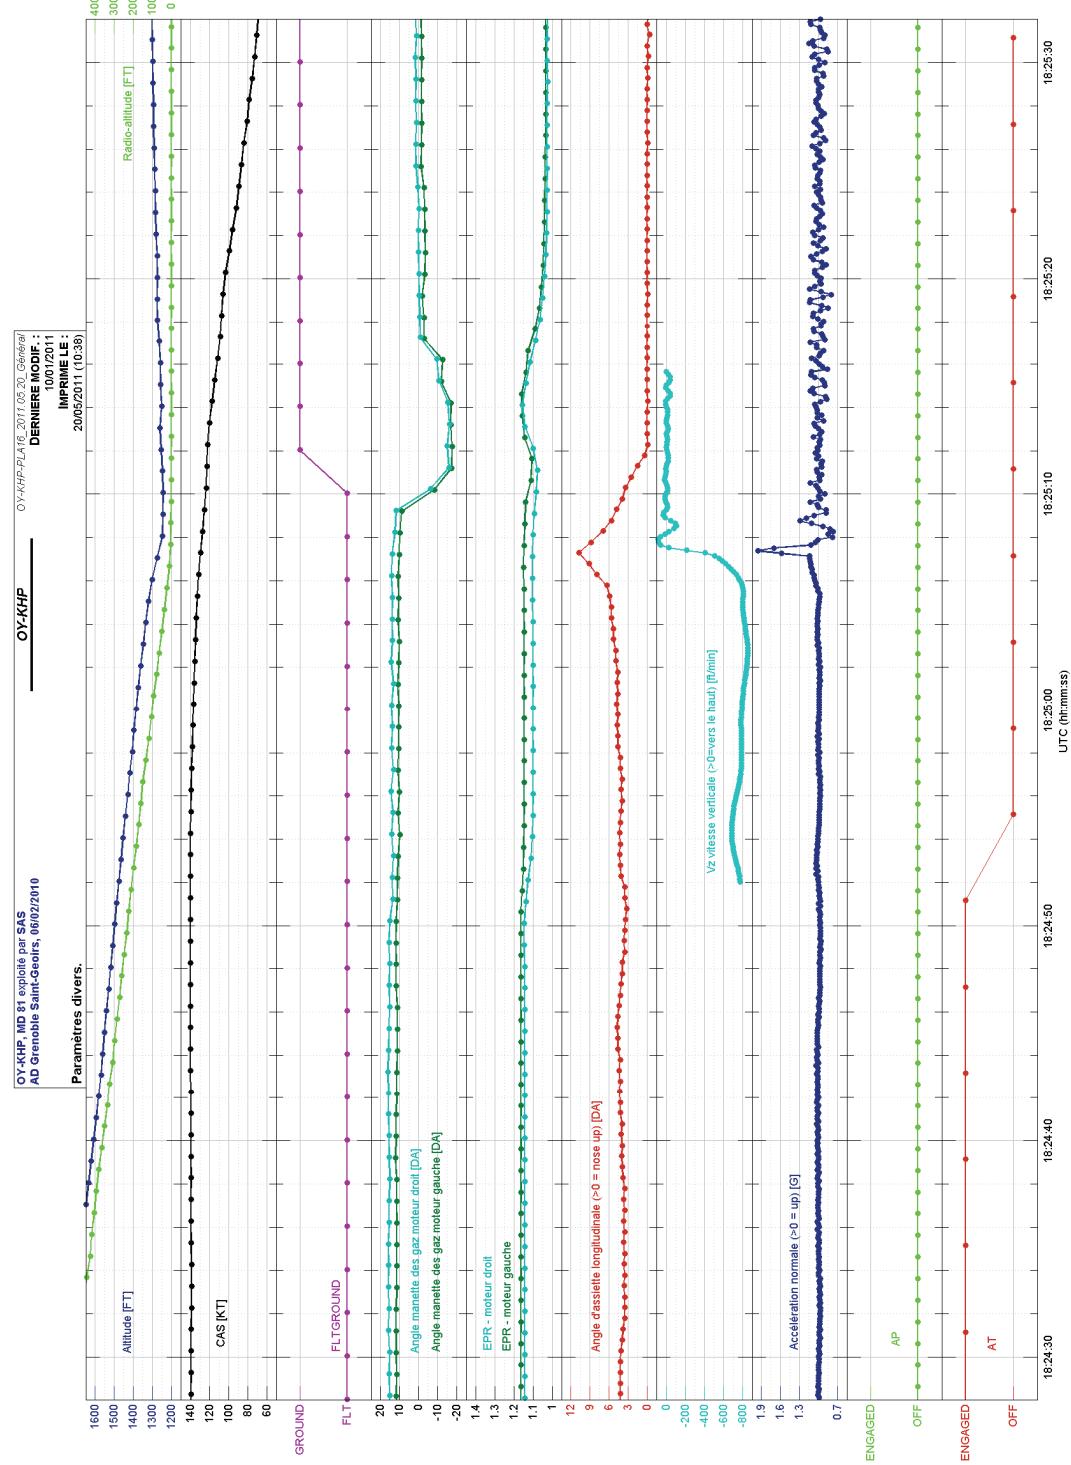
Graph of FDR parameters

At 100 ft, the IAS started to decrease and went below Vapp. The rate of descent increased and reached 850 ft/min. The pitch attitude was 4° nose up and began to increase slightly.

At a height of 30 ft, the airplane went slightly below the glide path and the IAS was Vapp - 4 kt.

At a height of 15 ft, the elevator was sharply moved to nose up, leading to a swift increase in pitch attitude.

Two seconds later, the rear of the fuselage touched the runway, with a pitch attitude of 10.7°. The marks left on the runway indicated a point of contact 166 metres before the touchdown zone. The vertical acceleration value reached a maximum of 1.95g. Two seconds later, the thrust levers were retarded and the thrust reversers were deployed. The airplane then taxied to the parking ramp.
