AIR ACCIDENT INVESTIGATION DEPARTMENT

AIR SERIOUS INCIDENT INVESTIGATION REPORT

AIRCRAFT SUBSTANTIAL DAMAGE AFTER COLLISION WITH PAPI LIGHT DUE TO RUNWAY CONFUSION

CL600-2B19
A6-BNH
Gama Aviation FZC
Dubai International Airport,
United Arab Emirates
9th May, 2011

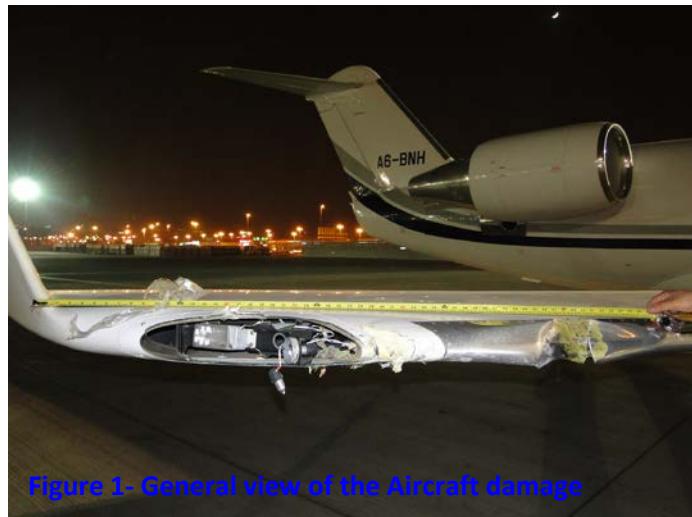
Because of impacting the PAPI light unit, the right wingtip leading edge was deformed, the wingtip fairing lower skin was torn, the right strobe light and its fixing bracket detached.

The front right wing spar sustained a minor dent.

Figure 1- General view of the Aircraft damage

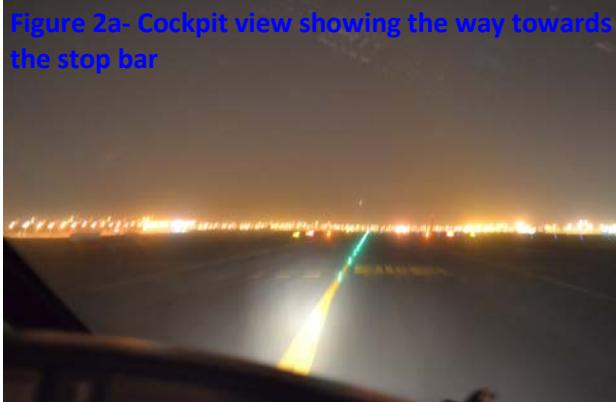
The test revealed no physical or marking distraction along the taxi path from the departure point up to the runway. On the other hand, floodlights, fixed at a position directly opposite to the stop bar, were emitting intensive light that might be of some influence on eyesight in cases of long waiting at RWY 30L stop bar (figures 2a and 2b).

Figure 2a- Cockpit view showing the way towards the stop bar

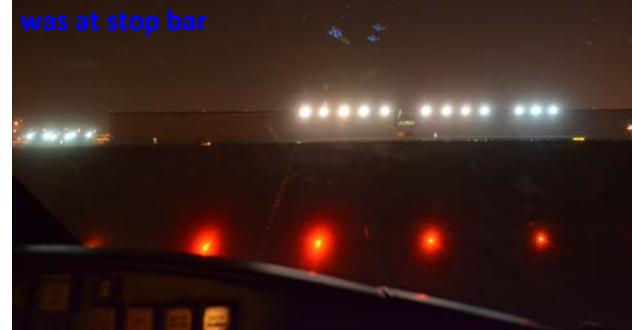
Figure 2b- Cockpit view showing the flood lights as perceived from the cockpit when the test aircraft was at stop bar

The 1 minute 22 seconds of waiting at the hold position might not be long time enough to affect the crew eyes sight by the high intensity floodlights in front of the RWY 30L stop bar, but the investigation could not determine whether longer times might affect crew eyes' performance.

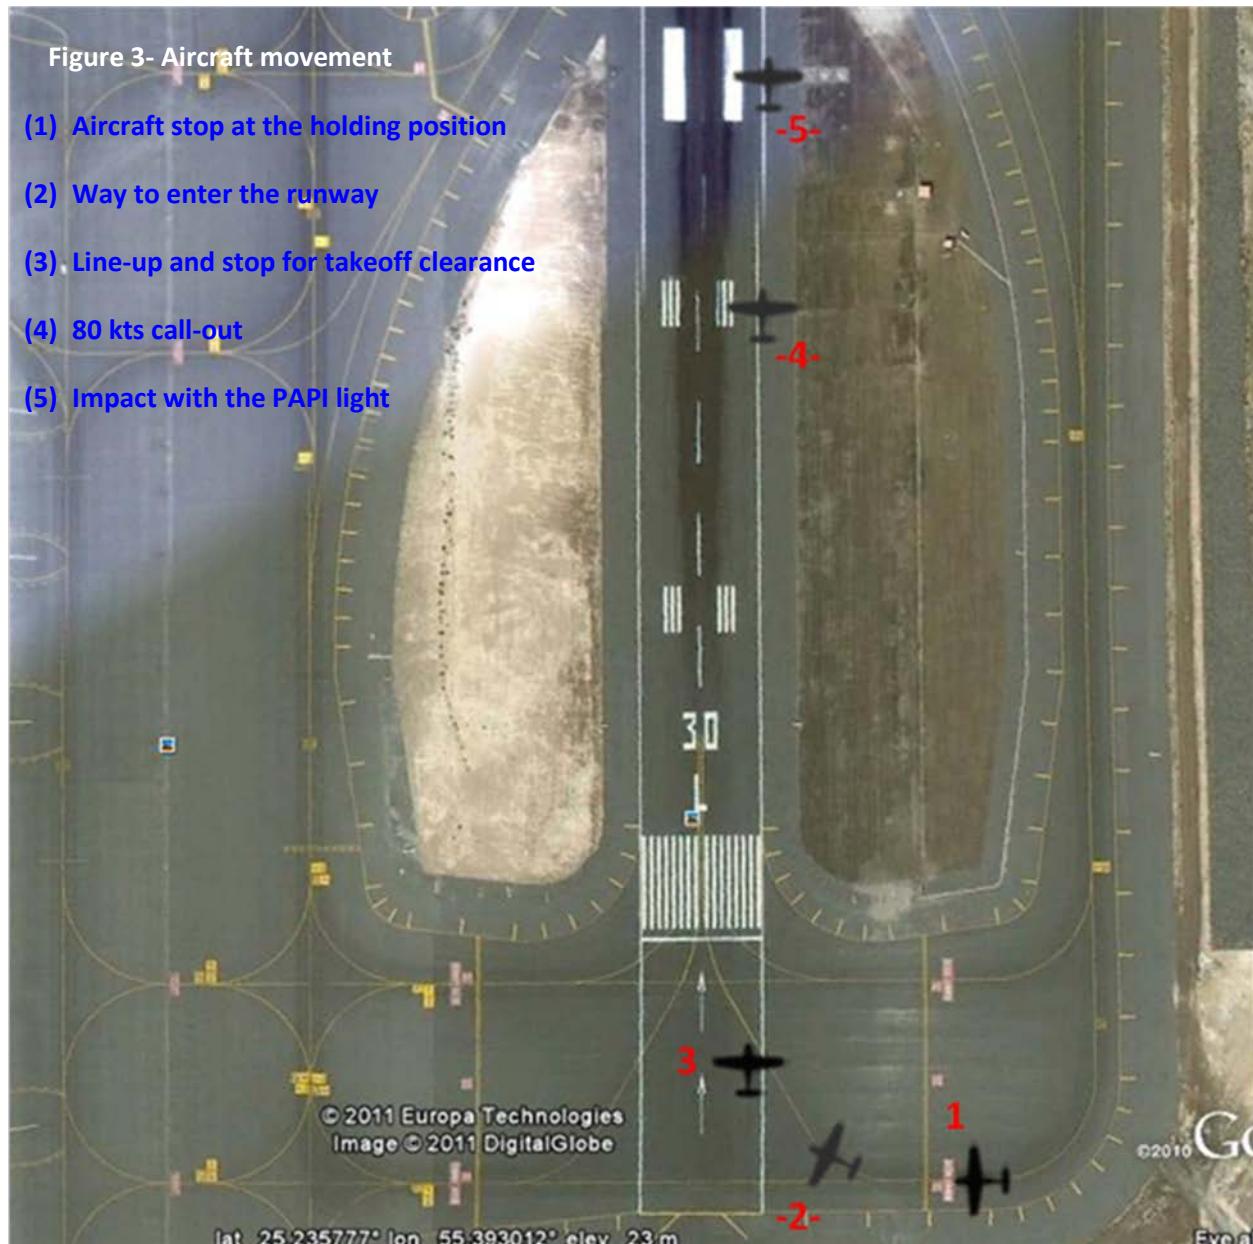
The period, from the point of Aircraft stoppage at the runway holding position until the Aircraft started the takeoff, could be divided into three time segments. During each segment, the crew were busy on activities that deviated from their primary tasks on runway entry which took away their attention to the situation of the Aircraft in relation to the runway's lines and/or lights (see figure 3):

- The first time segment was when the Aircraft was waiting for a preceding landing of B777 aircraft; the crew were busy with monitoring the landing aircraft since they should determine the safe time of entering the runway (Position 1 in figure 3);
- The second time segment was while the Aircraft was moving towards the runway, entering and taxiing until it stopped before the threshold; the crew were busy with performing the “Before Takeoff Checklist” (Position 2 in figure 3); and
- The third time segment was when the Aircraft stopped before the runway threshold waiting for takeoff clearance; the crew were busy for obtaining the takeoff clearance and transfer of control (Position 3 in figure 3).
