# **Air Accident Investigation Central Directorate**

**Final Incident Report**

**Involving Emirates Airlines**

**At Khartoum Airport**

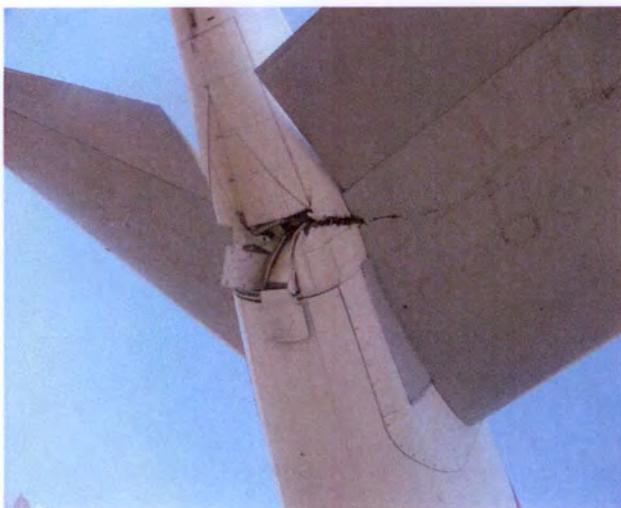
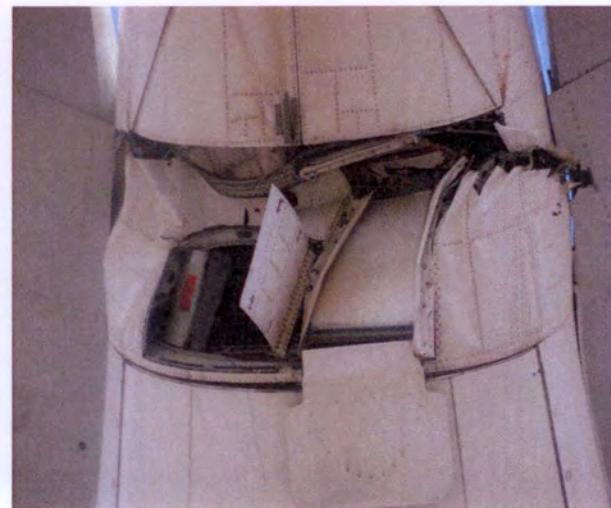
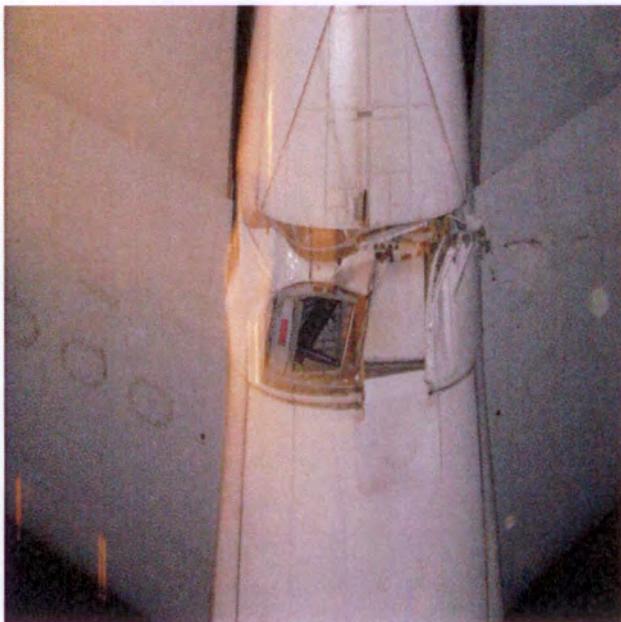
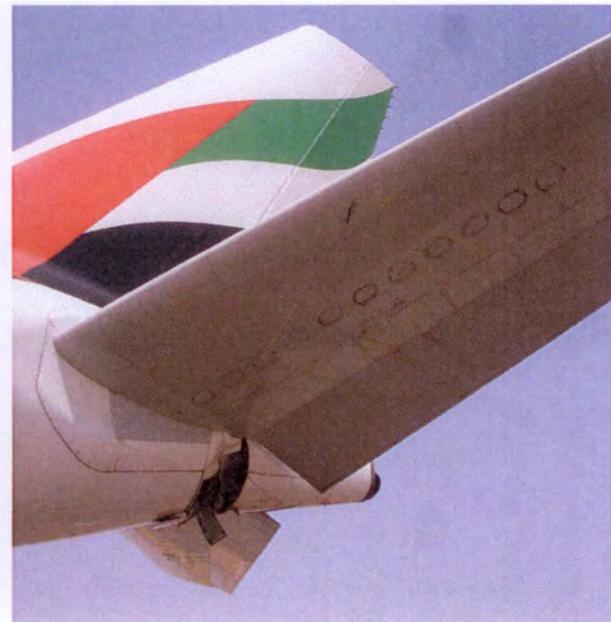
A345 was substantially damaged. A332 was slightly damaged.

- The left winglet of KLM sustain slight damage
- Emirates A345 observed damage as follows:-
- Left hand stabilizer.
- Aft Fuselage lower frame.
- APU inlet splitter.
- APU fire bottle compartment access door.
- Right hand stabilizer.

- Left winglet damage.

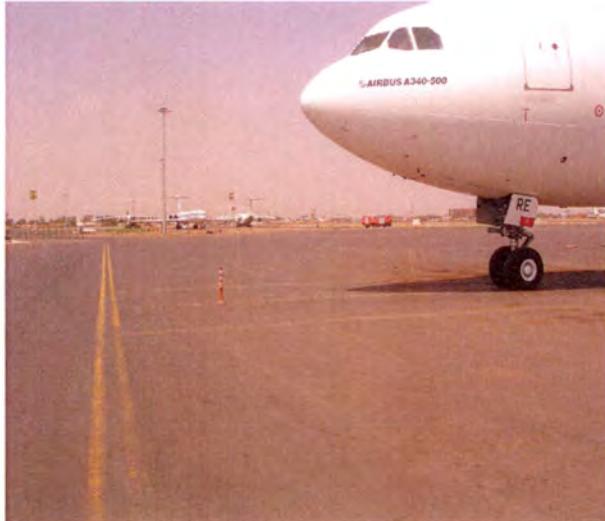
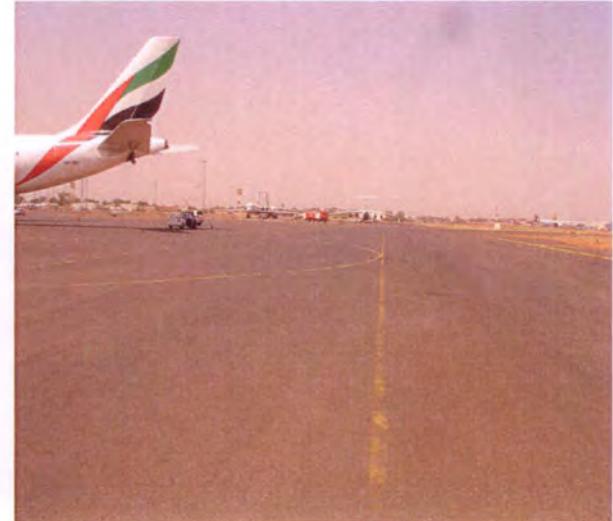
- 1- The distance from taxilane centre line to its eastern edge is 15.55m and to its western edge is 11.5m.
- 2- A345 was parked on stand with nose wheel located approximately 10.75m from the edge of the service road. The distance of the aircraft nose located approximately 4.6m from that edge, clearance between parked aircraft and objects is not assured (Annex 14 v1 chapter 5).
- 3- The distance between the taxilane centre line and aft edge of aircraft was 22.25m. Wingtip clearance is not assured (Annex 14 v1 chapter 5).

- 4- The distance between the taxilane centre line and the point of contact was 25.75.
- 5- A345 wings extended beyond the parking bay restraint line by 5.65m and 6.25m to the left and right respectively.
- 6- The Airtraffic Controller on duty at the tower during the incident was recently transferred (one month) to Khartoum Tower from Area Control Centre without prior briefing or refresher training.

- 1-Approved SMS for Khartoum Airport is highly recommended.
- 2-All apron aircraft stands specifications should be according to ICAO requirements taking into consideration the types of aircraft that could use them.
- 3-Special procedures should be published reflecting the non-conformities to ICAO Standards in respect to taxiways and parking restrictions and circularized to all stakeholders.

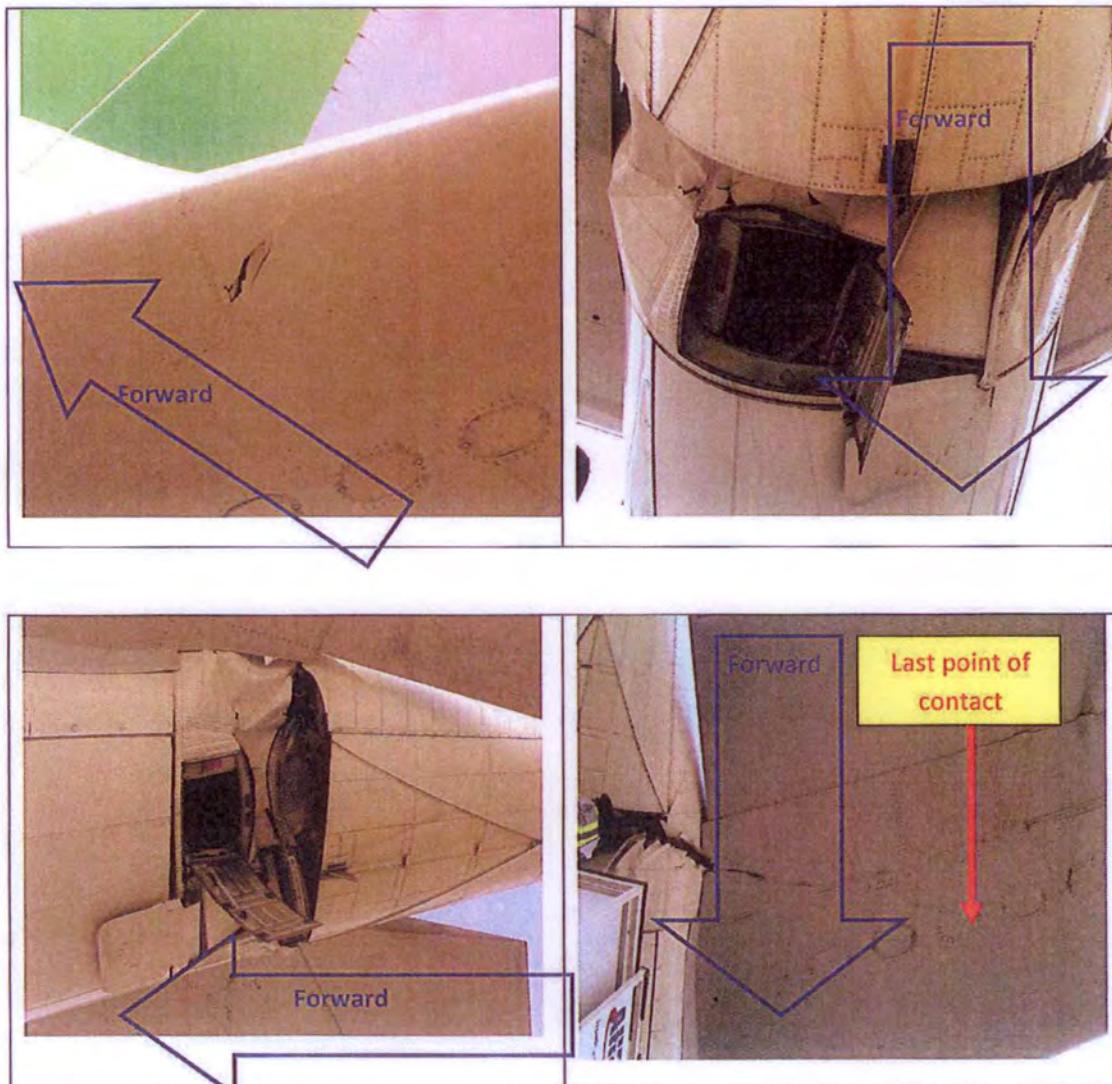
The A345 aircraft sustained damage to the tail cone, aft fuselage lower frame 91, the left and right stabilizer, APU inlet splitter and the APU fire bottle compartment access door (see pictures below). The A332 aircraft sustained damage to the left winglet. The 345 flight was cancelled and the aircraft was removed from service for repairs. The A332 aircraft was released for service.

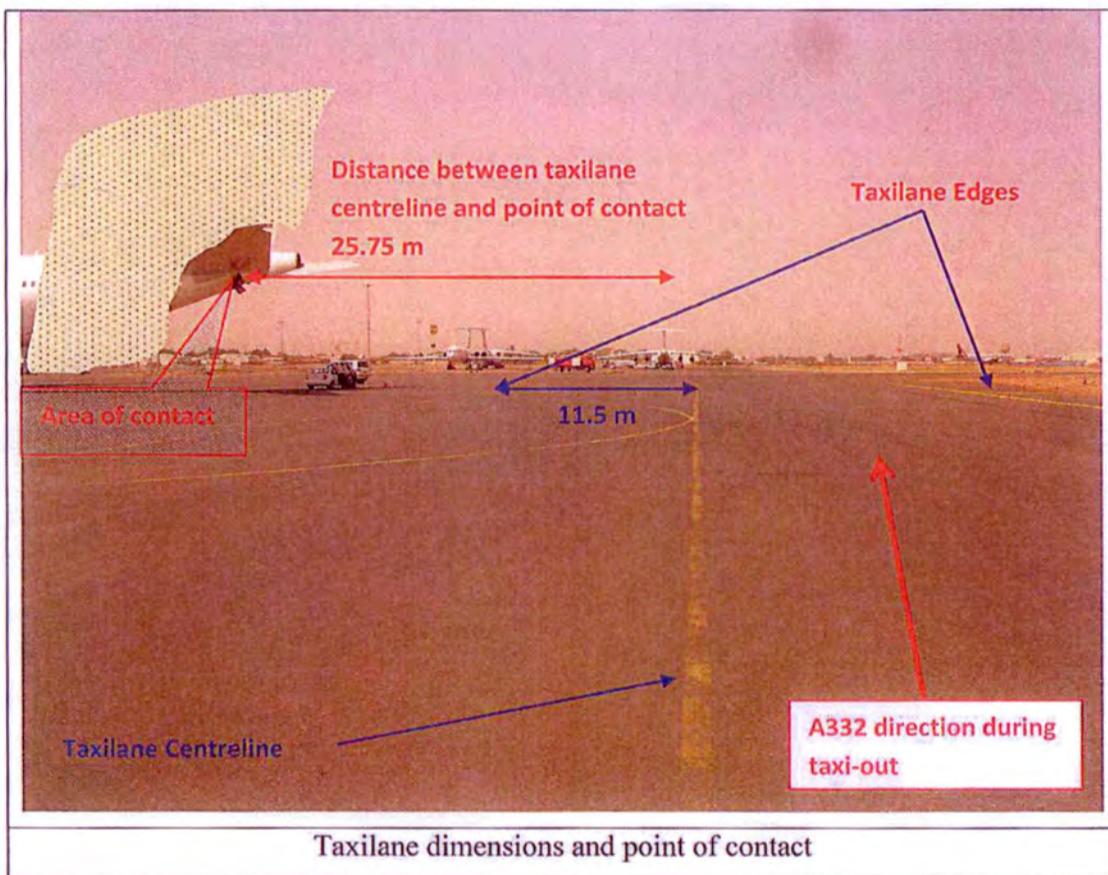
The KRT airport taxilane is 23 metres wide, and meets the ICAO Annex 14 specification for design of taxiways. The ICAO Annex 14 recommends that the design of the taxiway should be in a way that when the cockpit of an aeroplane for which the taxiway was intended remained on the taxiway centreline, the distance between the outer main gear and the edge of the taxiway should not be less than 4.5 metres. The taxilane design at KRT meets the criteria for accommodating aircraft based on the distance between the outer main gear and the edge of the taxiway. No provision was made for ensuring the aircraft on taxi maintaining the centreline were clear of obstacle that were on the apron side of the taxilane.

A scaled aircraft was overlaid on a Google Earth to simulate aircraft taxi and the available clearance. The simulation concluded that it was not possible to ensure safe passage of an A332 aircraft behind a parked A345.

It also concluded that safe passage of an A332 aircraft behind another A332 aircraft was only possible if the aircraft operating on the taxilane had the nosewheel either on the taxiway centreline or slightly to the right of the centreline.
